DEPARTMENT OF THE ARMY
OFFICE OF THE DEPUTY CHIEF OF STAFF, G-9
600 ARMY PENTAGON
WASHINGTON, DC 20310-0600

September 18, 2023

RE: Letter Report for Downhole Video Inspection for Well BGMW08, Fort Wingate Depot Activity, McKinley County, New Mexico. EPA# NM6213820974

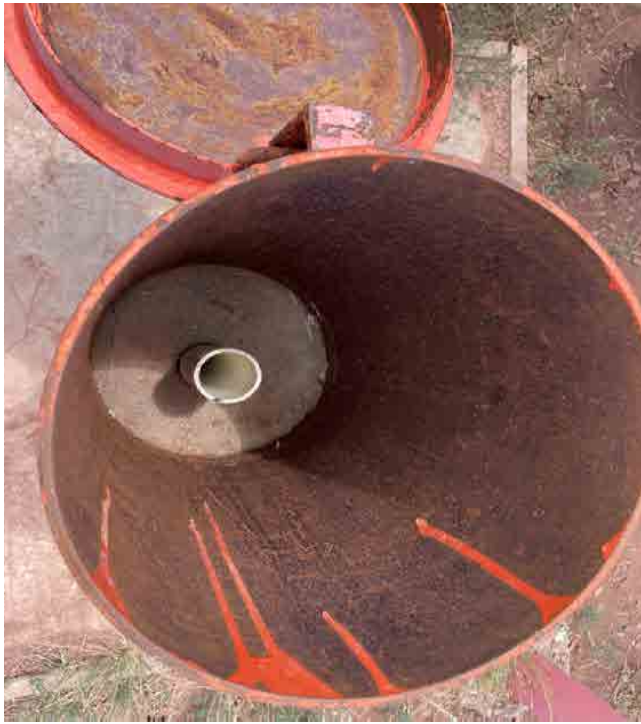
Photograph #1

Description of Photograph:
Well head of BGMW08.

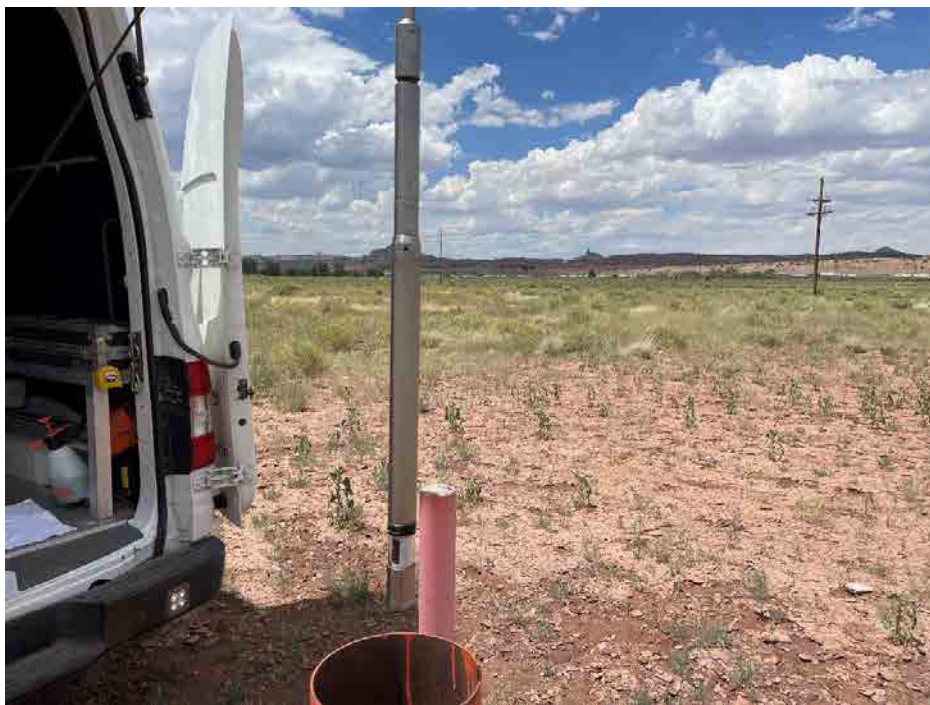
Photograph #2

Description of Photograph:
Downhole camera suspended prior to exploration.

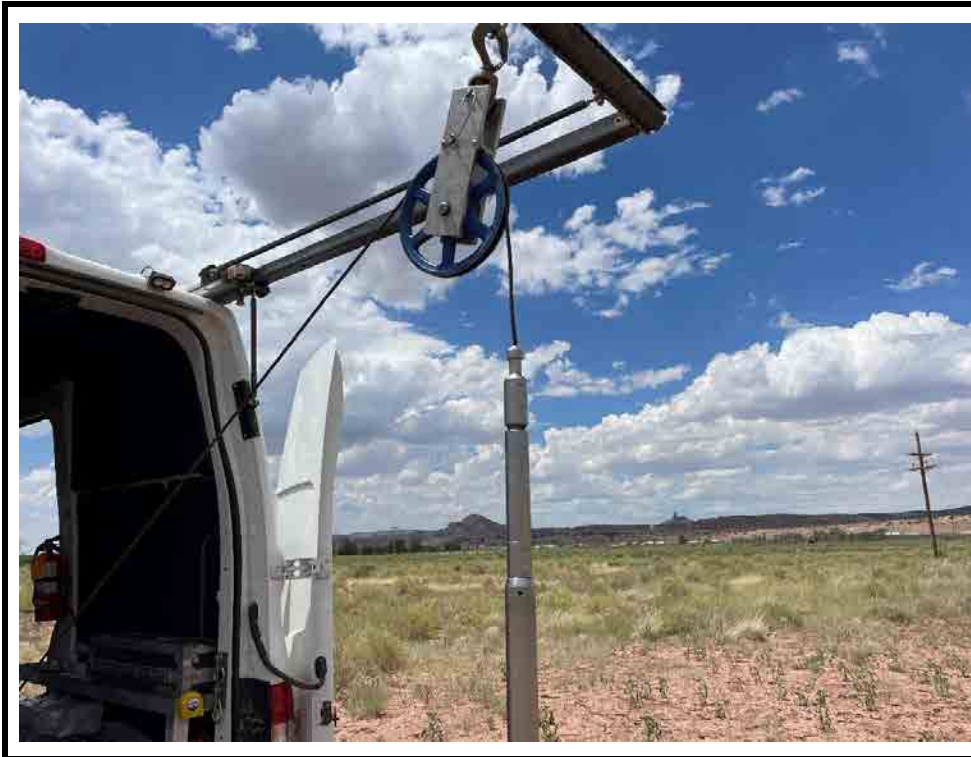
Photograph #3

Description of Photograph:
Camera pulley system.

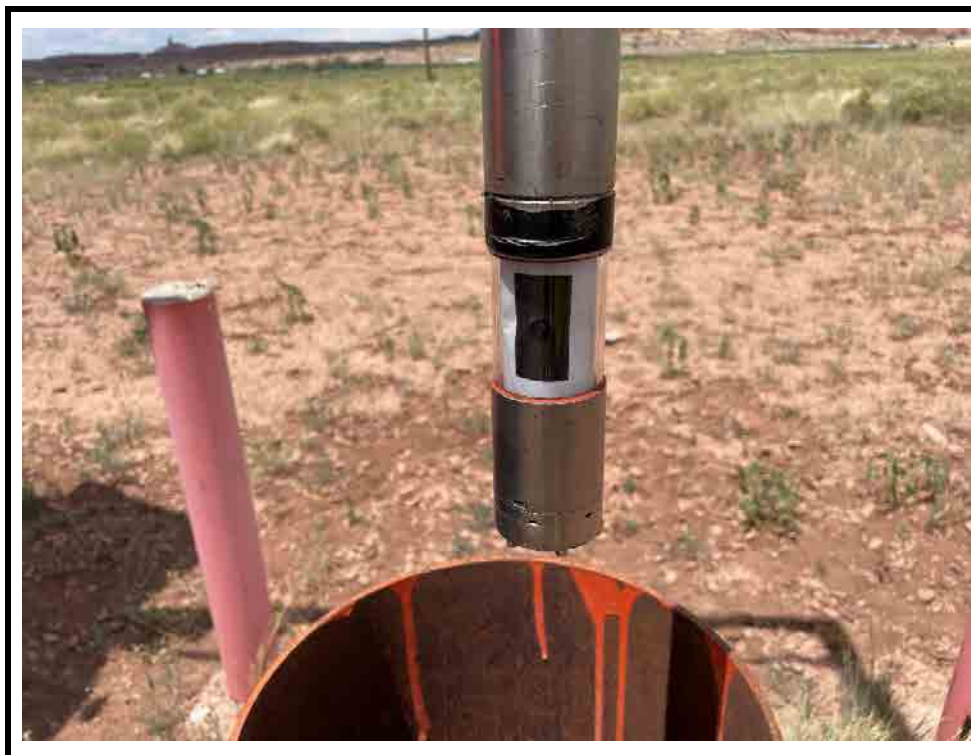
Photograph #4

Description of Photograph:
Downhole camera side view.
