# FORT WINGATE DEPOT ACTIVITY McKINLEY COUNTY, NEW MEXICO

# SURVEY OF BUILDINGS IN THE ADMINISTRATION AND WORKSHOP AREAS

U.S. ARMY CORPS OF ENGINEERS FORT WORTH DISTRICT

**April 9, 2008**

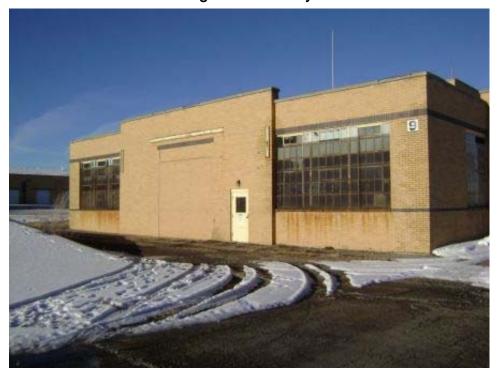
Building 9 Northeast corner looking southwest at east end of building. Building 12, Navajo Nation Food distribution warehouse in background.

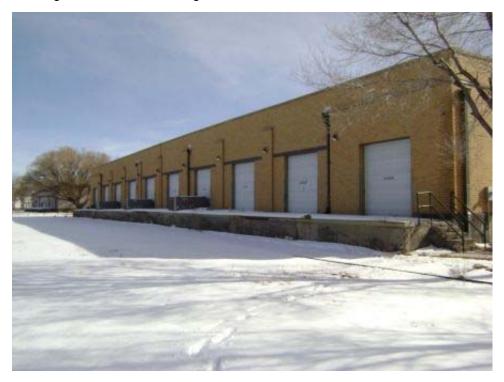
Building 13 Northwest corner of building looking east showing North side of structure. Note refrigeration condenser units on dock. Also shown is deterioration of steps and dock in foreground. Building 14 in background.

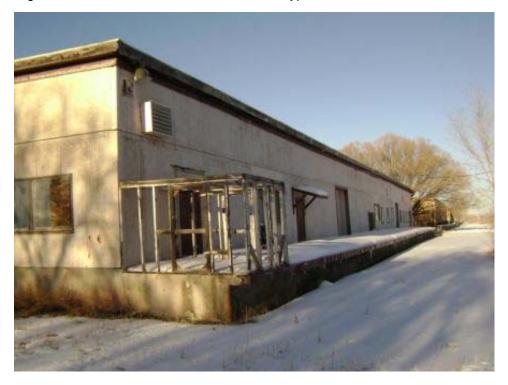
Building 14 North side of building. Framework on dock was for trash storage. Note condition of roof facia.

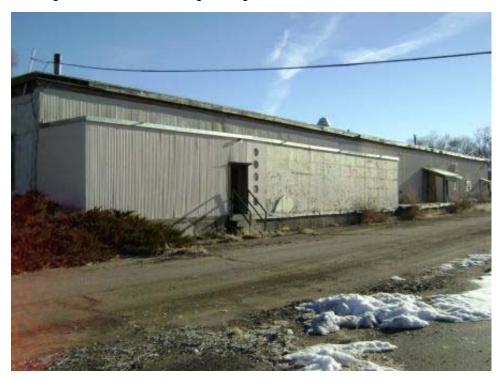
Building 14 South side of building looking northeast. Note poor condition of roof/facia at southwest corner.

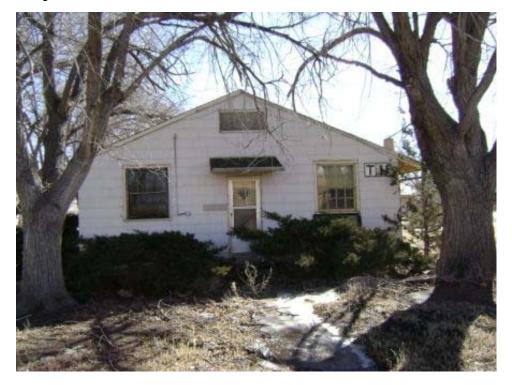
Building 16 West end of building looking east.

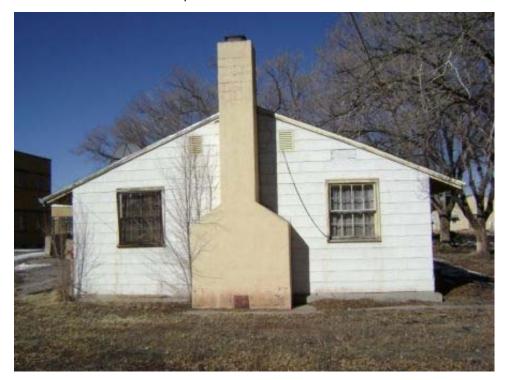
Building 16 East end of building. Note missing and broken transite shingles.

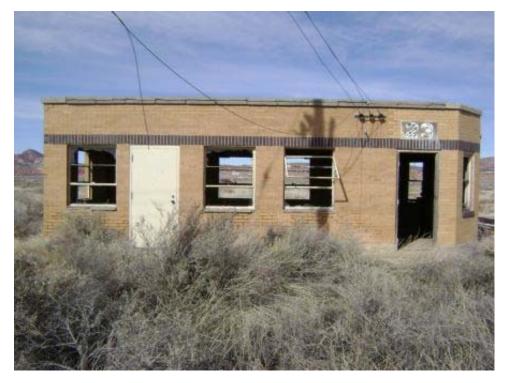
Building 23 South side of structure looking north. Note missing window glass and damaged roof coping.

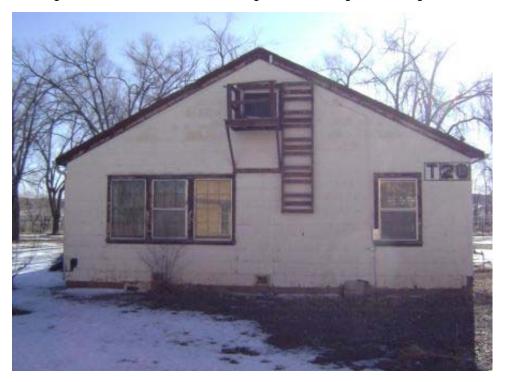
Building 28 West side of structure looking east. Note damaged transite siding and external second floor access.

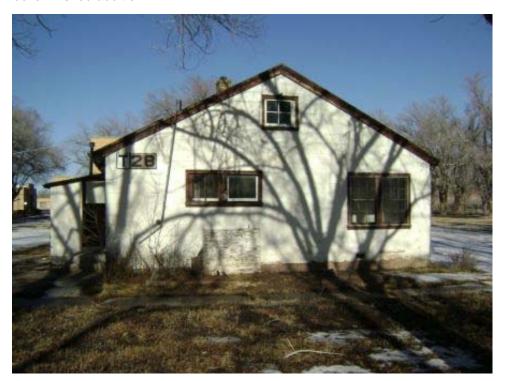
Building 28 East side of structure looking west. Note damaged transite siding.

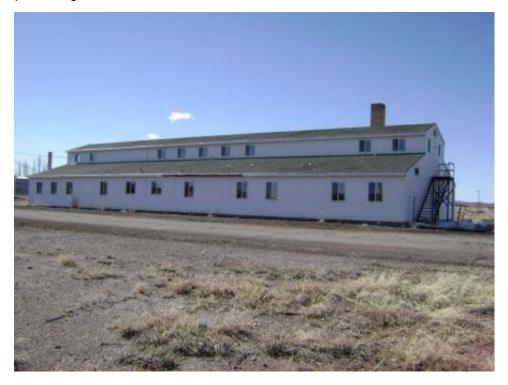
Building 30 Northeast corner looking at east side. Note poor condition of roof shingles. Transite siding remains under metal siding.

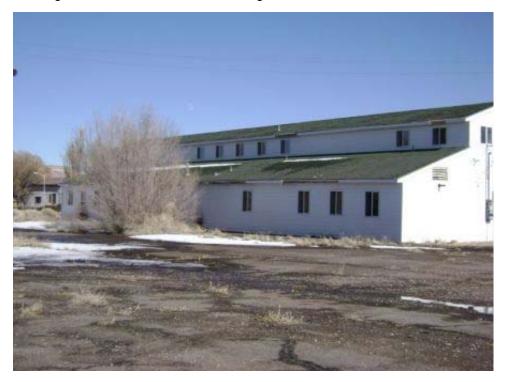
Building 30 Southwest corner looking at west side. Note condition of roof and facia.

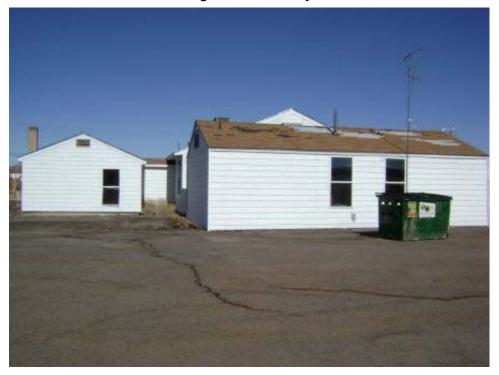
Building 31South face of structure showing 2 additions. Note wind damaged roof. Dumpster is for use by FWDA caretakers.

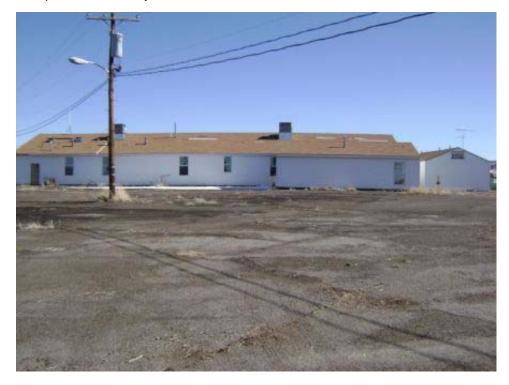
Building 31 West face of structure. Note roof mounted AC units and damaged shingles. Gas service entrance at left (north) end of building.

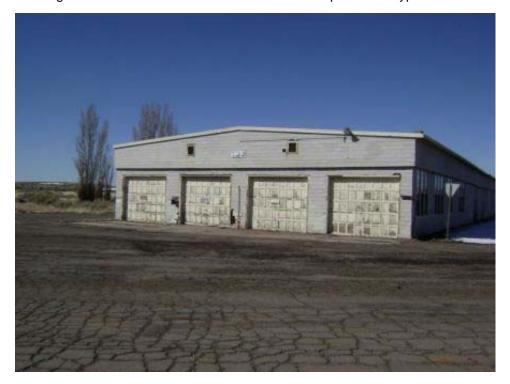
Building 33 East end of structure. Note poor condition of transite siding and doors.

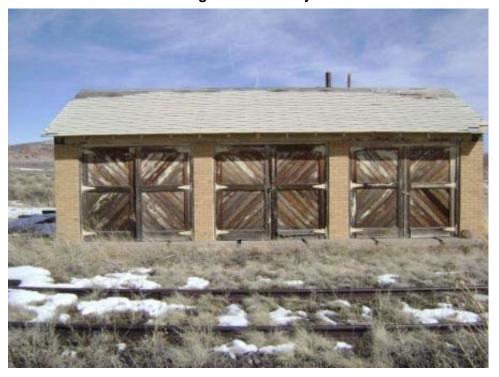
Building 43 West side looking east. Note poor condition of roofing material.

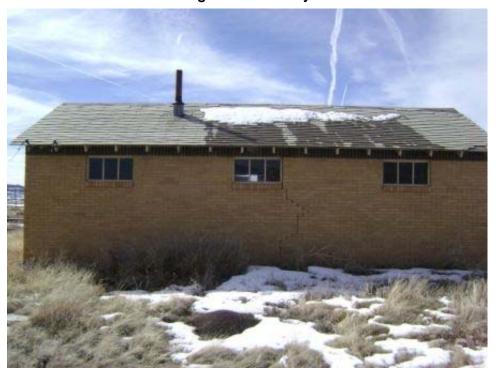
Building 43 East side looking west. Note roof condition, disconnected electric service.

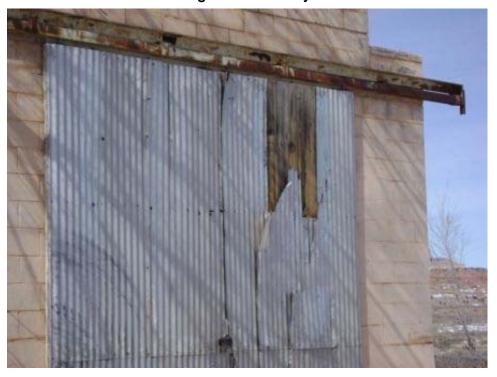
Building 48 East end. Note condition of door cover.

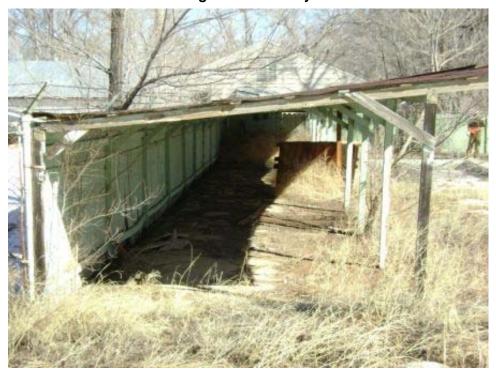
Building 54 South end showing rock paving in poor condition.

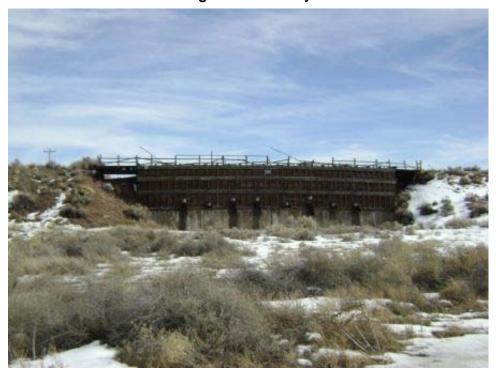
Building 57 Coal unloading trestle. Note poor condition of cat walk.

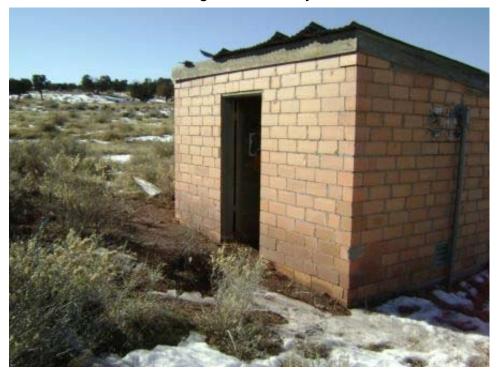
Building 519 North side looking east. Note condition of tile and roofing material.

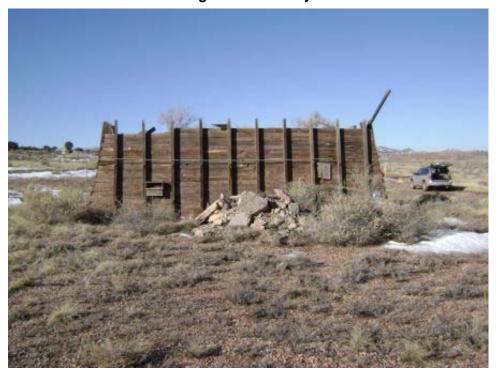
Building 521 North side looking south. Note broken timbers and concrete rubble.

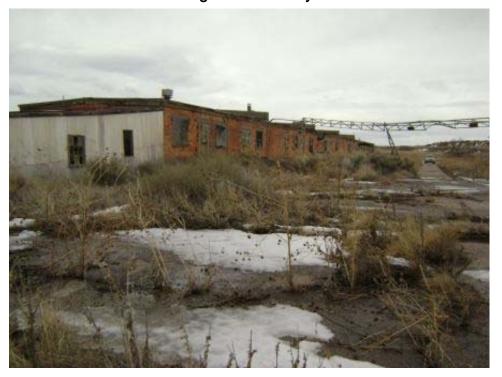
Building 522 South side of building looking east. Note extreme deterioration of structure and condition of vacuum line and support structure between 522 and 509/510.

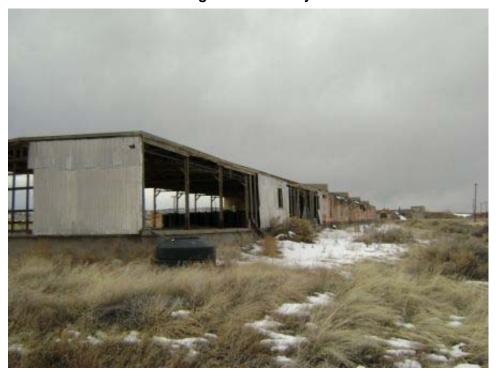
Building 522 North side of building looking west. Note condition of covered dock and deterioration of wall tiles. Dock used for empty unused drum storage.

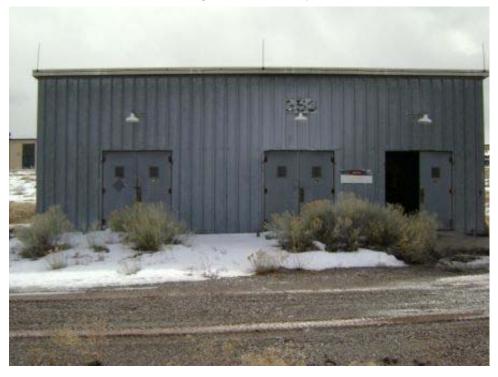
Building 550 North side looking south. Building 528 in background. Note door on right bay missing.

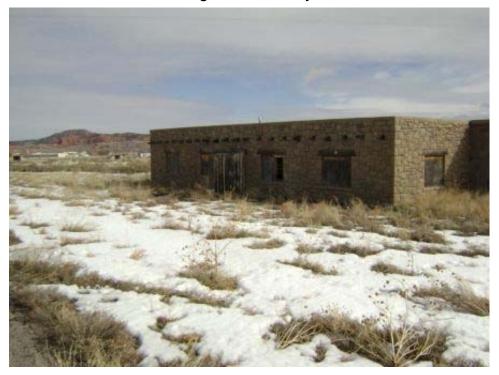
Building 600 West side looking north. Note covered windows. Most glass missing/broken.
