**RELEASE ASSESSMENT REPORT
PARCELS 11, 12, 14 AND 25
DRAFT**

**FORT WINGATE DEPOT ACTIVITY
McKinley County, New Mexico**

28 August 2007

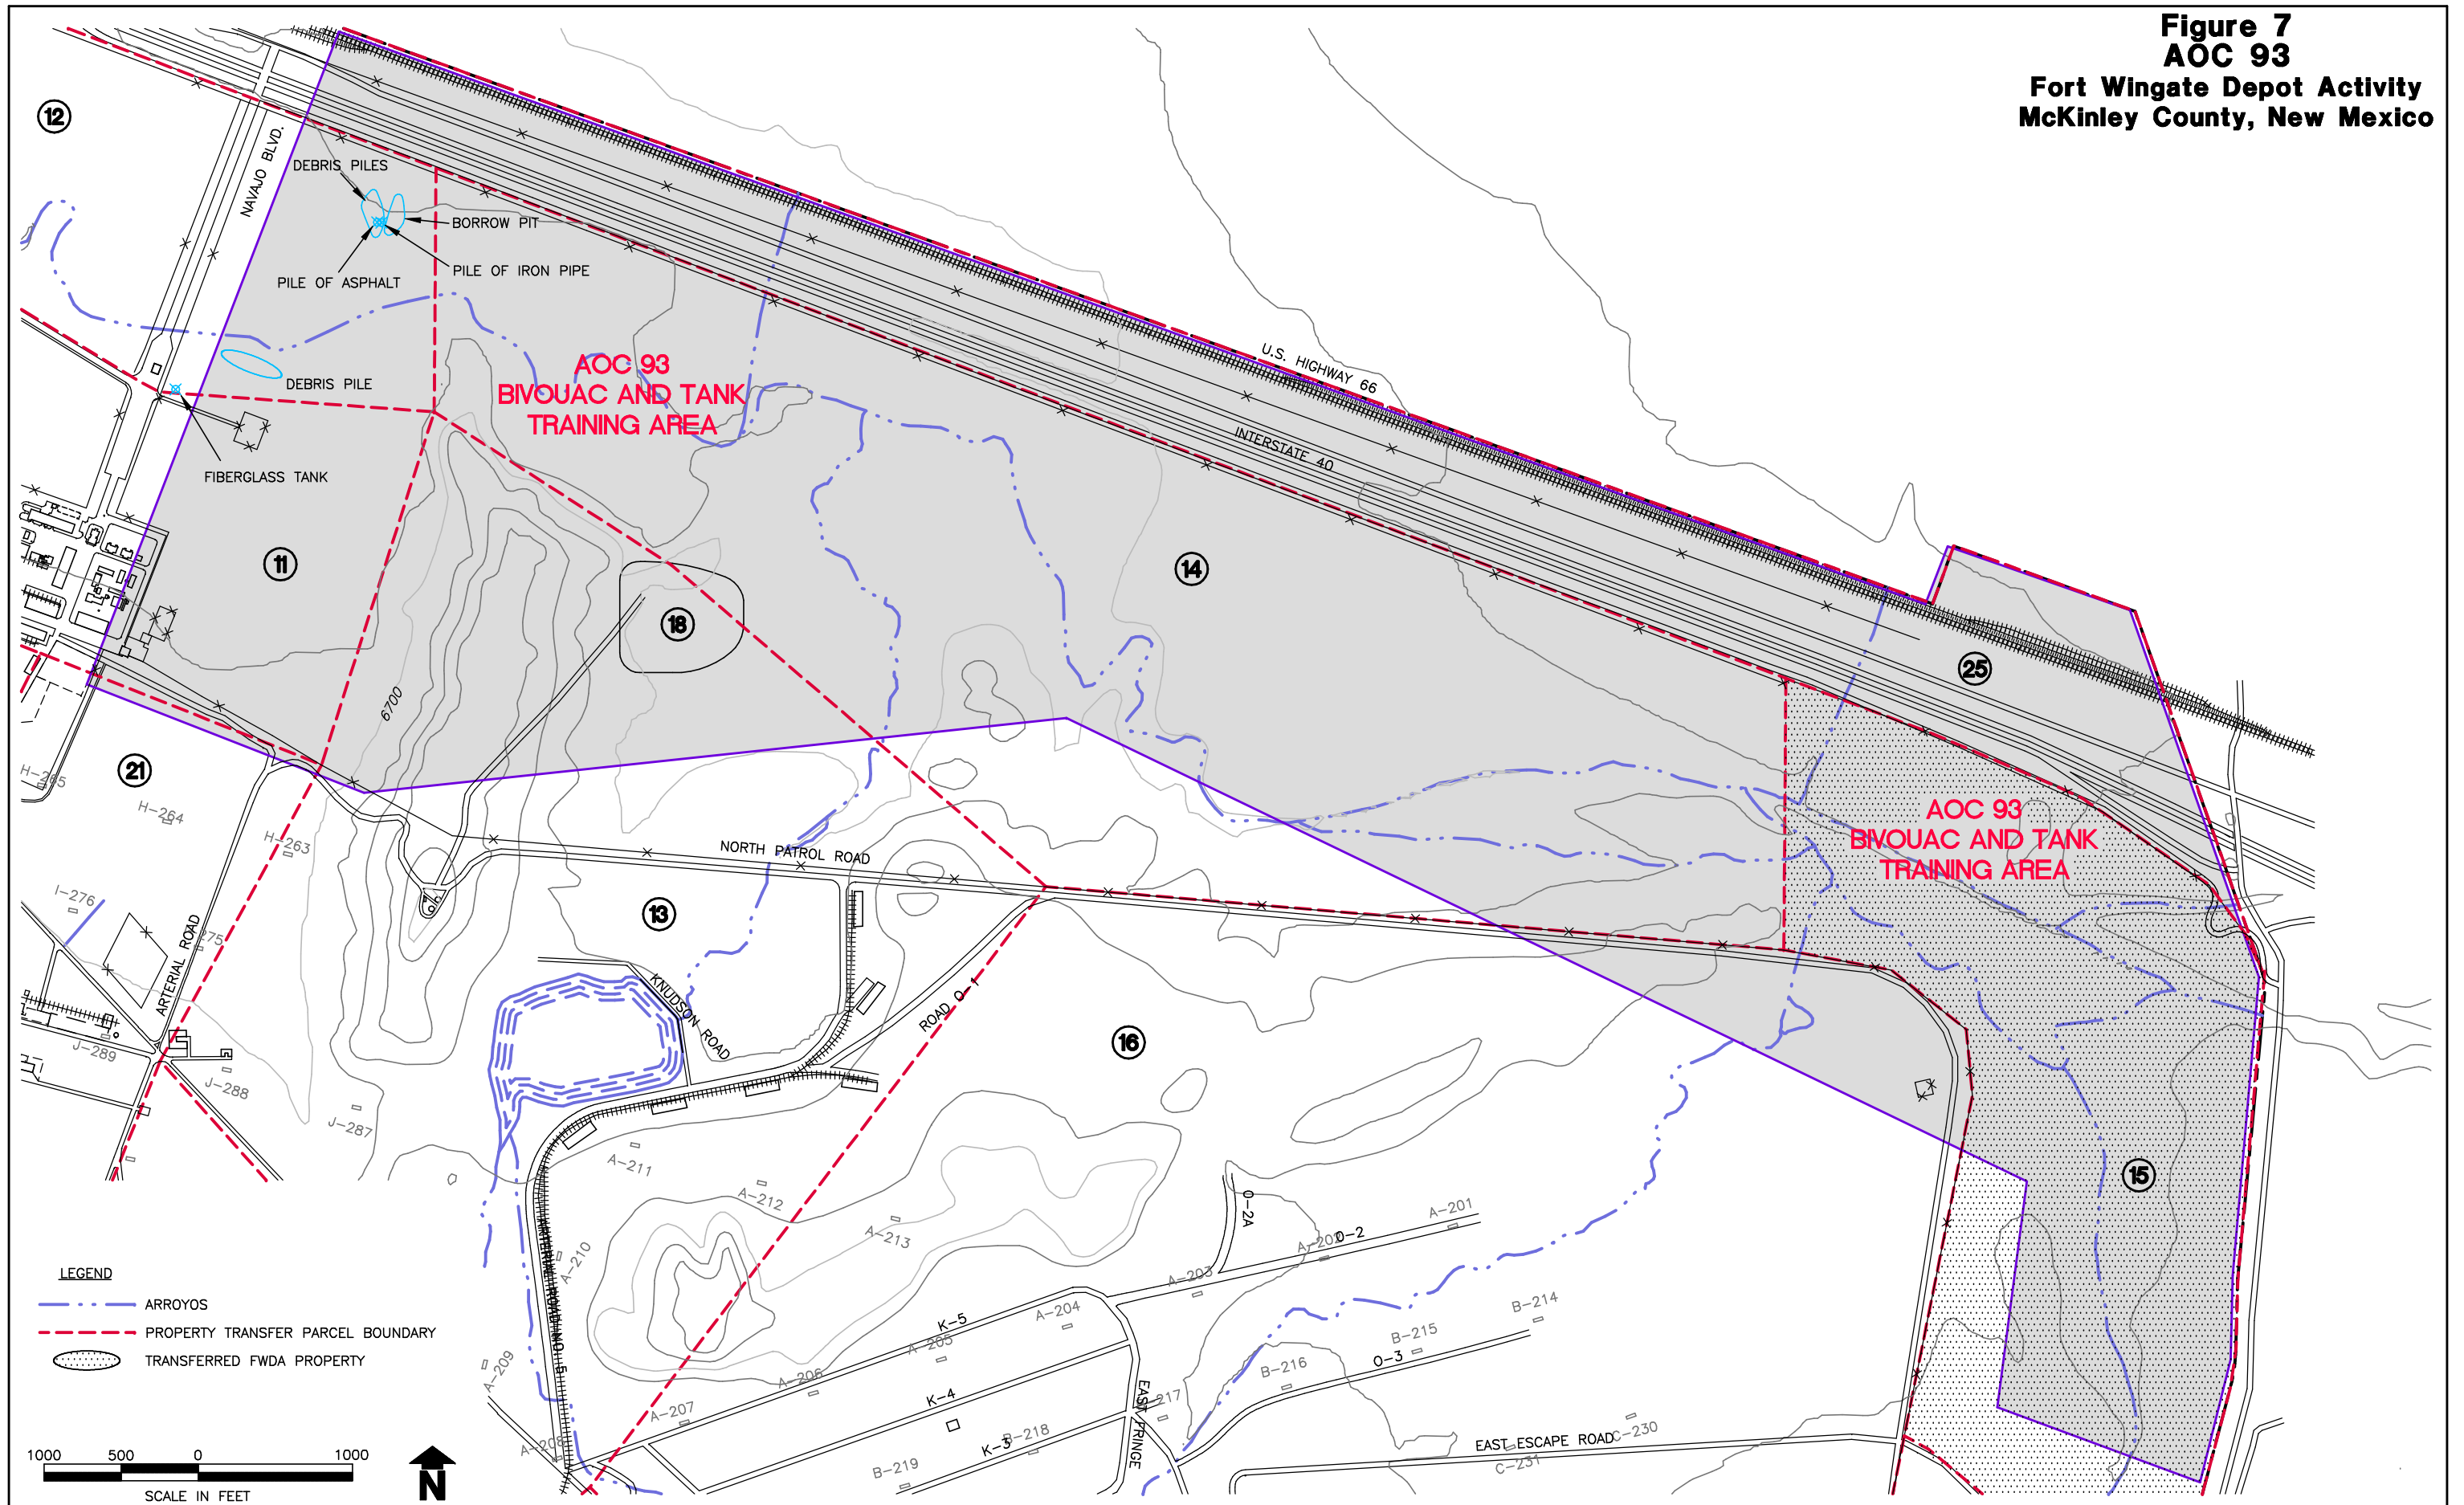
Figure 7
AOC 93
Fort Wingate Depot Activity
McKinley County, New Mexico

8 Debris consisting of concrete, tile, and brick was observed along the top of the
9 south bank of the Rio Puerco River valley (Photos 36 through 39, Appendix C).
10 Because of the placement and the type of debris, it is assumed this debris was
11 placed to prevent erosion of the south bank of the Rio Puerco River channel
12 (Figure 7).

13 A large borrow pit and piles of demolition debris were observed in the central
14 portion of the eastern half of Parcel 12 (Figure 7). The borrow pit consists of a
15 depression approximately 150 feet in diameter and approximately 15 feet deep at
16 the deepest part (to the north and east). The piles of demolition debris are
17 located to the west of the borrow pit and consist of concrete and asphalt
18 pavement debris, cast iron pipe, wood, presumed asbestos cement pipe, plastic
19 pipe, soil, and gravel. The borrow pit and debris piles are shown in Photos 40
20 through 46 (Appendix C). According to the aerial photo analysis, the origin of the
21 borrow pit appears to have occurred simultaneously with the construction the
22 Interstate 40. The piles of debris appear to have originated from a construction
23 project somewhere on FWDA.
