**FORT WINGATE DEPOT ACTIVITY
GALLUP, NM**

**BUILDING 11 PCB INVESTIGATION
REPORT**

23 March 1999

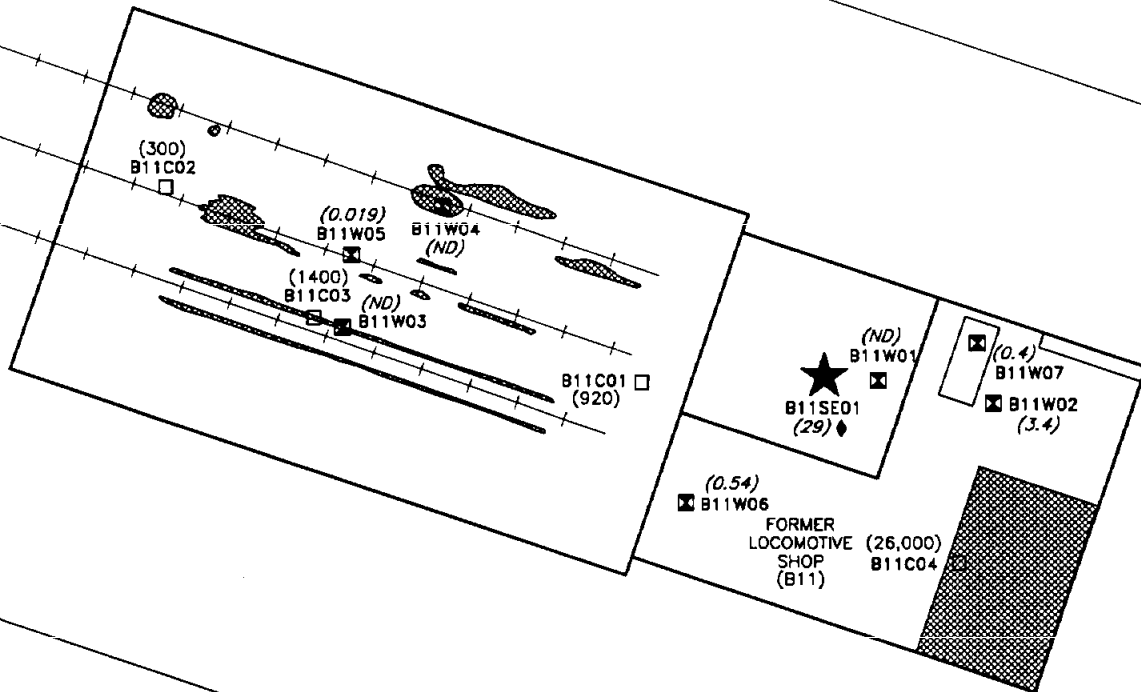
**Figure 2-5
Previous Sample Location Schematic
Building 11 PCB Investigation
Fort Wingate Depot Activity
Gallup, New Mexico**

Seven wipe samples (B11W01-B11W07) were collected from within the building from observed stained and unstained areas. Two samples were collected in apparently unstained areas, one (B11W05) near the middle set of railroad tracks and the second (B11W06) in the office area. PCB 1254 was detected in both samples at concentrations of 0.019 micrograms per square centimeter ($\mu\text{g}/\text{cm}^2$) and $0.54 \mu\text{g}/\text{cm}^2$, respectively.

The remaining five wipe samples were collected in stained areas along the railroad tracks (B11W03 and B11W04), under the standby generators (B11W02 and B11W07), and adjacent to the basement sumps (B11W01). PCBs were not detected in samples B11W01, B11W03, and B11W04. PCB 1254 was detected in samples B11W02 and B11W07 at concentrations of $3.4 \mu\text{g}/\text{cm}^2$ and $0.4 \mu\text{g}/\text{cm}^2$, respectively.

Four chip samples (B11C01-B11C04) were collected from within the building from observed stained and unstained areas. Two samples (B11C01 and B11C02) were collected in apparently unstained areas near the railroad tracks. PCB 1254 was detected in both samples at concentrations of 920 micrograms per gram ($\mu\text{g}/\text{g}$) and $300 \mu\text{g}/\text{g}$, respectively.

The remaining two samples were collected in stained areas, one (B11C03) adjacent to the railroad tracks and the second (B11C04) in the standby generator engine pit. PCB 1254 was detected in both samples at concentrations of $1,400 \mu\text{g}/\text{g}$ and $26,000 \mu\text{g}/\text{g}$, respectively.

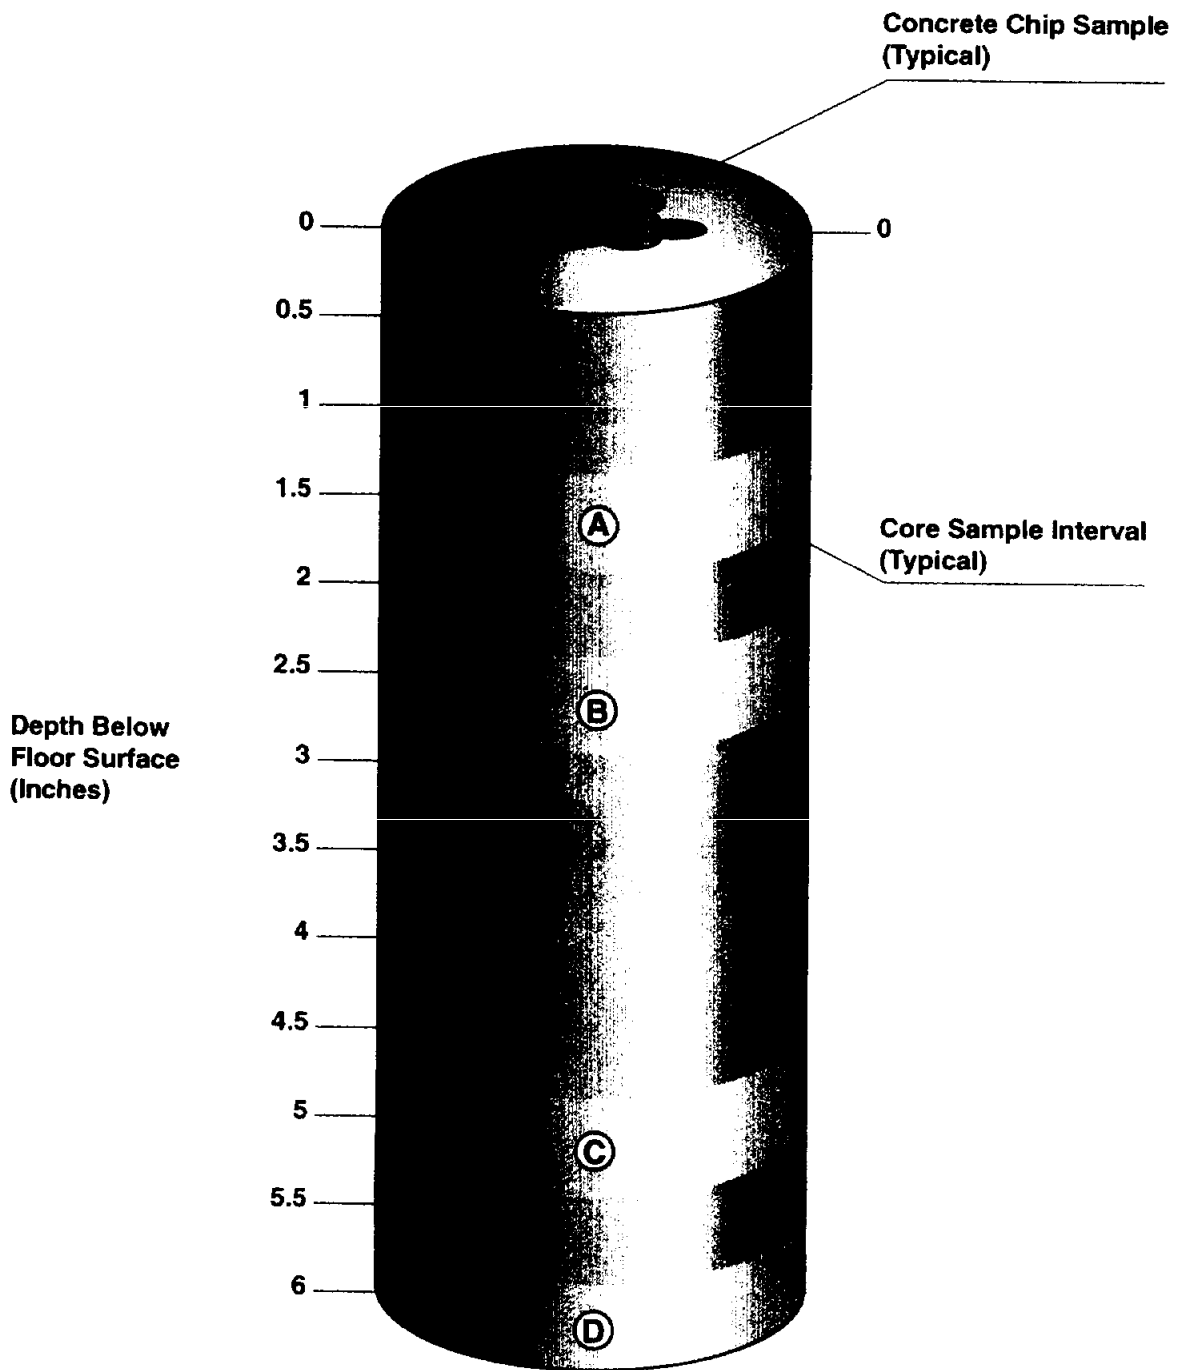
Figure 2-6
Concrete Core Sample Schematic
Building 11 PCB Investigation
Fort Wingate Depot Activity
Gallup, New Mexico

Once concrete cores were removed from the floor, discrete intervals were cut as shown in Figure 2-6. The core was sliced with a reciprocating saw and the half-inch thick slices were broken and placed in a laboratory-supplied sample container. The approximate sample intervals were as follows: the 1- to 1.5-inch depth (A), the 2- to 2.5-inch depth (B), the 4.5- to 5-inch depth (C), and the bottom 0.5 inches (D) of each core. When the samples were received at the laboratory, the entire half-inch thick sample was ground up and extracted for analysis. These samples were then analyzed following a phased approach. First the "A" sample was analyzed. If the sample from this interval was contaminated, then the "B" sample was analyzed, and so on.

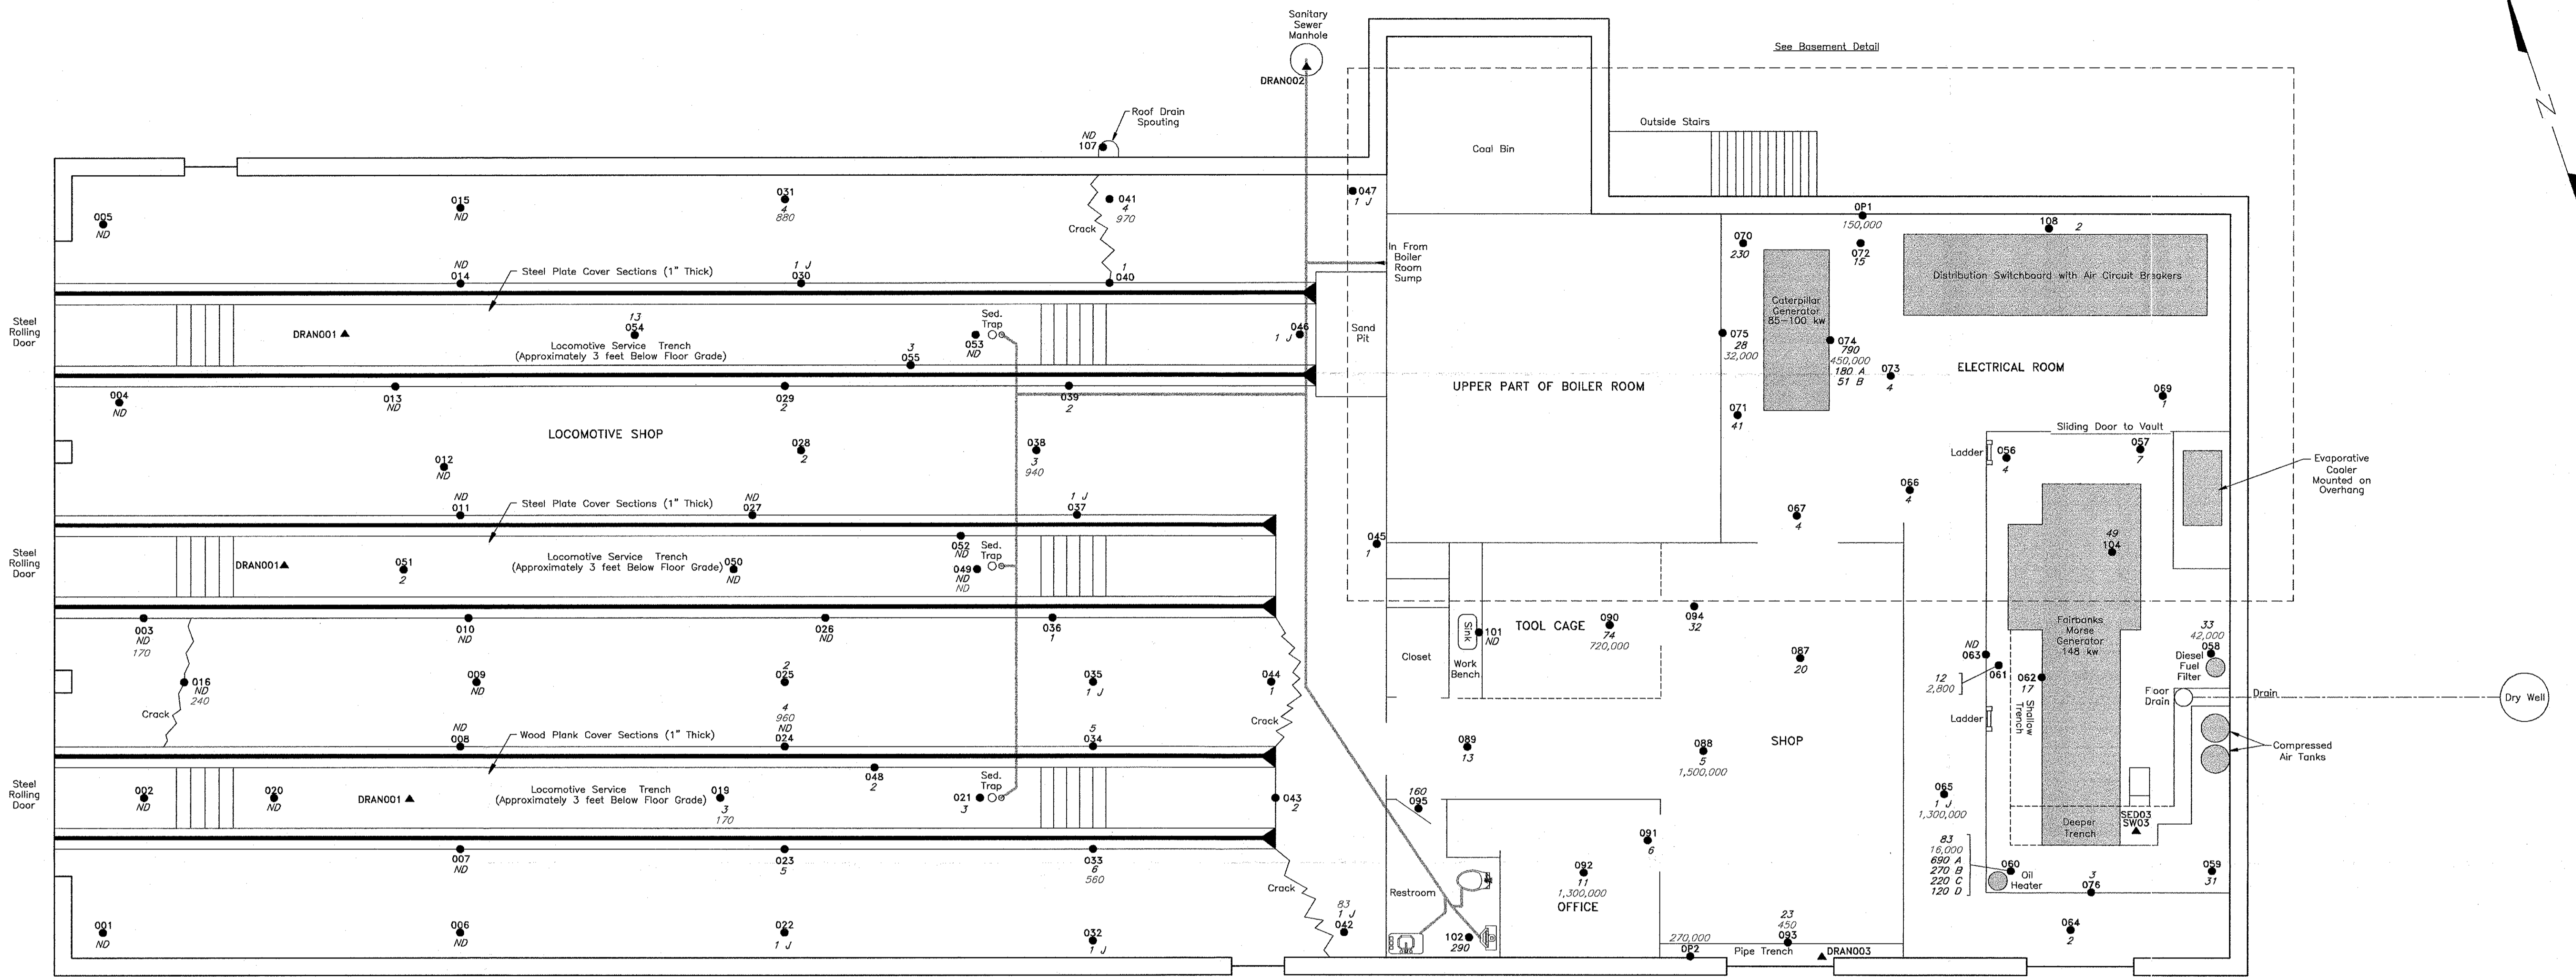
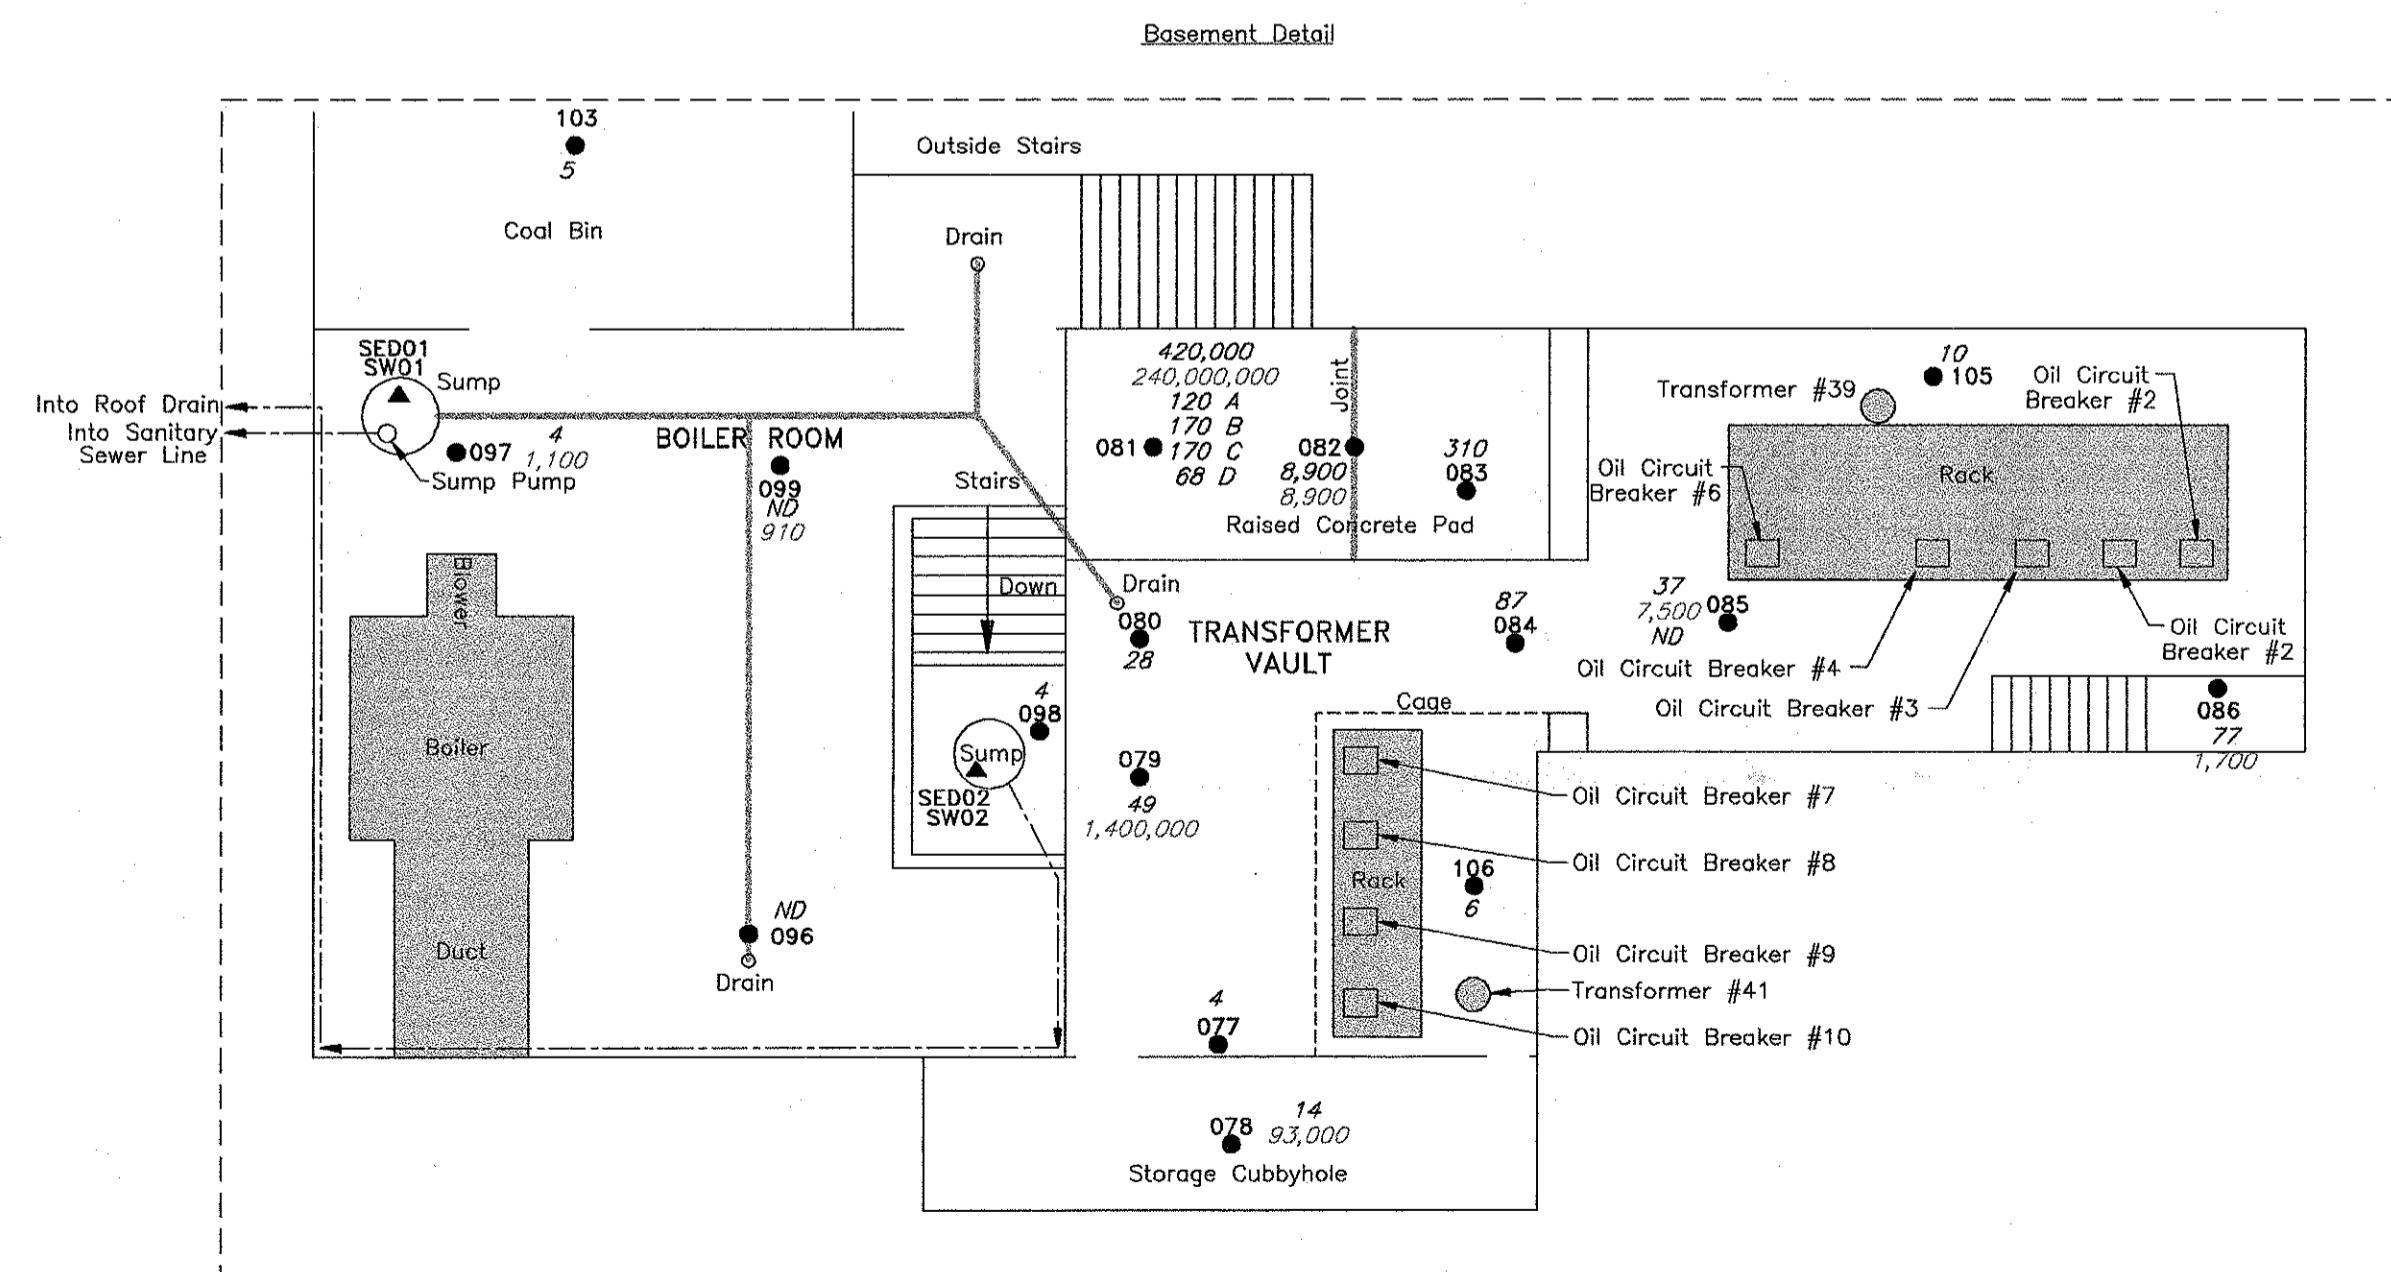
Appendix A
Building Drawings

Sample DRAN001 was a composite of solid materials found in the bottom of all three locomotive service trenches.

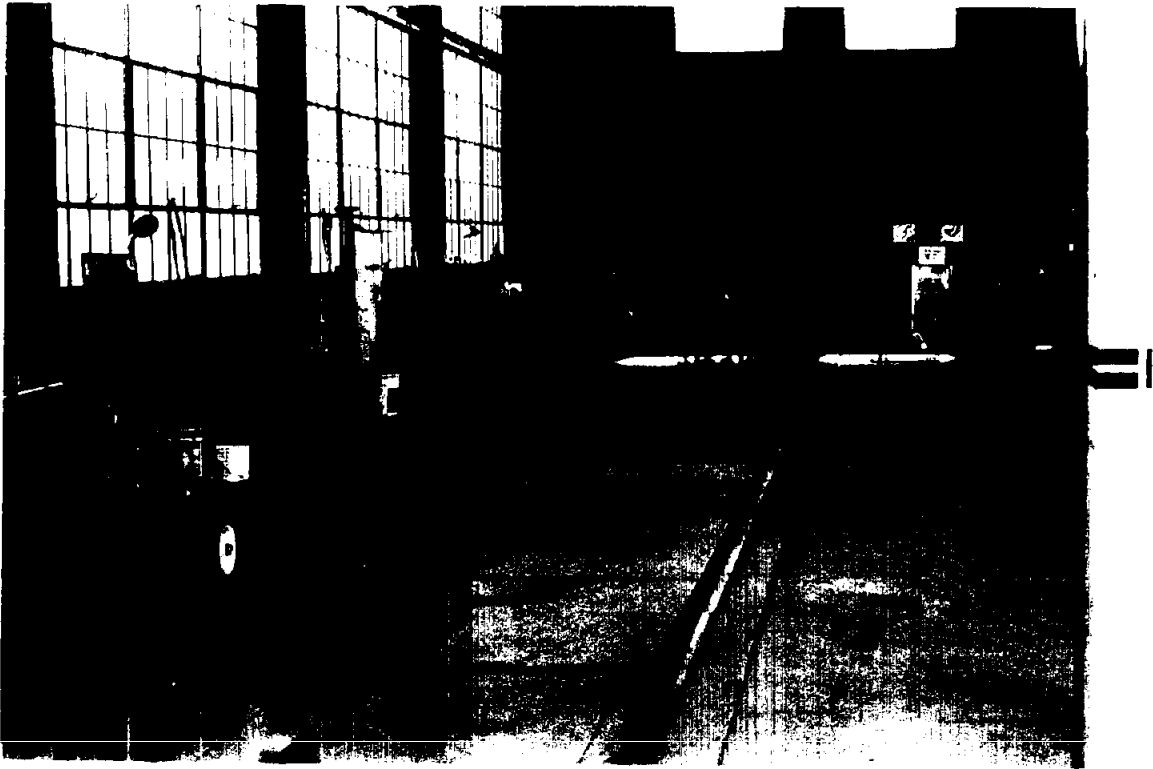
Fifty-three wipe samples were collected in both visibly stained and unstained areas on the floor and in the locomotive service trenches (Photos 1 through 6, Appendix D). The floor in the Locomotive Shop was observed to be unpainted concrete and generally in good condition with only a few cracks. The service trenches were also observed to be unpainted concrete and in good condition, with no observed cracks. PCBs were not detected in 23 of the 53 samples collected. As shown in Table 3-1, PCB 1254 was detected in 30 of 53 samples at concentrations ranging from 1 to 13 $\mu\text{g}/100\text{ cm}^2$. Only one detection (B11WIPE054 at 13 $\mu\text{g}/100\text{ cm}^2$) exceeds the TSCA surface cleanup level of 10 $\mu\text{g}/100\text{ cm}^2$. This sample was located in the bottom of the north locomotive service trench.

Photo 1. Locomotive Shop, north set of rails looking east.

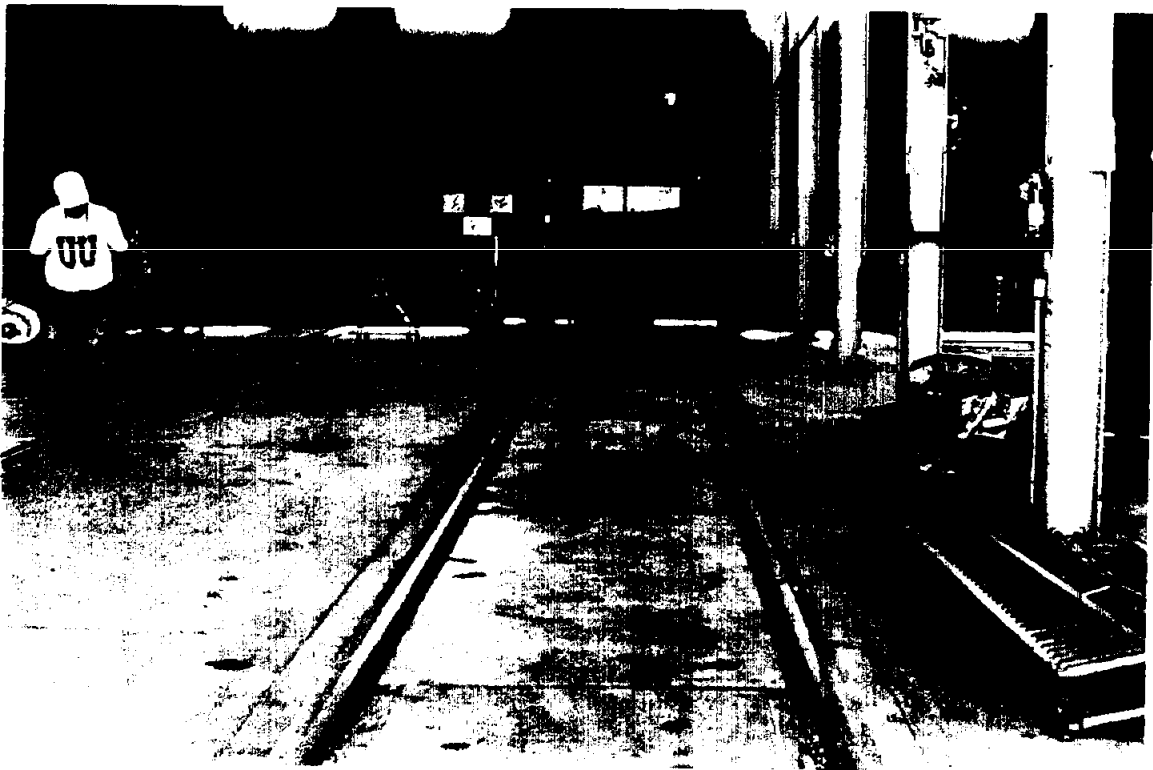
Photo 2. Locomotive Shop, middle set of rails looking east. Machine in center is a gasoline-powered track tender.

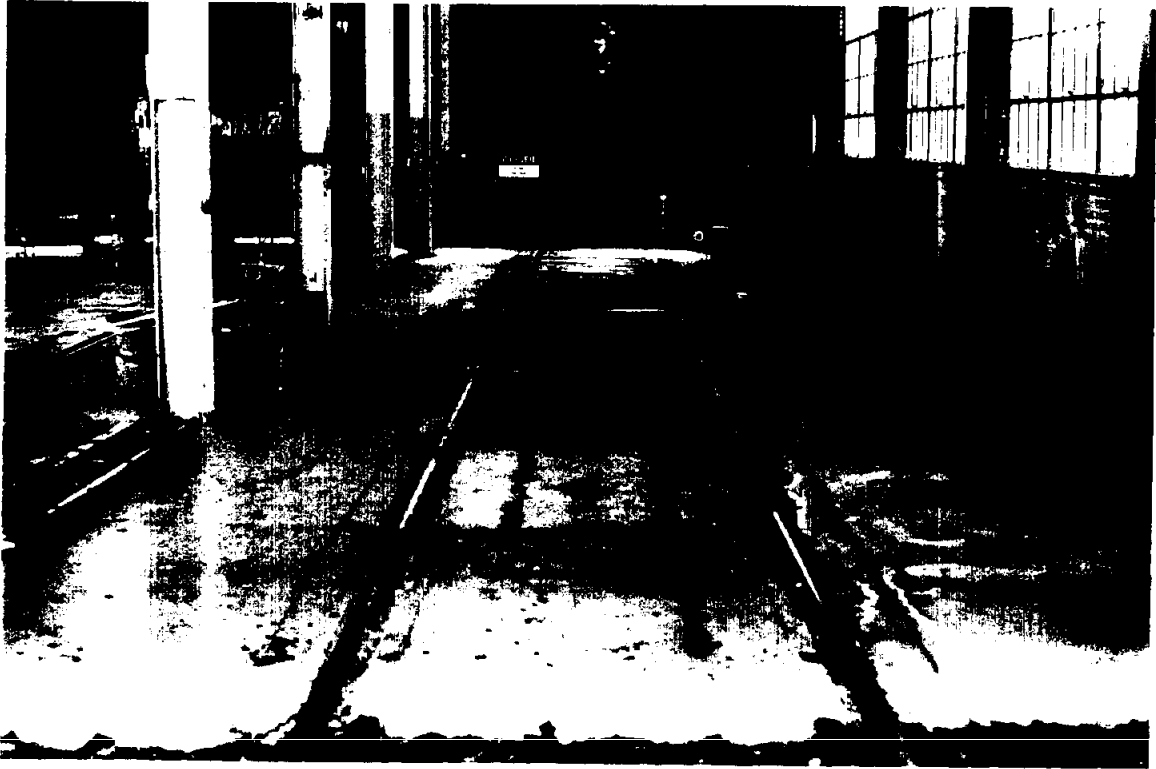
Photo 3. Locomotive Shop, south set of rails looking east.

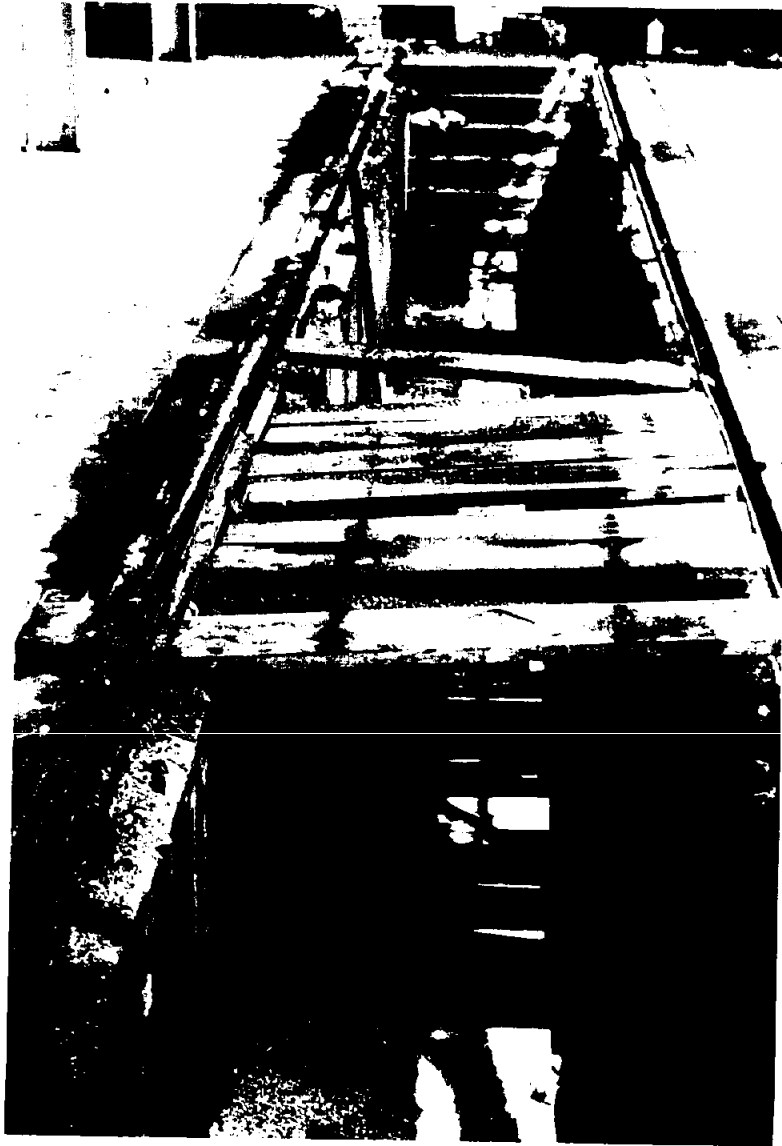
Photo 6. Locomotive Shop, south service trench looking east, showing debris, drip pan with oil filter, and drain at far end.

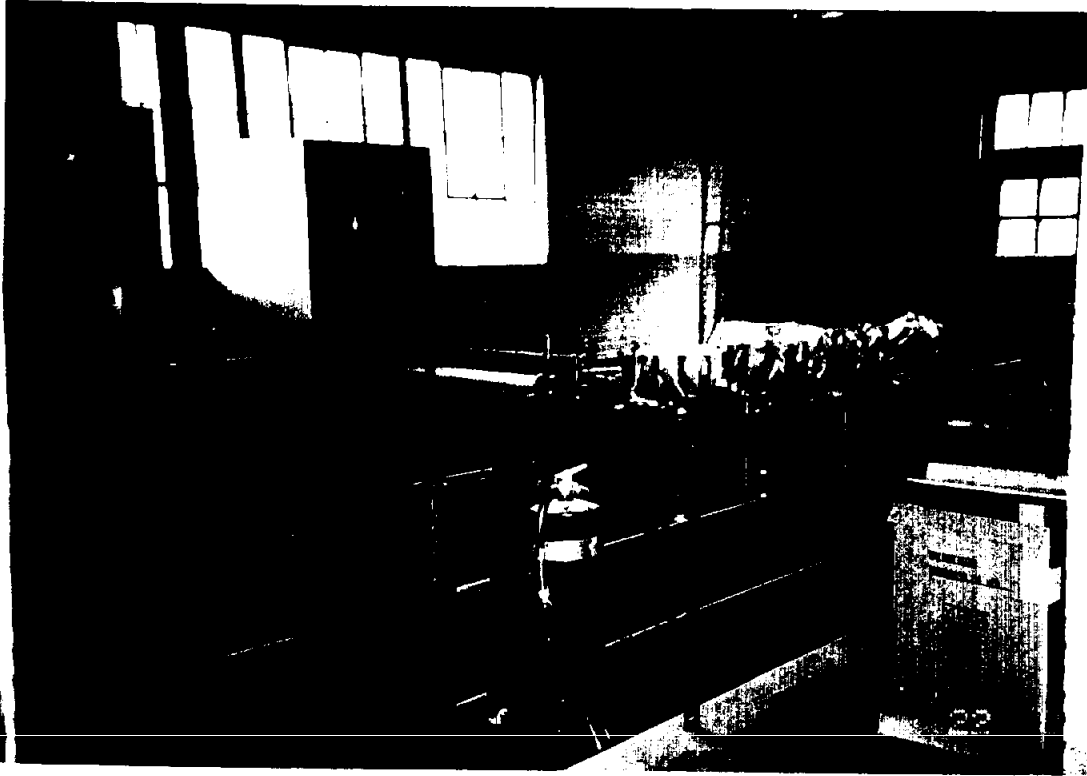
Eighteen wipe samples were collected from both visibly stained and unstained areas on the floor and in the Engine Pit (Photos 7 through 11, Appendix D). The floors in the Electrical Room were observed to be painted concrete and in good condition. The floor of the Engine Pit was observed to

Photo 8. Electrical Room, looking south, showing Fairbanks Morse generator and appurtenances.

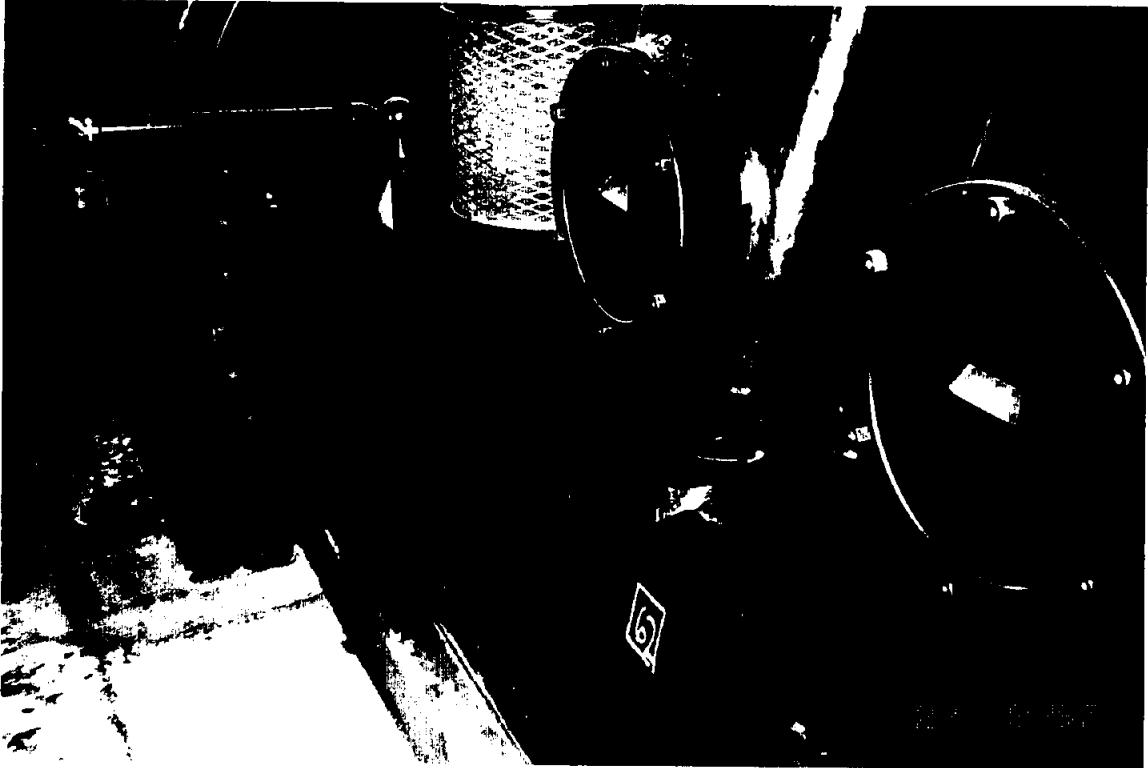
Photo 13. Electrical Room, Engine Pit, showing wipe sample on side of Fairbanks Morse Generator.

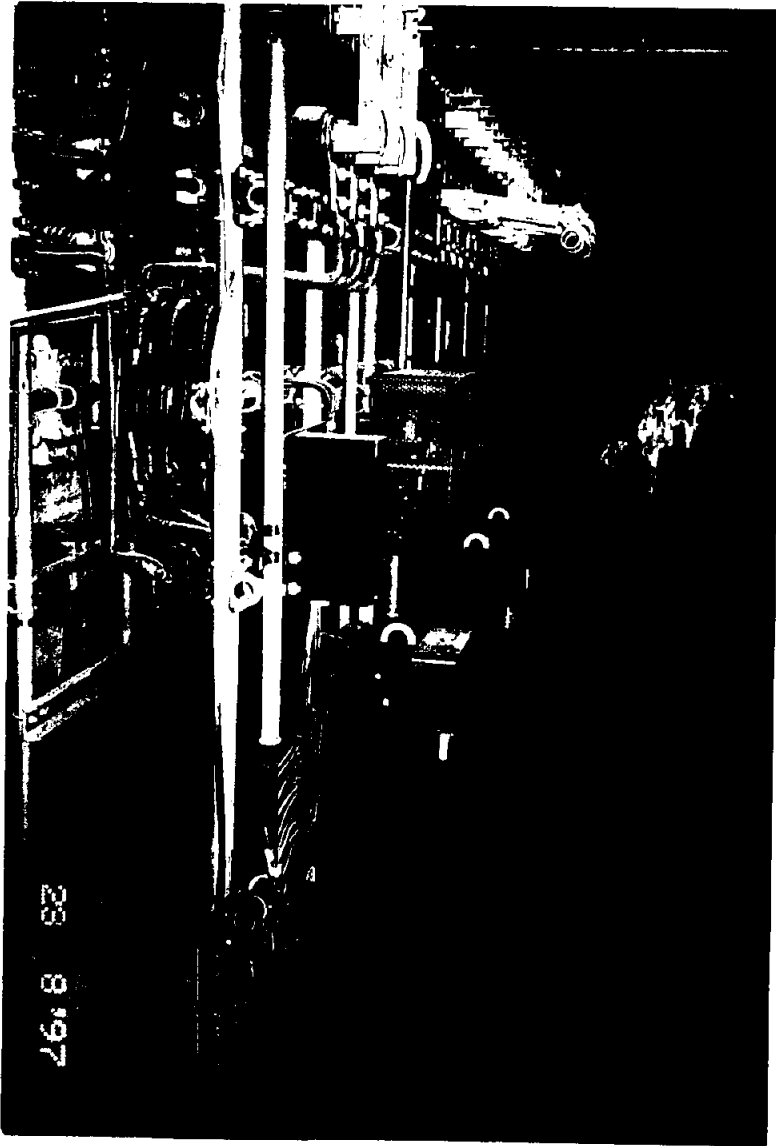
Twelve wipe samples were collected in both visibly stained and unstained areas on the floor (Photos 14 and 15, Appendix D). The Transformer Vault floor was observed to be unpainted concrete and generally in good condition, although it is covered with a layer of fine sediment (presumably from flooding). As shown in Table 3-1, PCB 1260 was detected in all samples, at concentrations ranging from 4 to 420,000 $\mu\text{g}/100\text{ cm}^2$. Three samples contained PCBs at or below the TSCA surface cleanup level of 10 $\mu\text{g}/100\text{ cm}^2$. Nine samples exceeded the TSCA surface cleanup level of 10 $\mu\text{g}/100\text{ cm}^2$. The sample with the highest concentration (B11WIPE081, 420,000 $\mu\text{g}/100\text{ cm}^2$) was collected in a thick, viscous stain on the 6-inch high concrete slab on the north side of the vault (Photo 16, Appendix D). The stain was small, less than 10 square feet, and did not appear to be recent. A sample (B11WIPE082) obtained from an adjacent, unstained area (Photo 17, Appendix D) yielded a concentration of 890 $\mu\text{g}/100\text{ cm}^2$.

Photo 14. Transformer Fault, east room, showing clean floor.

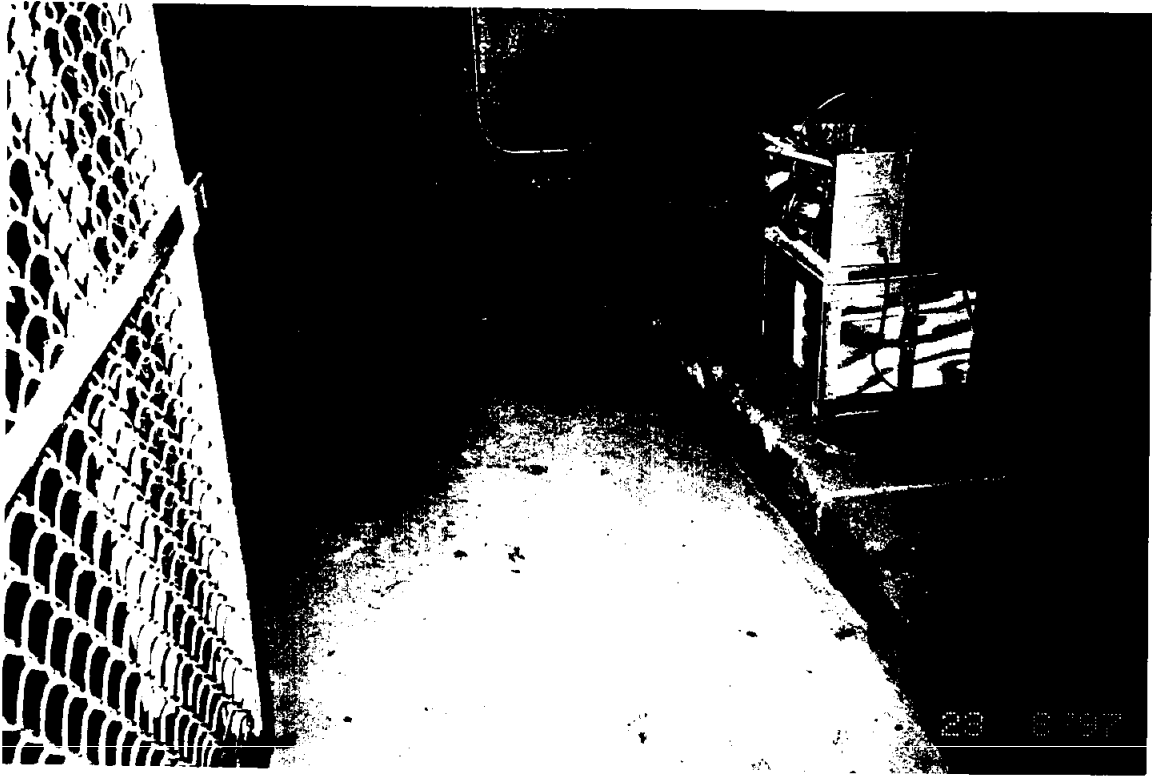
Two 4-inch diameter floor drains were observed in the basement, one in the Transformer Vault (Photo 15, Appendix D) and one in the Boiler Room (Photo 19, Appendix D). As shown on Figure 3-1 (Appendix A), both appear to drain to the sump in the northwest corner of the Boiler Room. A discharge pipe was observed entering the sump on the east side. Samples collected at this discharge location were discussed in Section 3.3.

Photo 15. Transformer Vault, west room, showing raised concrete slab and heavy stain on right, floor drain at top center.

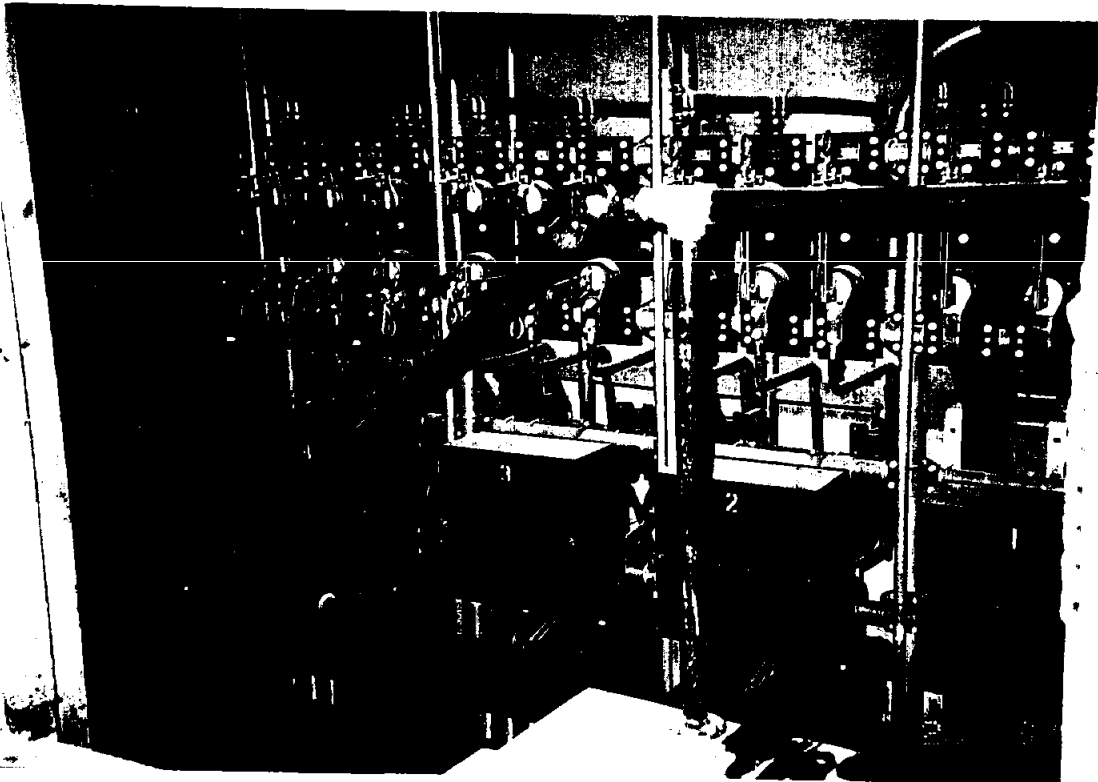
Nine oil circuit breakers (OCB) are located in the Transformer Vault, each with a stenciled identification number on the front (Photo 28, Appendix D). Five (OCB #1-4, and #6) are located on a rack in the east room and four (OCB #7-10) are located on a rack in the west room. After all power was shut off and verified off by a licensed electrician, a sample was withdrawn from the oil reservoir on each OCB by loosening the retaining nut at each corner and tipping the reservoir (Photos 29 and 30, Appendix D). Eight OCBs contained oil with less than 50 ppm PCBs. Only OCB #9 was found to contain PCB oil (greater than 500 ppm PCBs). The estimated volume of oil in OCB #9 was approximately 3 gallons. One transformer was sitting on the floor behind each OCB rack (Photo 31, Appendix D). Both were labeled "PCB-Free" and were not tested.

Photo 28. Transformer Vault, east room, oil circuit breakers #1 through #6.

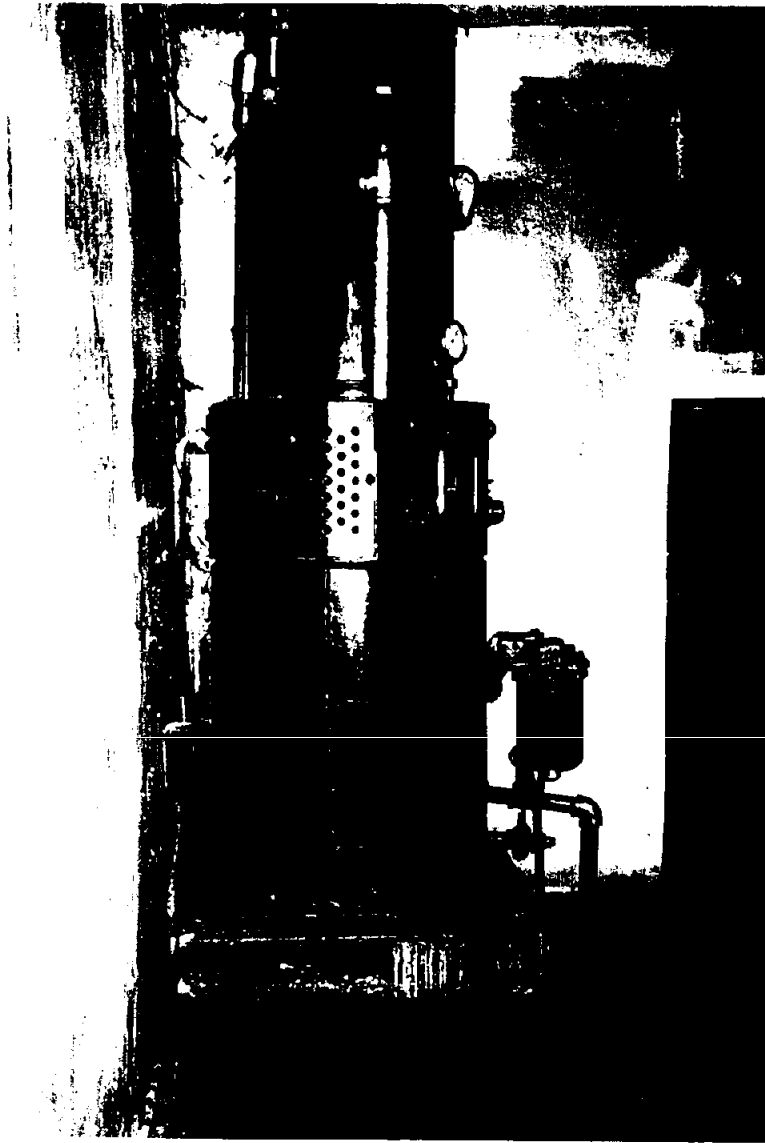
Photo 33. Electrical Room, Engine Pit, oil heater in southwest corner.

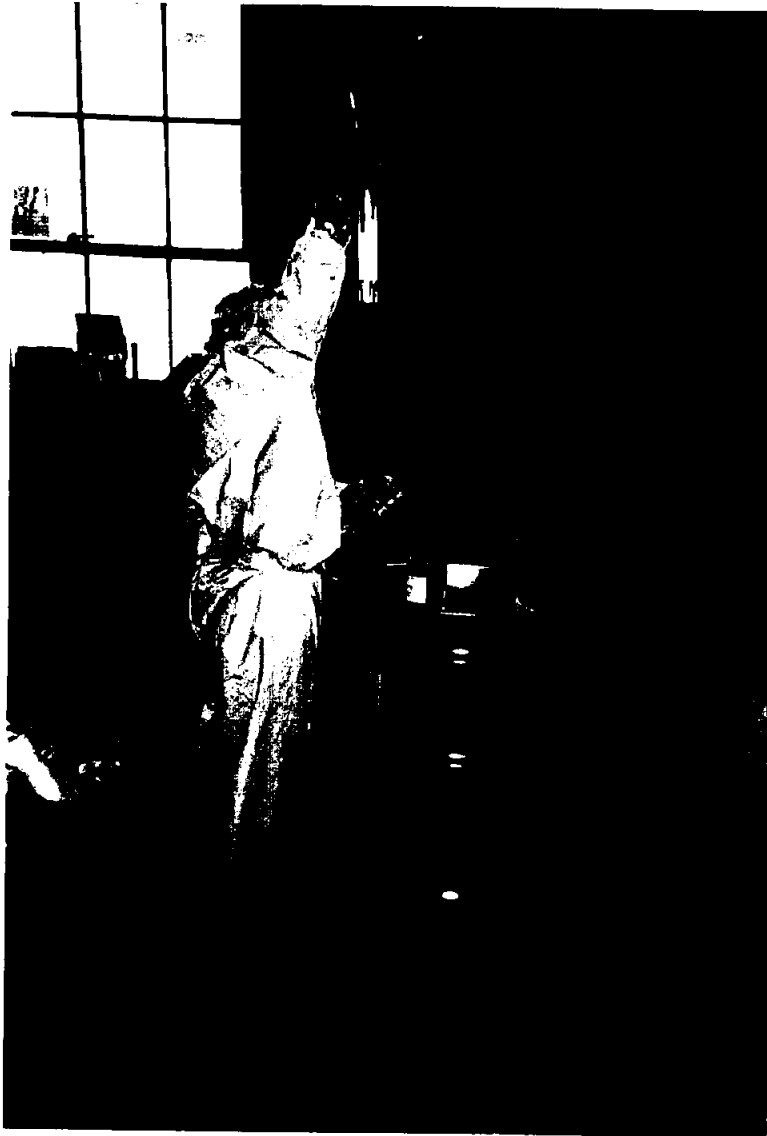
Photo 40. Locomotive Shop, sampling of oil drums.
