<p>Client Name: USACE</p>	<p>Project: HWMU Removal Action Completion Report</p>	<p>Project No. 16170613 & 60517380</p>
<p>Photo No. 1</p> <p>Description: Construction of Corrective Action Management Unit (CAMU) cells.</p>	 	
<p>Photo No. 2</p> <p>Description: Final grading of CAMU cells.</p>

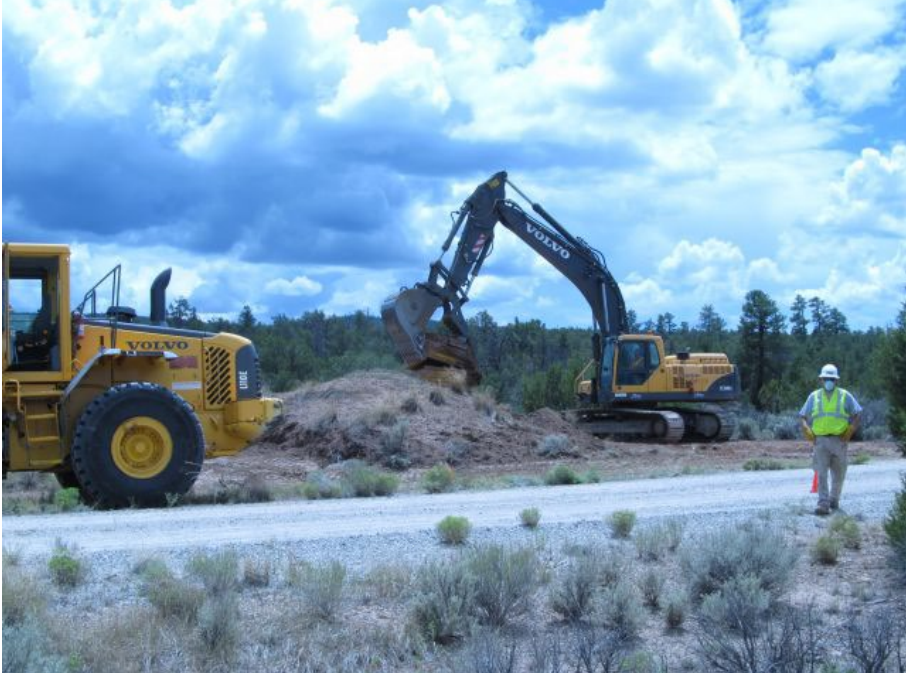
<p>Client Name: USACE</p>	<p>Project: HWMU Removal Action Completion Report</p>	<p>Project No. 16170613 & 60517380</p>
<p>Photo No. 5</p> <p>Description: Removal inspected day box with an excavator. Auxiliary task completed as part of RA mobilization.</p>

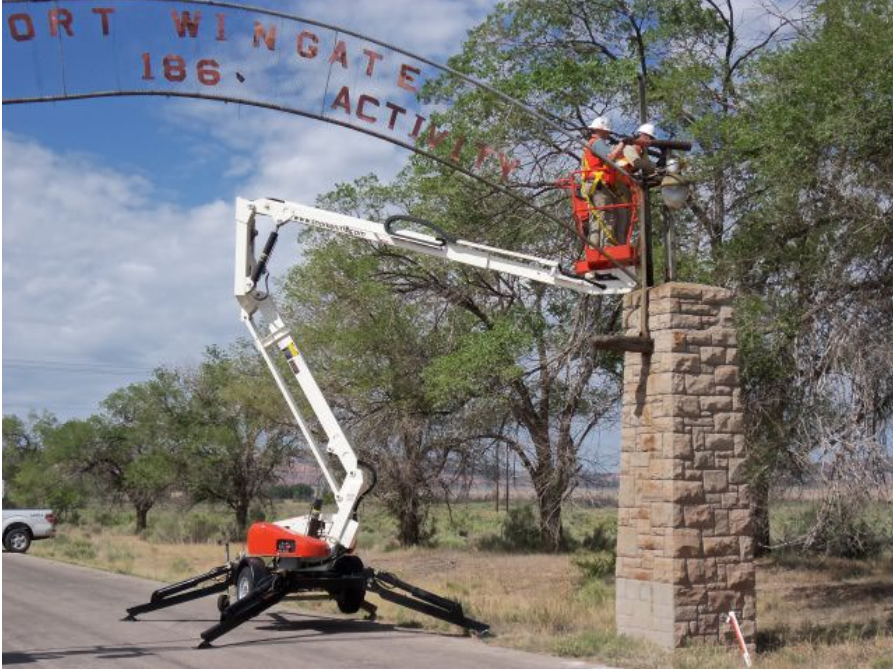
<p>Photo No. 6</p> <p>Description: Removal of decorative munitions from the Fort Wingate Depot Activity (FWDA) main gate. Auxiliary task completed as part of RA mobilization.</p>

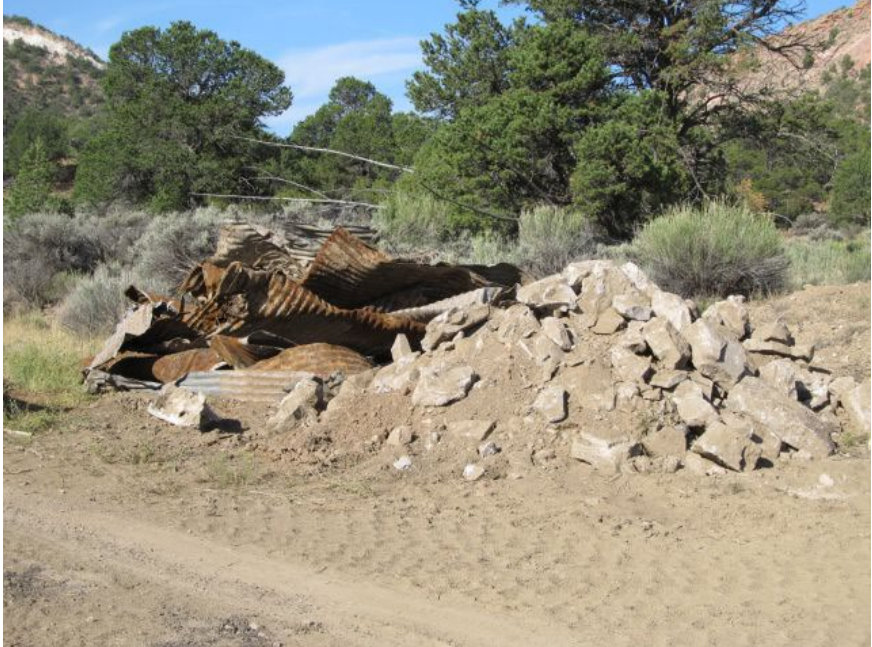
<p>Client Name: USACE</p>	<p>Project: HWMU Removal Action Completion Report</p>	<p>Project No. 16170613 & 60517380</p>
<p>Photo No. 7</p> <p>Description: Debris and soils removed during low-water crossing construction. Auxiliary task completed as part of RA mobilization.</p>

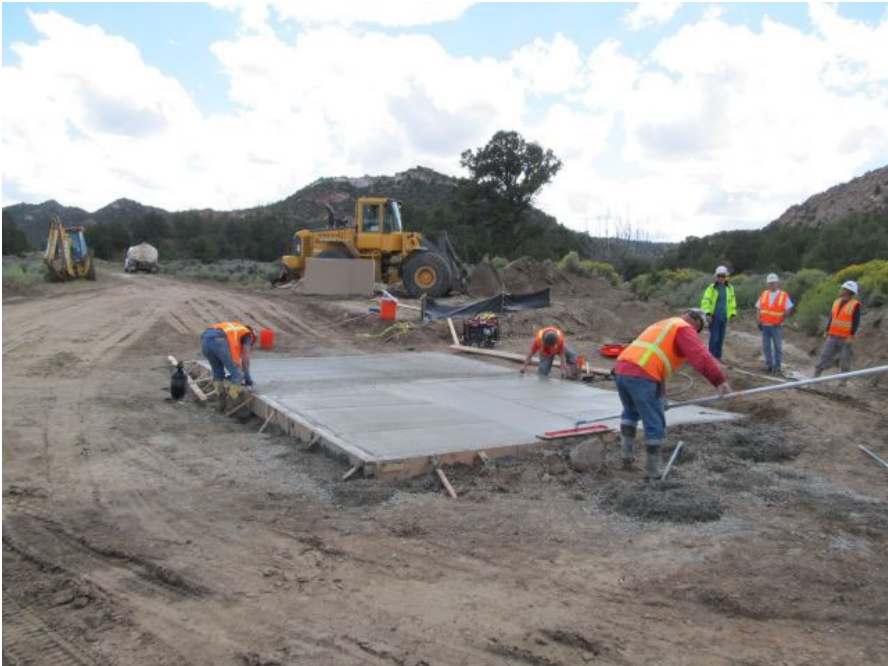
<p>Photo No. 8</p> <p>Description: Pouring concrete at low-water crossing. Auxiliary task completed as part of RA mobilization.</p>

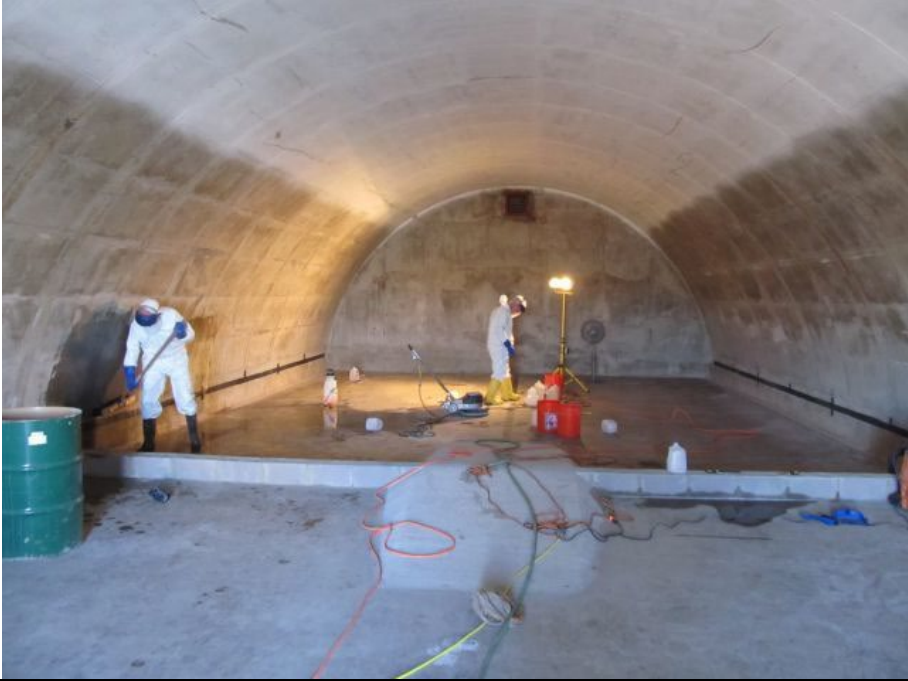
Client Name: USACE	Project: HWMU Removal Action Completion Report	Project No. 16170613 & 60517380
Photo No. 11 Description: Applying epoxy coating on floor to establish a less than 90-day hazardous waste storage facility. Auxiliary task completed as part of RA mobilization.

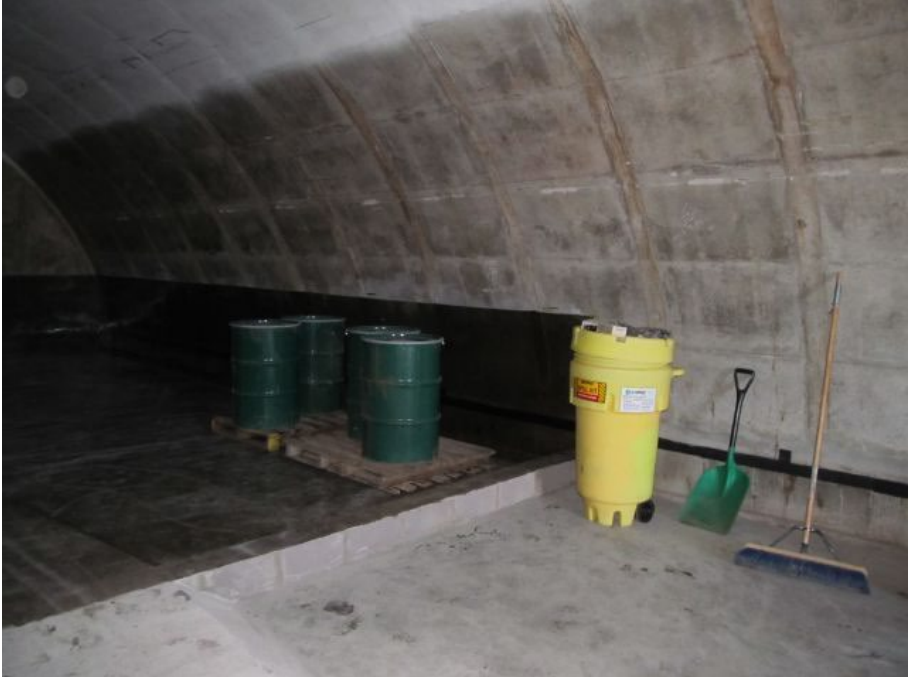
Photo No. 12 Description: Interior of less than 90-day storage. Auxiliary task completed as part of RA mobilization.

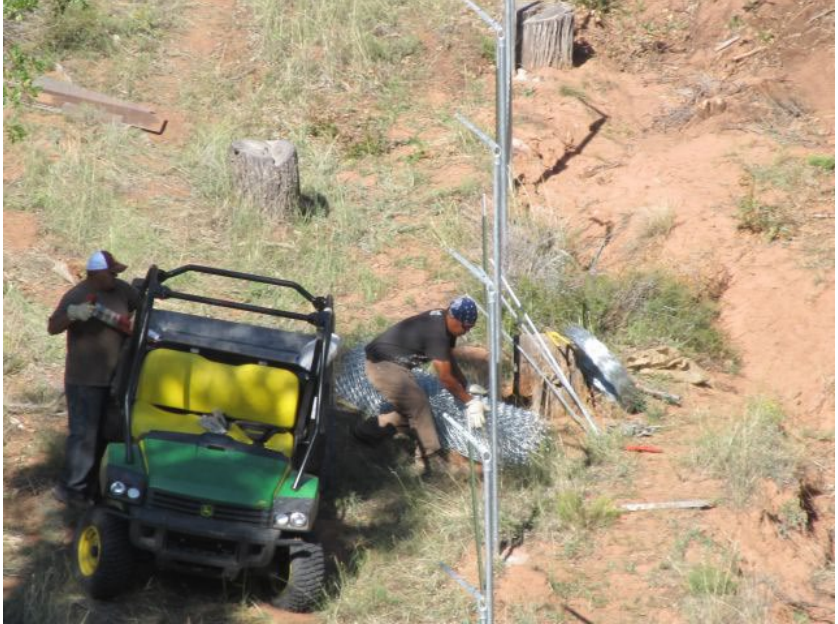
<p>Client Name: USACE</p>	<p>Project: HWMU Removal Action Completion Report</p>	<p>Project No. 16170613 & 60517380</p>
<p>Photo No. 13</p> <p>Description: Installing security fence fabric. Auxiliary task completed as part of RA mobilization.</p>

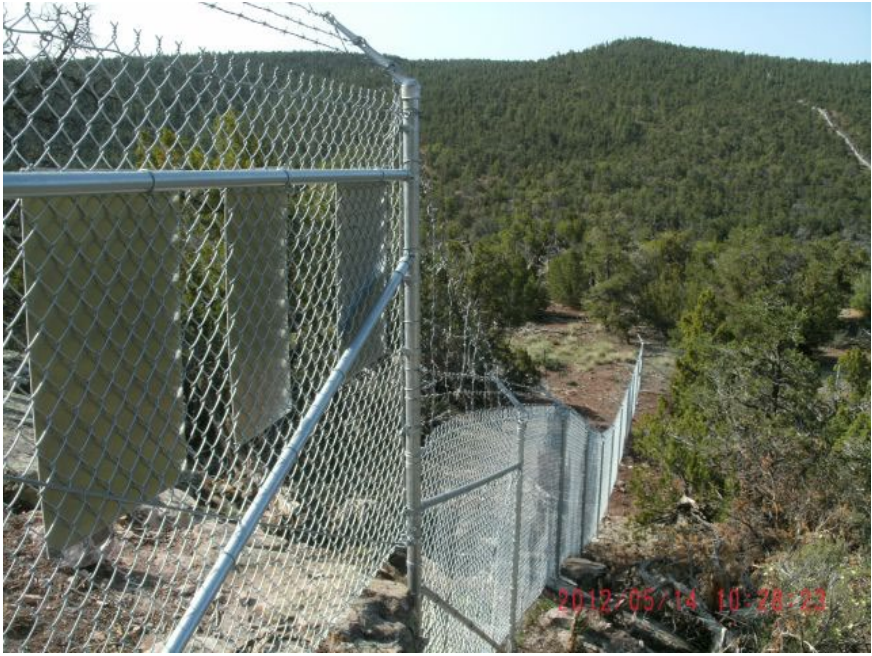
<p>Photo No.14</p> <p>Description: Completed security fencing installed as an auxiliary task completed as part of RA mobilization.</p>

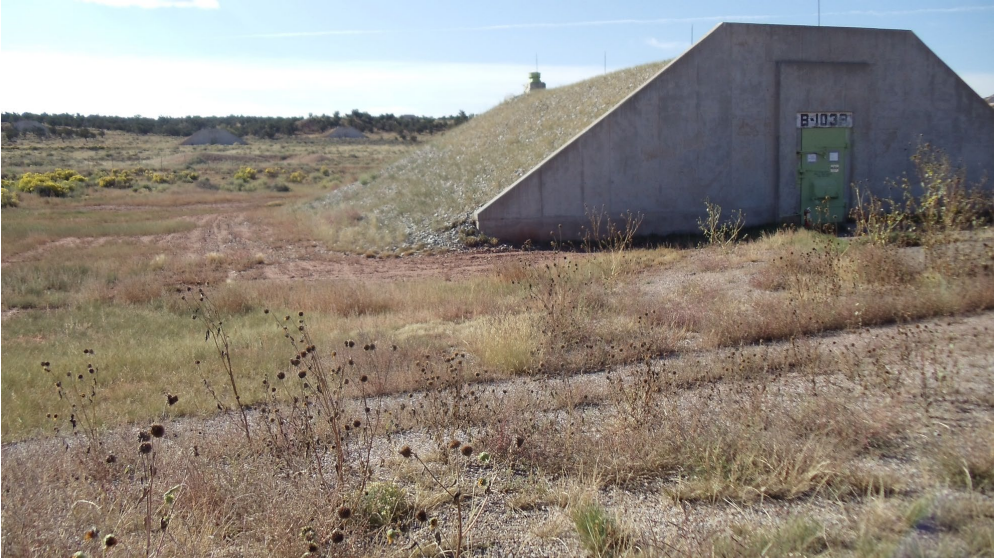
<p>Client Name: USACE</p>	<p>Project: HWMU Removal Action Completion Report</p>	<p>Project No. 16170613 & 60517380</p>
<p>Photo No. 15</p> <p>Description: Earth covered magazine (ECM) B-1038 prior to vegetation removal.</p>

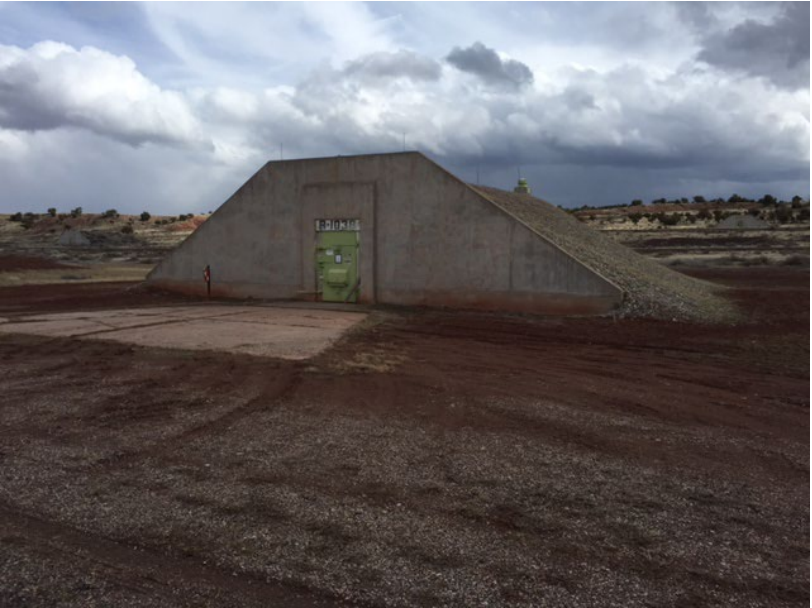
<p>Photo No. 16</p> <p>Description: ECM B-1038 after vegetation removal.</p>

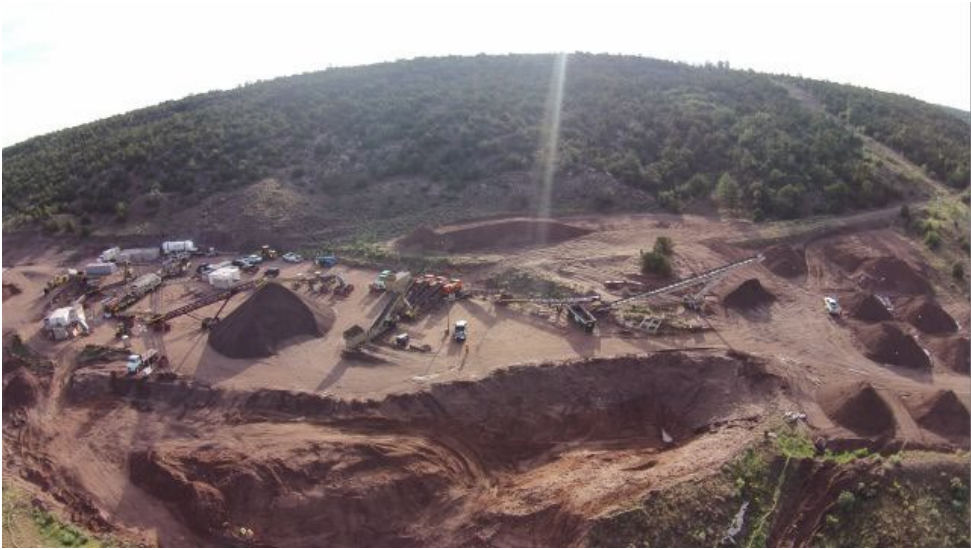
<p>Client Name: USACE</p>	<p>Project: HWMU Removal Action Completion Report</p>	<p>Project No. 16170613 & 60517380</p>
<p>Photo No. 25</p> <p>Description: First contract, processing plant with CRP01 partially excavated.</p>

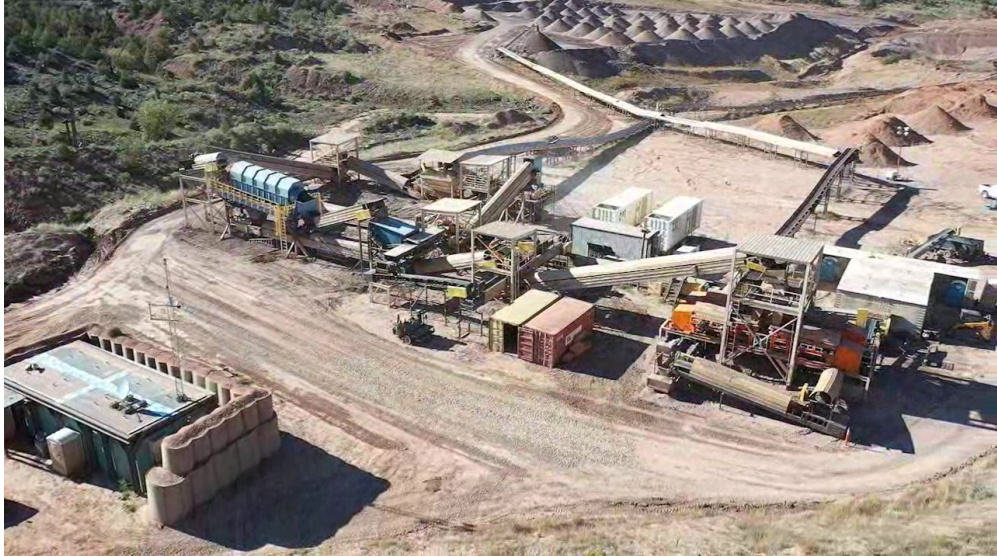
<p>Photo No. 26</p> <p>Description: Second contract, processing plant with remote control building in foreground and stockpiles staged in background.</p>

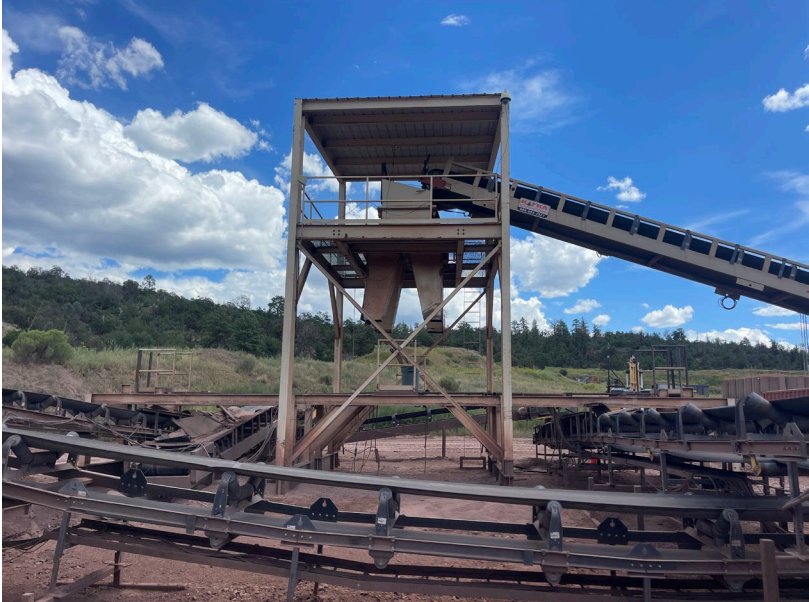
<p>Client Name: USACE</p>	<p>Project: HWMU Removal Action Completion Report</p>	<p>Project No. 16170613 & 60517380</p>
<p>Photo No. 27 Description: Eddy current non-ferrous metal separator.</p>

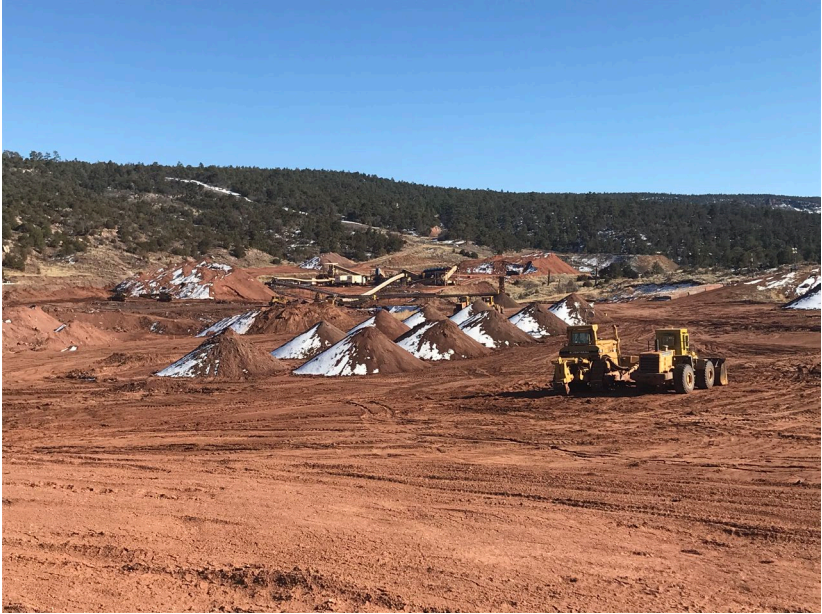
<p>Photo No. 28 Description: HWMU RA soil excavation overview.</p>

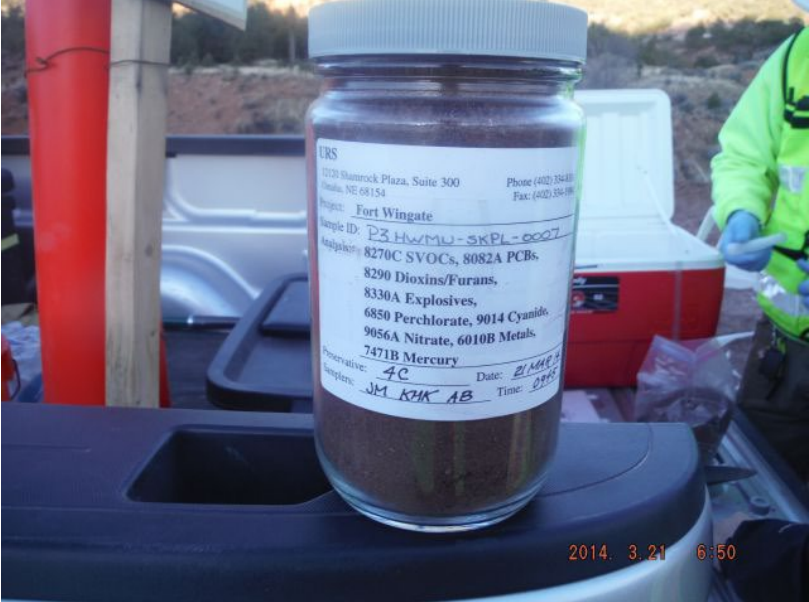
<p>Client Name: USACE</p>	<p>Project: HWMU Removal Action Completion Report</p>	<p>Project No. 16170613 & 60517380</p>
<p>Photo No. 37 Description: Typical stockpile composite soil sample.</p>

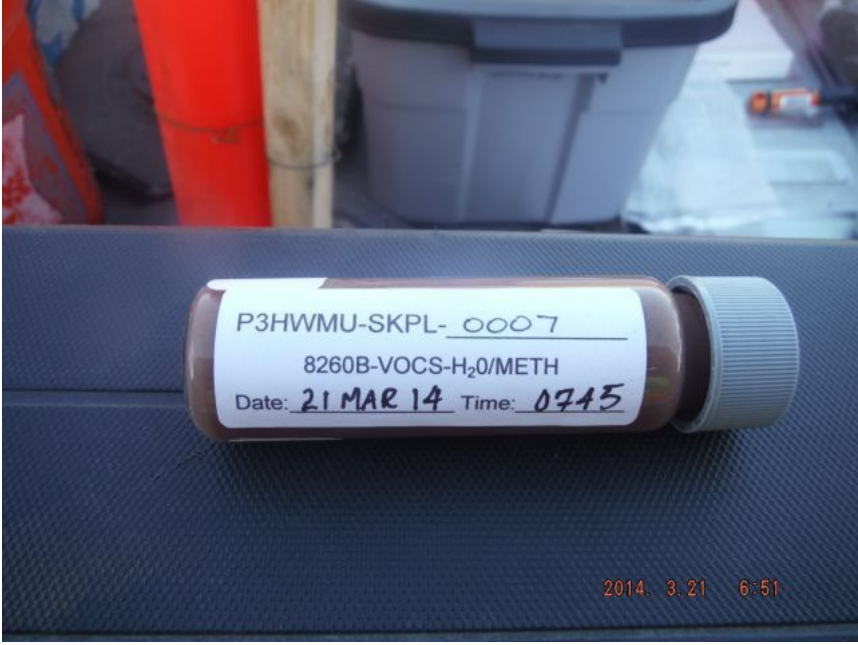
<p>Photo No. 38 Description: Typical stockpile Terra Core soil sample collected for VOC analyses.</p>

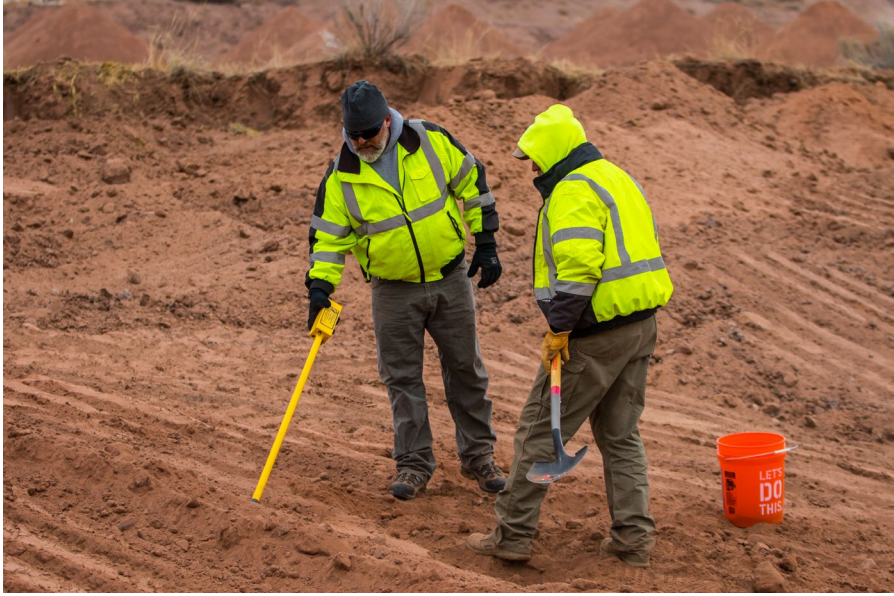
<p>Client Name: USACE</p>	<p>Project: HWMU Removal Action Completion Report</p>	<p>Project No. 16170613 & 60517380</p>
<p>Photo No. 43</p> <p>Description: Reacquiring and intrusively investigating DGM target anomaly.</p>

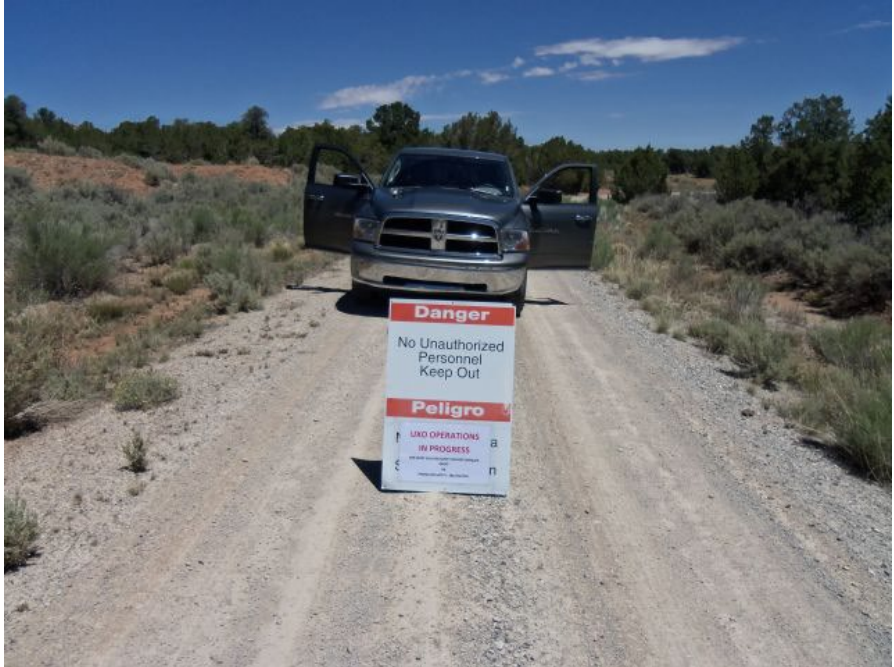
<p>Photo No. 44</p> <p>Description: Typical barricade established during demolition shots.</p>

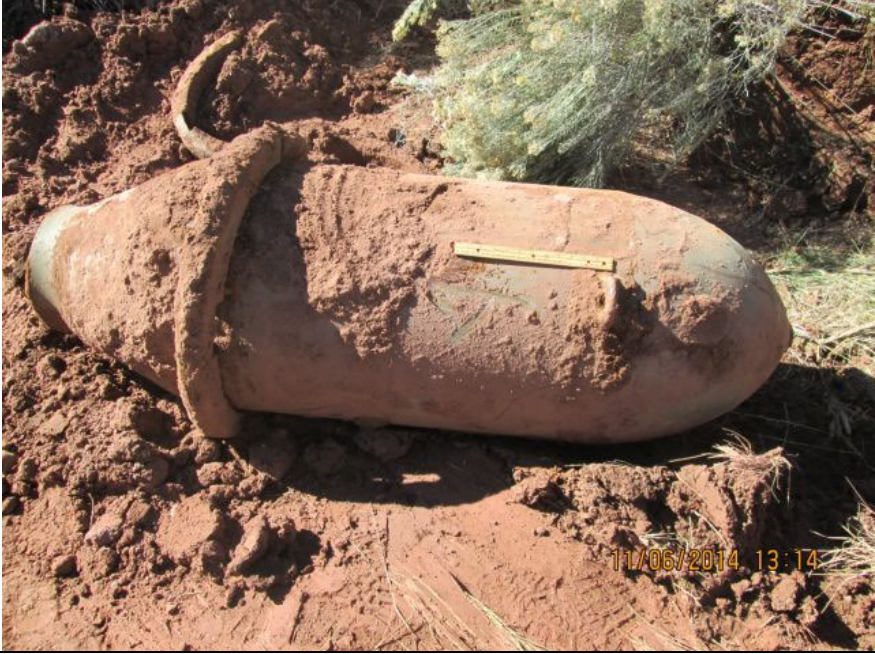
Client Name: USACE	Project: HWMU Removal Action Completion Report	Project No. 16170613 & 60517380
Photo No. 45 Description: Item recovered from the HWMU during the RA (2,000 pound general purpose bomb).

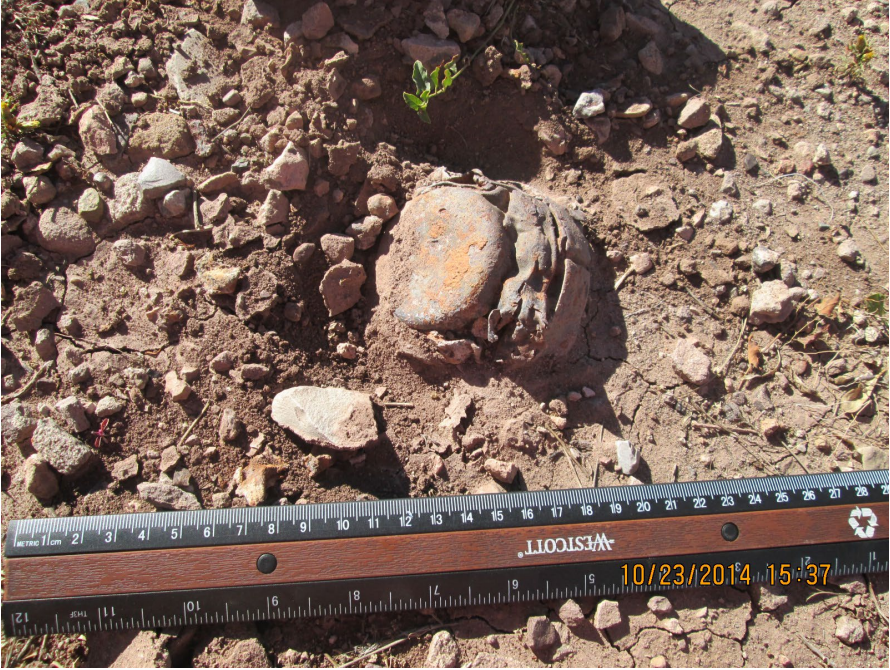
Photo No. 46 Description: Item recovered from the HWMU during the RA (BLU-4 submunition).

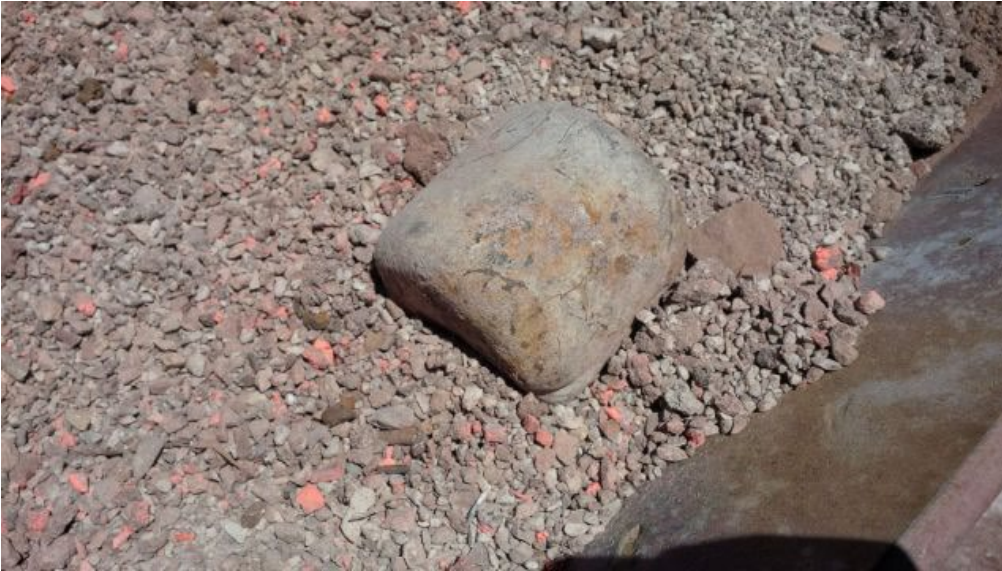
Client Name: USACE	Project: HWMU Removal Action Completion Report	Project No. 16170613 & 60517380
Photo No. 47

Description: Item recovered from the HWMU during the RA (M83 butterfly bomb).		
Photo No. 48

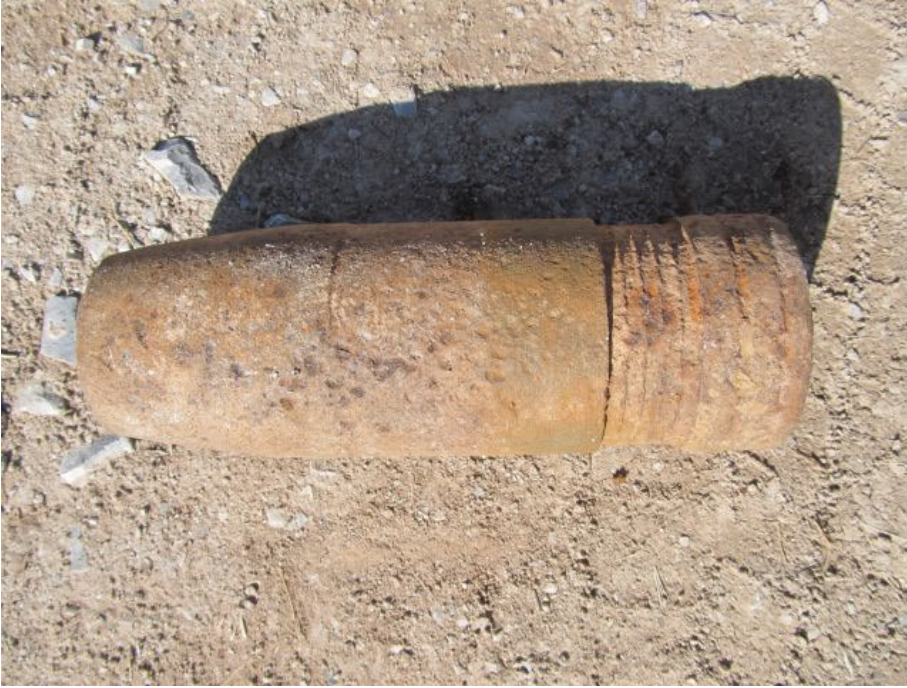
Description: Item recovered from the HWMU during the RA (75 mm projectile)

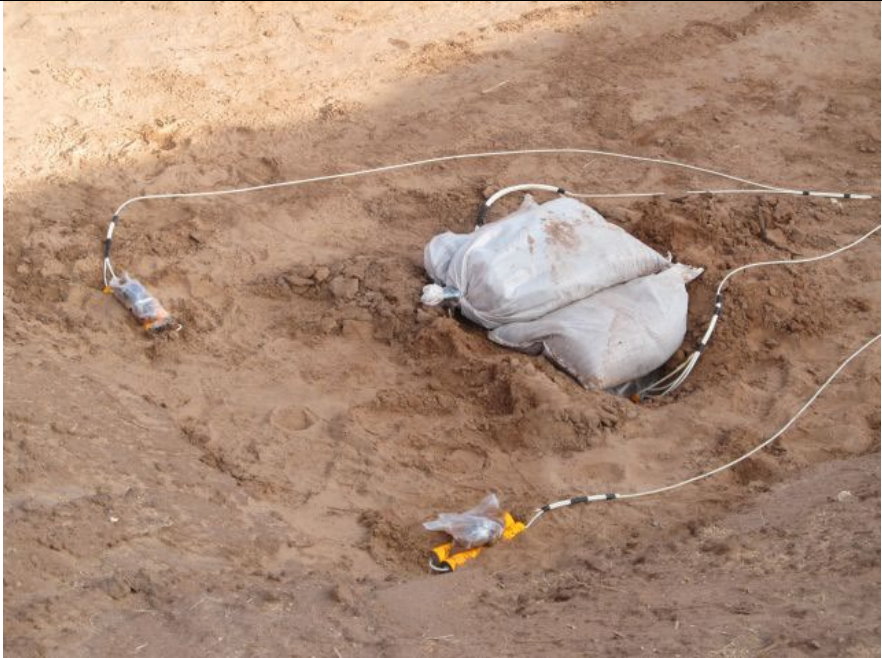
<p>Client Name: USACE</p>	<p>Project: HWMU Removal Action Completion Report</p>	<p>Project No. 16170613 & 60517380</p>
<p>Photo No. 55</p> <p>Description: Demolition shot prepared and ready to initiate.</p>

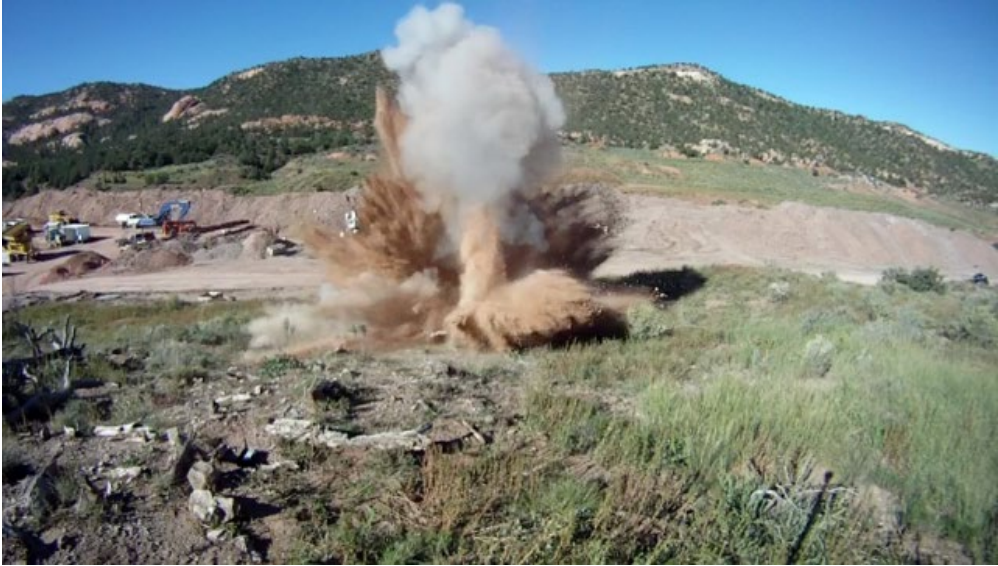
<p>Photo No. 56</p> <p>Description: MEC item found within HWMU detonated in place.</p>

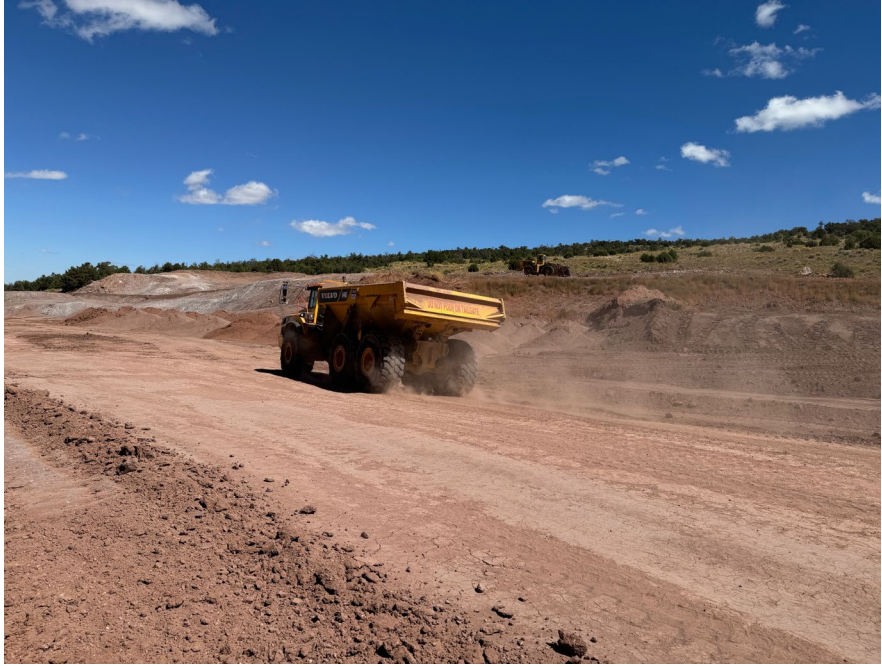
<p>Photo No. 62</p> <p>Description: Hauling in clean stockpile soils back into grids for backfill.</p>

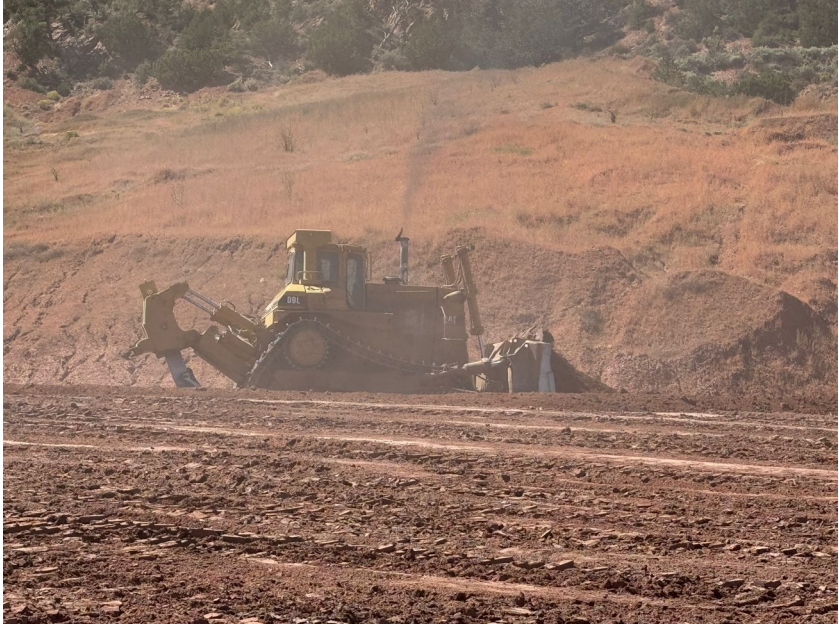
<p>Client Name: USACE</p>	<p>Project: HWMU Removal Action Completion Report</p>	<p>Project No. 16170613 & 60517380</p>
<p>Photo No. 63</p> <p>Description: Final backfill of completed grids.</p>

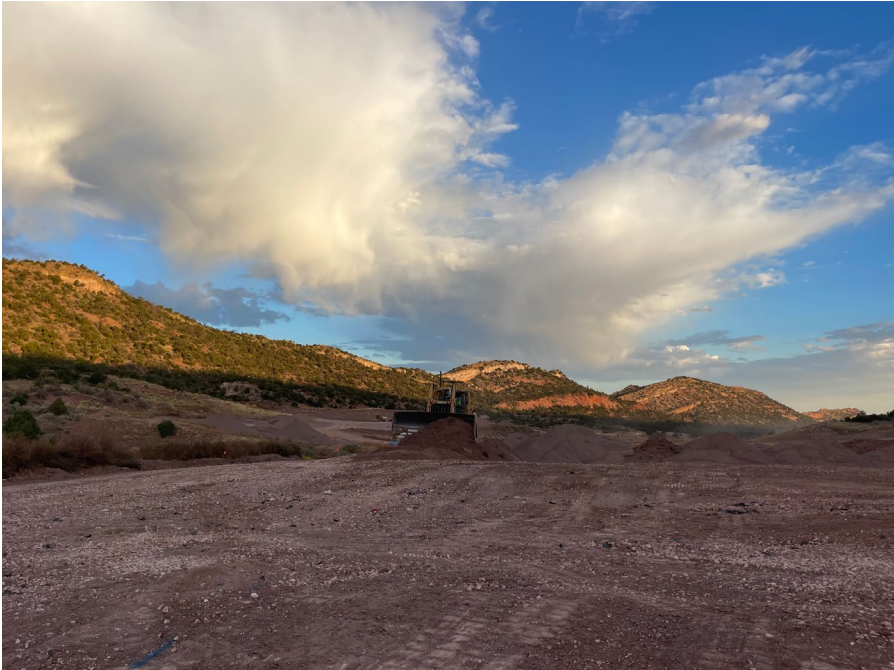
<p>Photo No. 64</p> <p>Description: Final HWMU restoration activities.</p>
