# Well 2 Assessment Report

22 October 2015

United States Army Corps of Engineers  
Albuquerque, New Mexico District

## **Ft. Wingate Well 2 Assessment Summary**

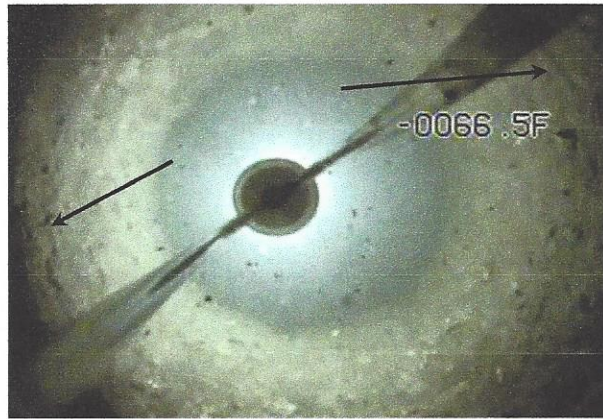
Photo 001  
Joint 13 1/4" OD casing

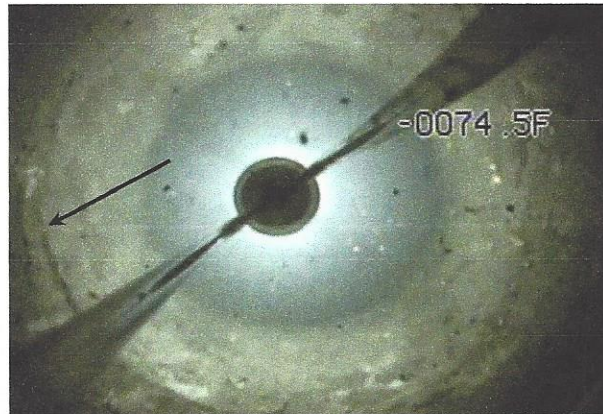
Photo 002  
Joint 13 1/4" OD casing

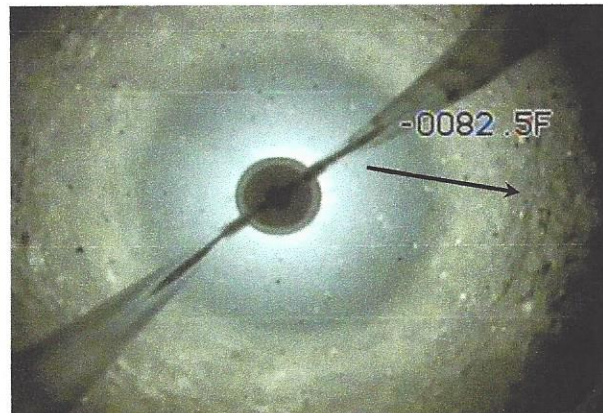
Photo 003  
Joint 13 1/4" OD casing

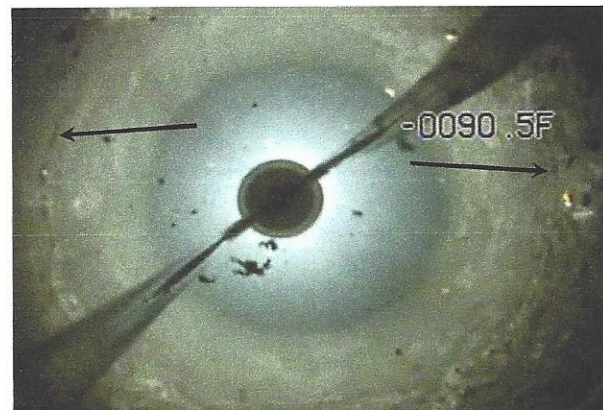
Photo 004  
Joint 13 1/4" OD casing

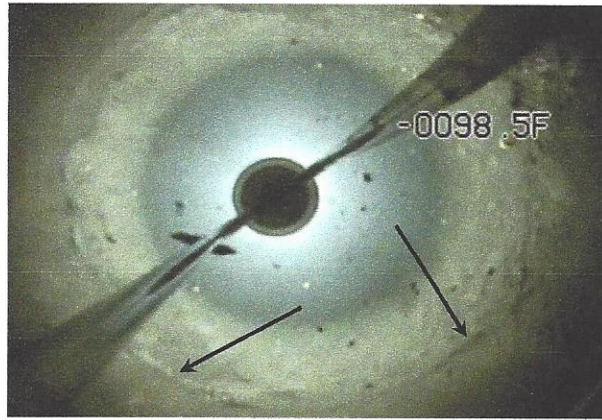
Photo 005  
Joint 13 1/4" OD casing

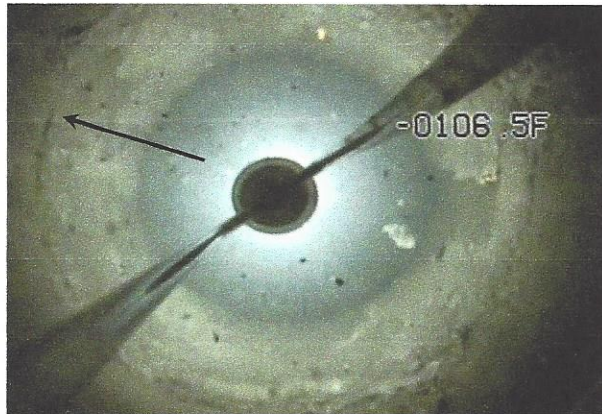
Photo 006  
Joint 13 1/4" OD casing

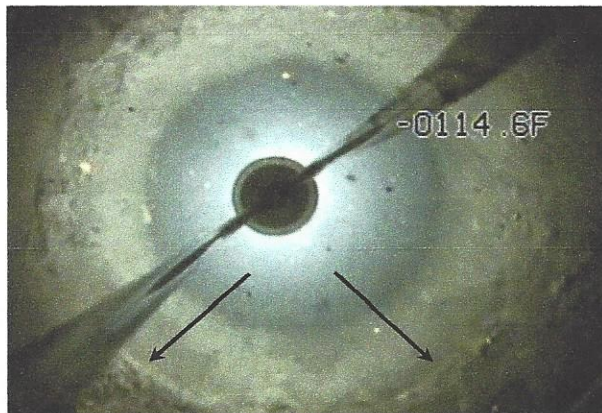
Photo 007  
Joint 13 1/4" OD casing

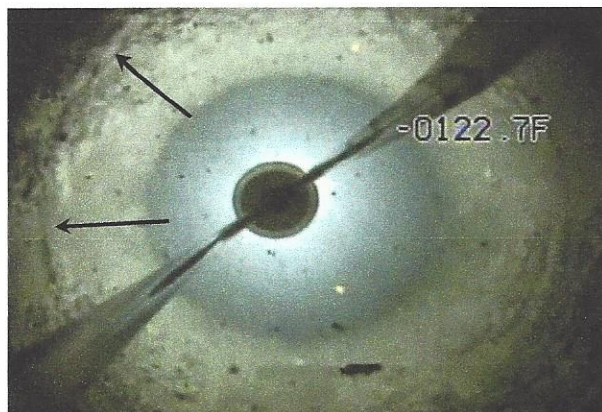
Photo 008  
Joint 13 1/4" OD casing

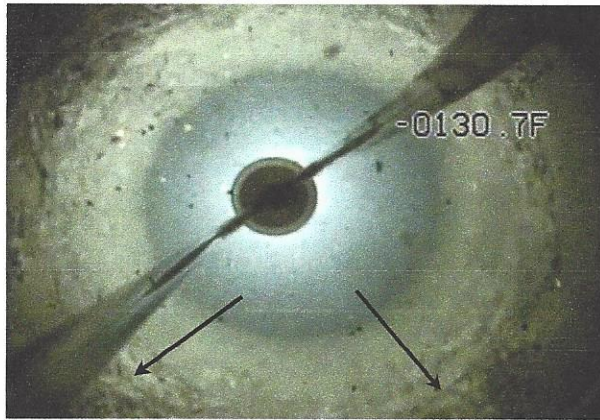
Photo 009  
Joint 13 1/4" OD casing

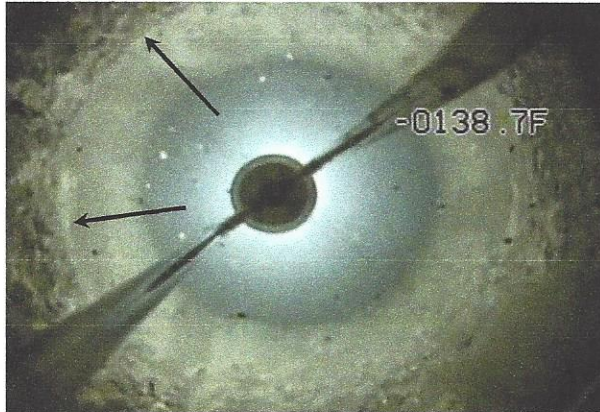
Photo 010  
Joint 13 1/4" OD casing

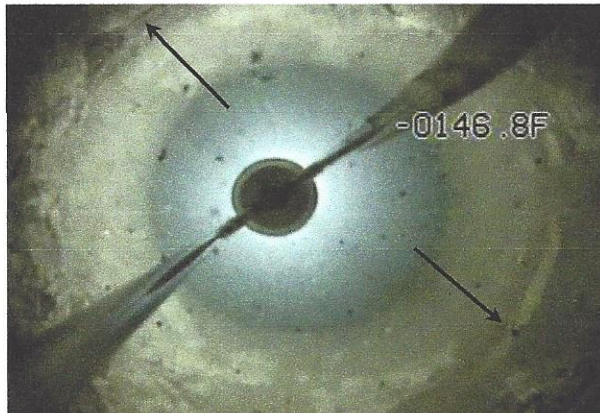
Photo 011  
Joint 13 1/4" OD casing

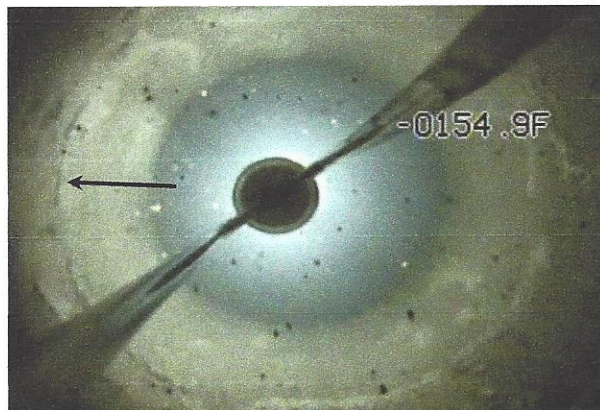
Photo 012  
Joint 13 1/4" OD casing

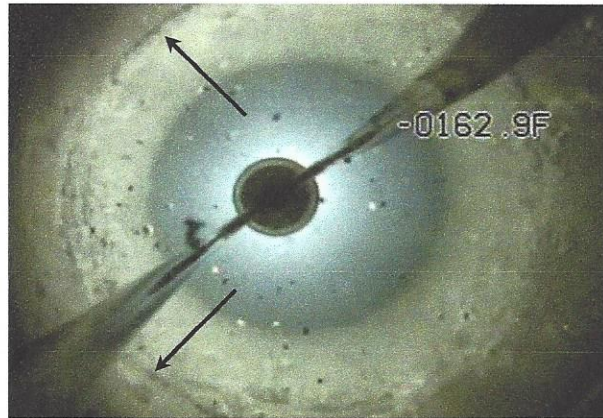
Photo 013  
Joint 13 1/4" OD casing

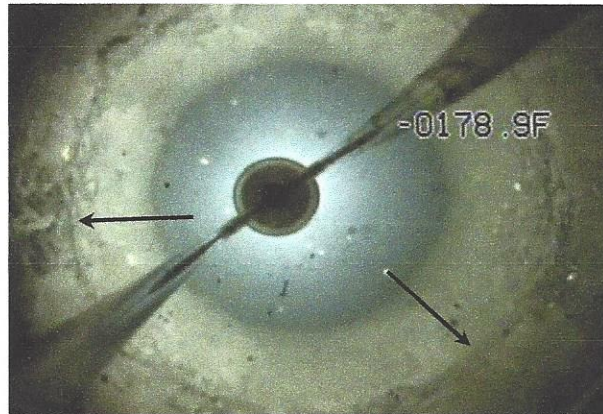
Photo 014  
Joint 13 1/4" OD casing

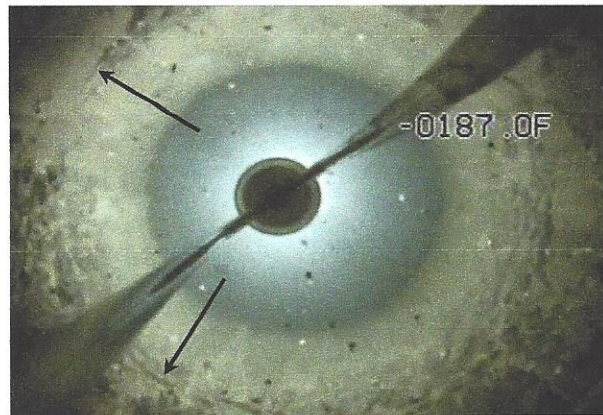
Photo 015  
Joint 13 1/4" OD casing

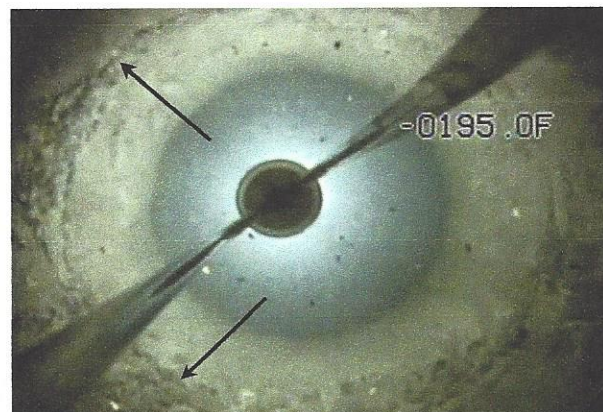
Photo 016  
Joint 13 1/4" OD casing

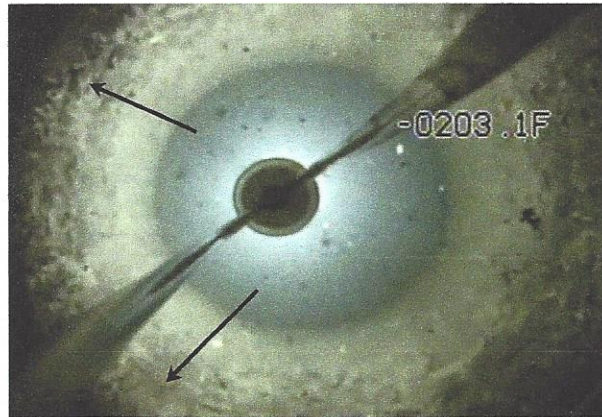
Photo 017  
Joint 13 1/4" OD casing

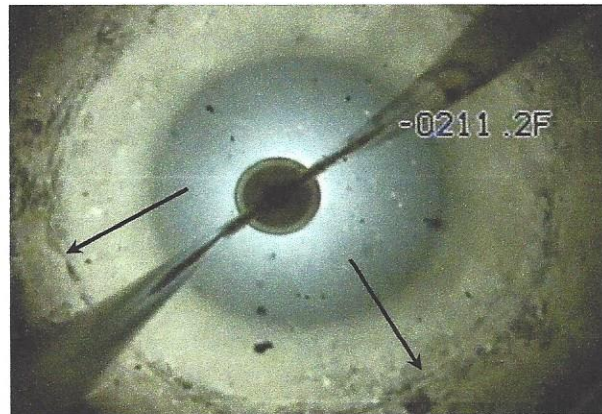
Photo 018  
Joint 13 1/4" OD casing

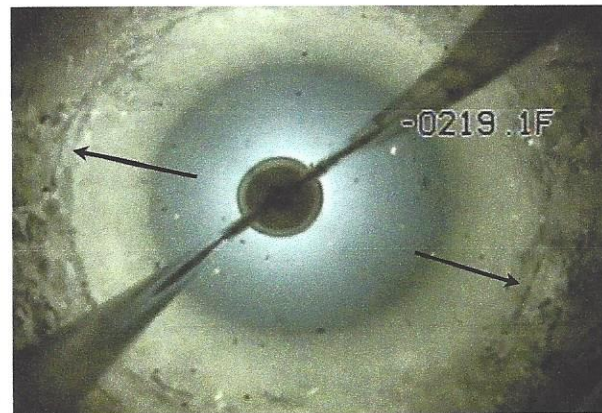
Photo 019  
Joint 13 1/4" OD casing

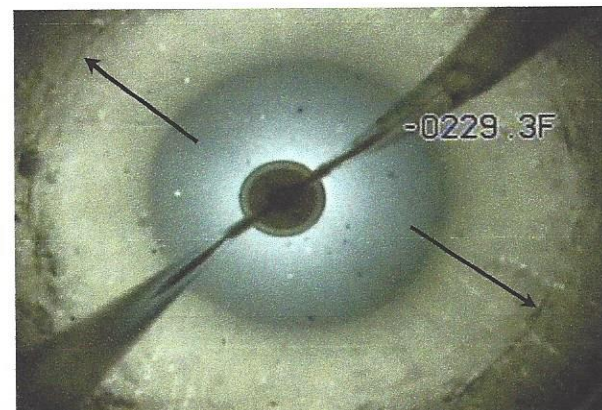
Photo 020  
Joint 13 1/4" OD casing  
Note this length is 10 ft  
All others thus far are 8 ft long

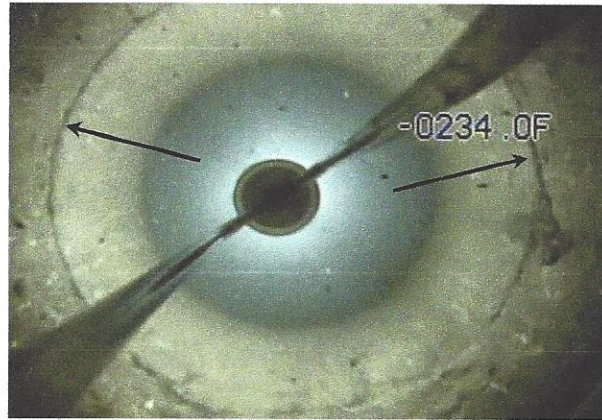
Photo 021  
Joint 13 1/4" OD casing  
Note this length is ~ 5 ft

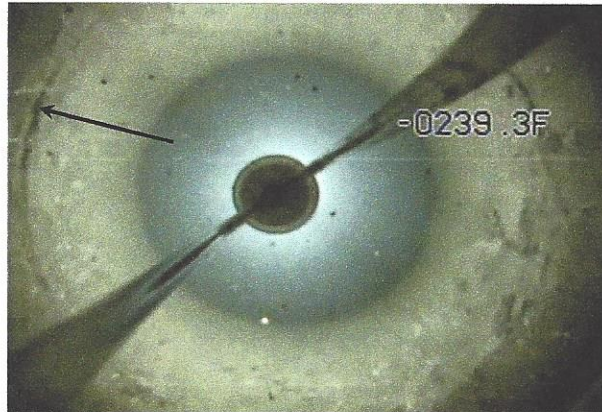
Photo 022  
Joint 13 1/4" OD casing  
Note that length is ~ 6 ft

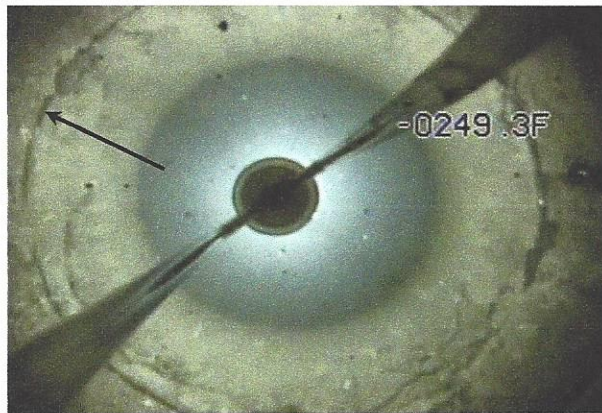
Photo 023  
Joint 13 1/4" OD casing  
Note this length is ~ 10 ft

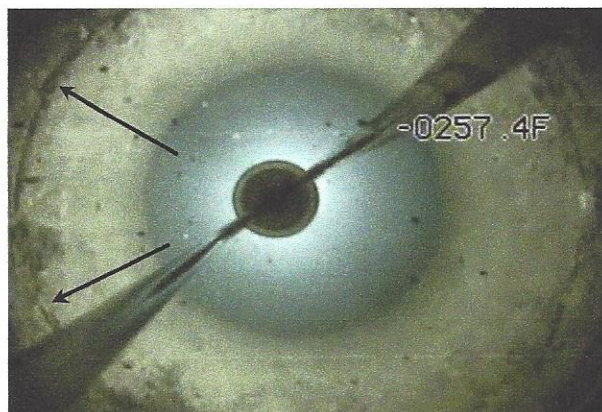
Photo 024  
Joint 13 1/4" OD casing

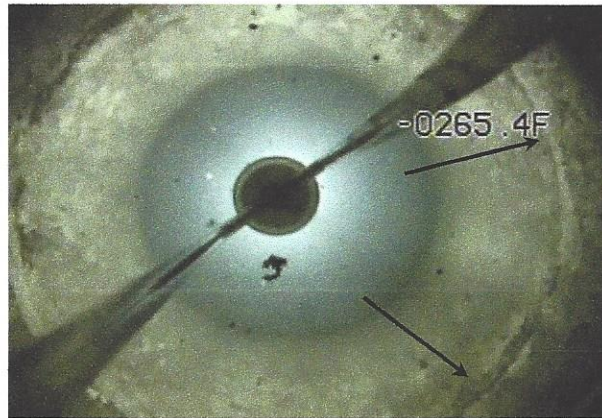
Photo 025  
Joint 13 1/4" OD casing

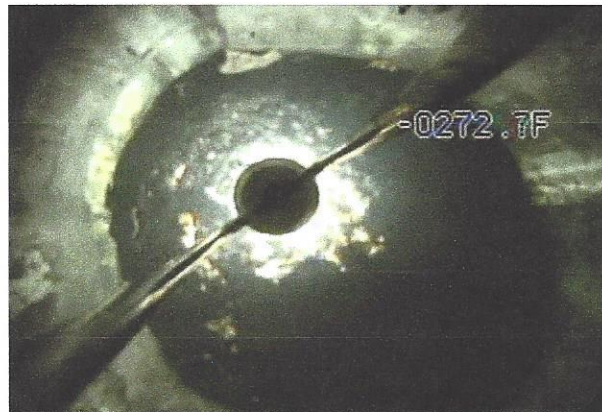
The total well depth can be inferred to be 273' deep. This inference comes from the fact that the camera penetrated fill at 272' and the cameras weight indicator dropped off at 273'. The length of 273' of 13¼" inside diameter will require placement of 857.65 ft<sup>3</sup> of plugging materials.

Photo 026  
Top of fill. Weight dropped off at  
273.7' indicating TD

Develop abandonment and plugging operation plan that includes a total volume of 858 ft<sup>3</sup> of plugging material. The construction of the well is unknown excepting our findings regarding the interior of the well. The casing appears to be in good condition. Therefore it is recommended that the well perforated with a mills knife tool, pulling 2' to 3' cuts bottom to top.
