**ARCHITECTURAL RECORDATION**  
Of the  
**GAS STATION**  
**FORT WINGATE, NEW MEXICO**

US Army Corps of Engineers  
Fort Worth District  
2011

**ARCHITECTURAL RECORDATION**  
**GAS STATION, FORT WINGATE, NEW MEXICO**

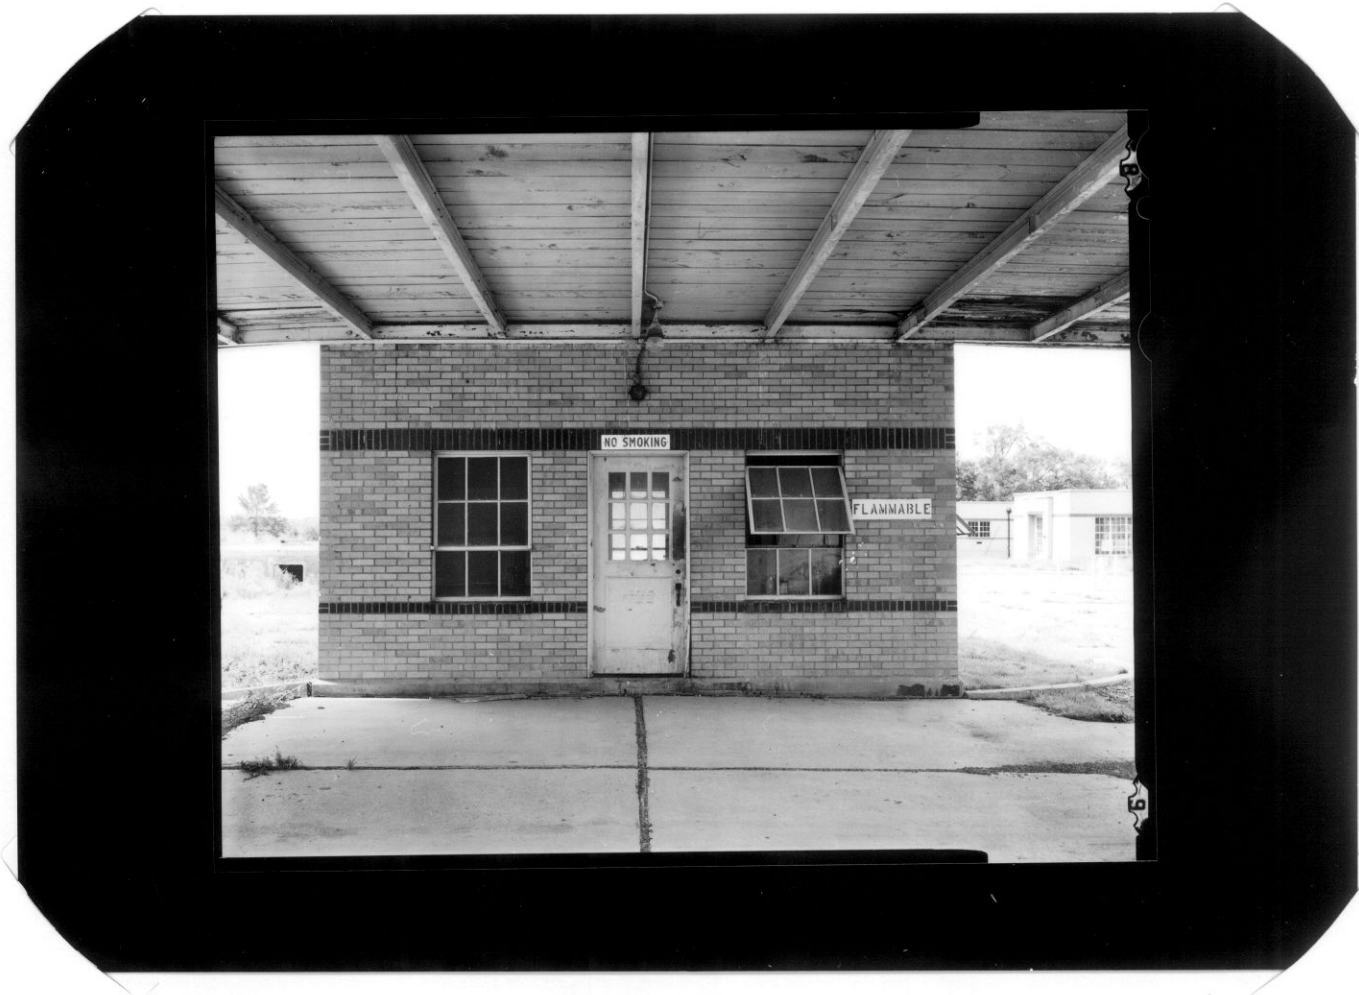
Photograph #5

4. Structural system, framing: Exterior is masonry load bearing construction. Steel joists support a metal roof deck.
5. Porches, stoops, balconies, porticoes, bulkheads: An exterior steel frame and wood canopy is supported by six steel columns that is connected to the main structure and extends over the filling area.

Font Wingate Gas Station Hudson Canopy 2011

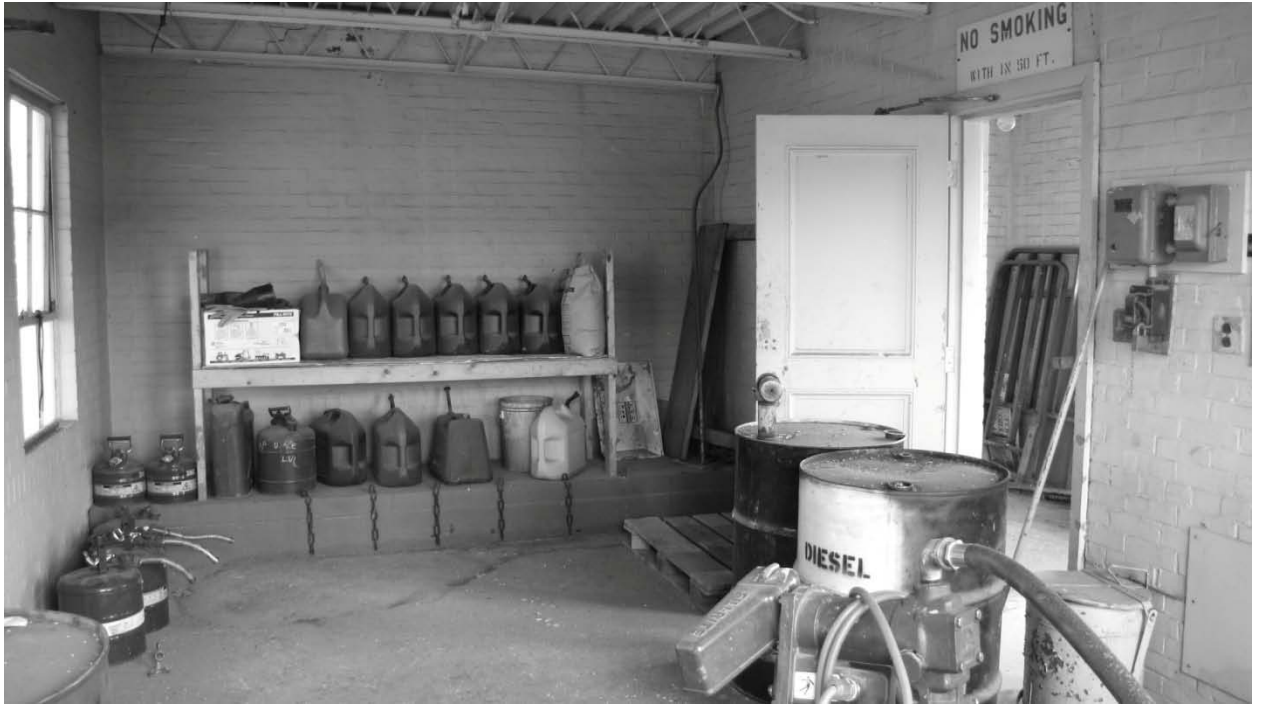
The one-story square floor plan is divided into two rooms joined by a single door in the middle flanked by two steel sash windows. The dividing wall is masonry and contains electrical panels and a bulletin board. The main room is 12' x 19' and contains drum fuel storage but was originally the office/work area. The brick walls are painted. The south wall is devoid of fenestration and contains racks for portable fuel storage containers. Two steel sash windows provide light and ventilation to the north. The rear room is 7' x 19' and was used as a storage room. The storage room has one window to the north and three on the west facade.

**Figure 2. Gas Station Interior Main Room.**

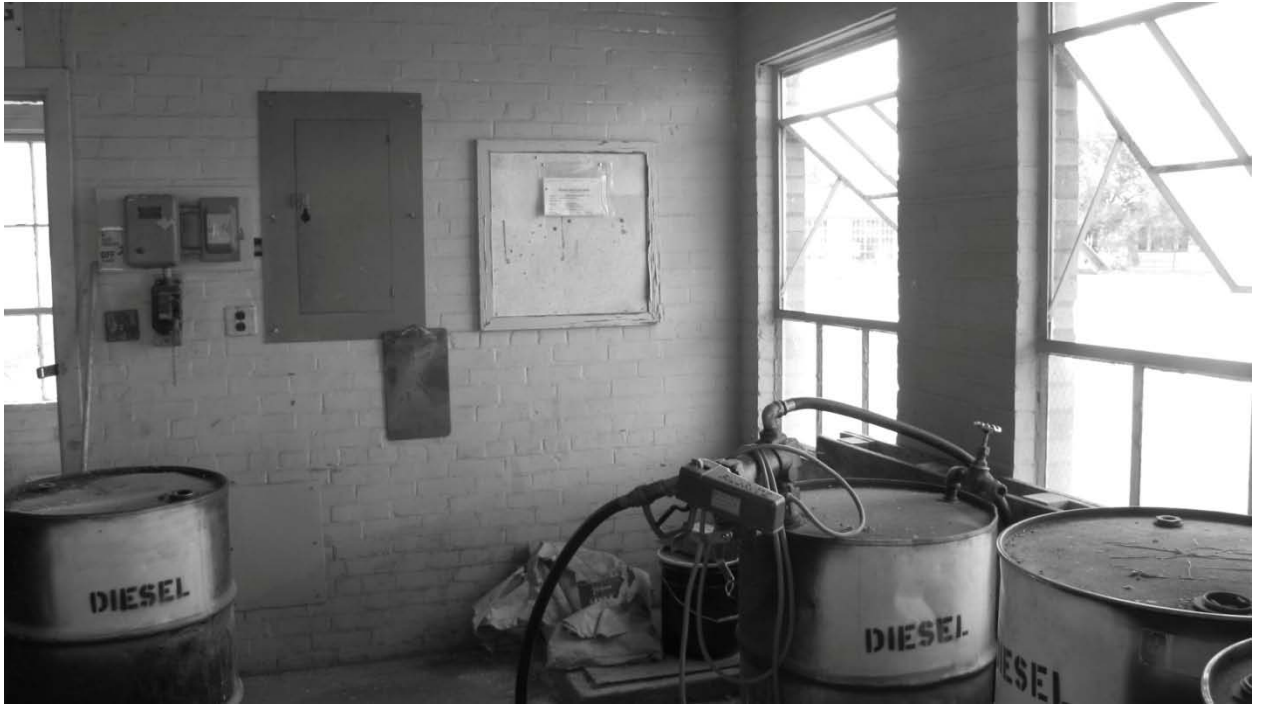
**Figure 5. Gas Station Interior Back Room.**

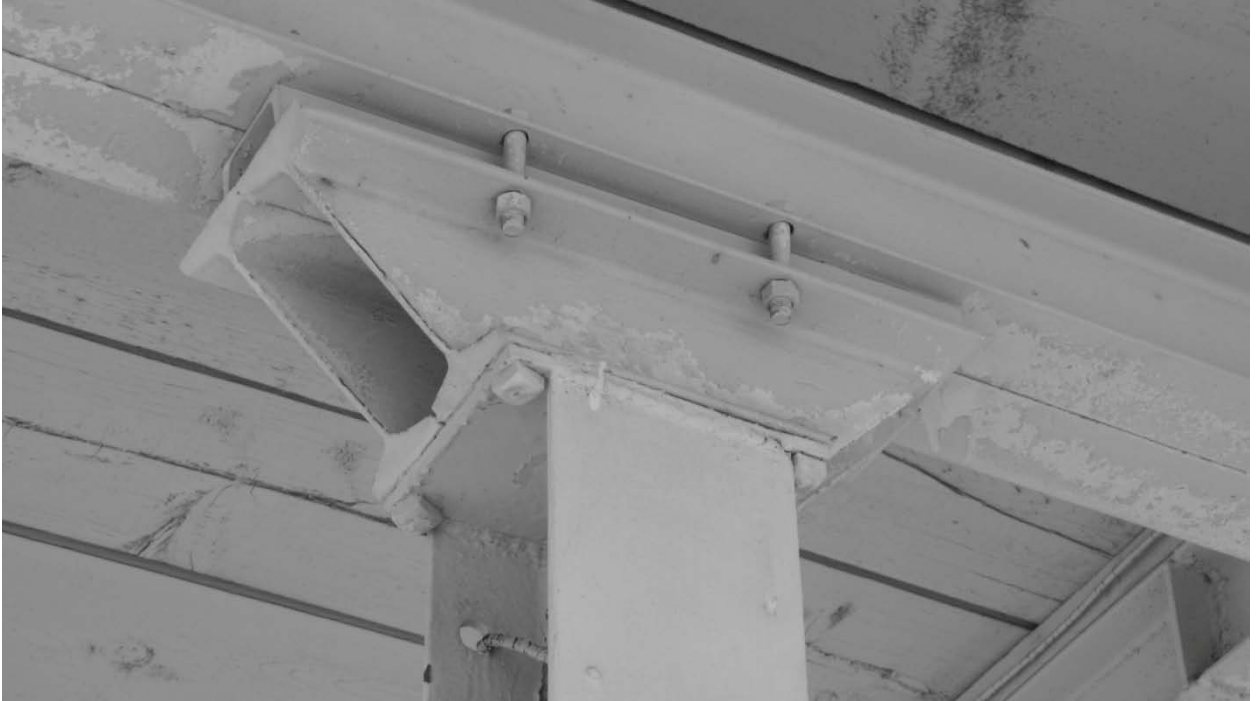
**Figure 6. Gas Station Canopy Column Detail.**

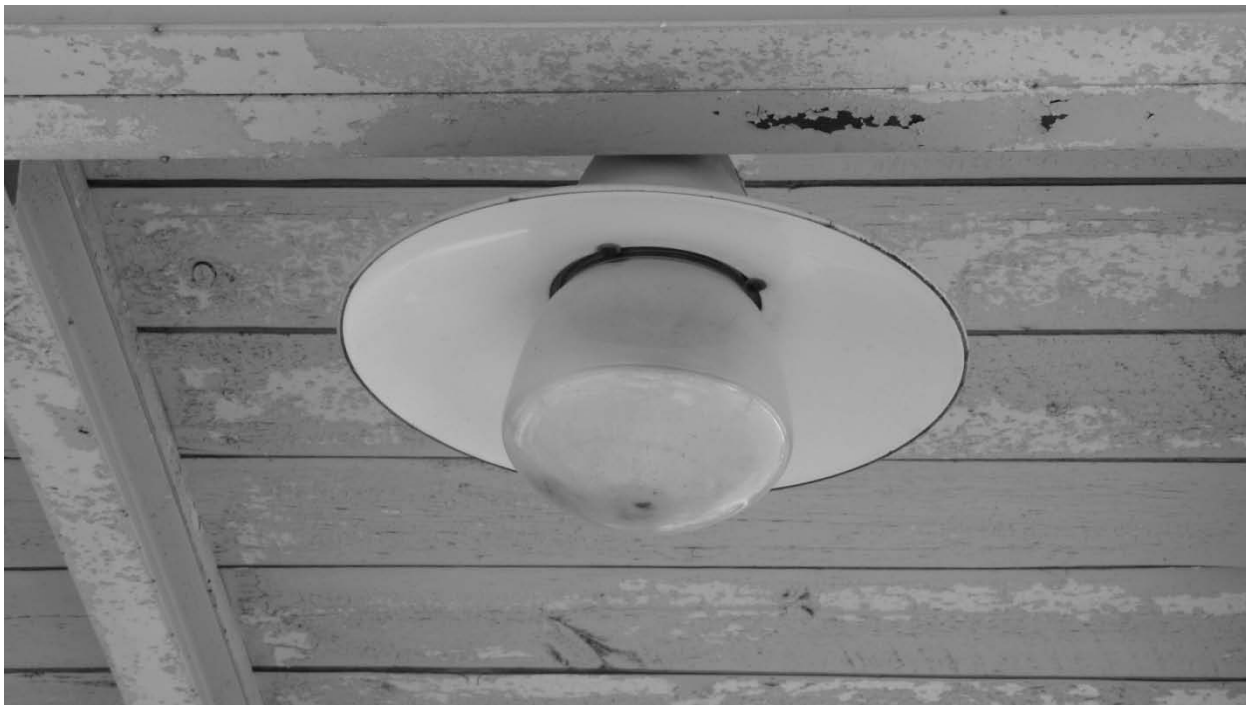
- a. Heating, air conditioning, ventilation: No central air. Steam heating. Operable windows provide ventilation.
- b. Lighting: Fluorescent tube and metal halide lighting. Most of the original lighting has been replaced.
- c. Plumbing: None.

**Figure 7. Gas Station Canopy Light Fixture.**

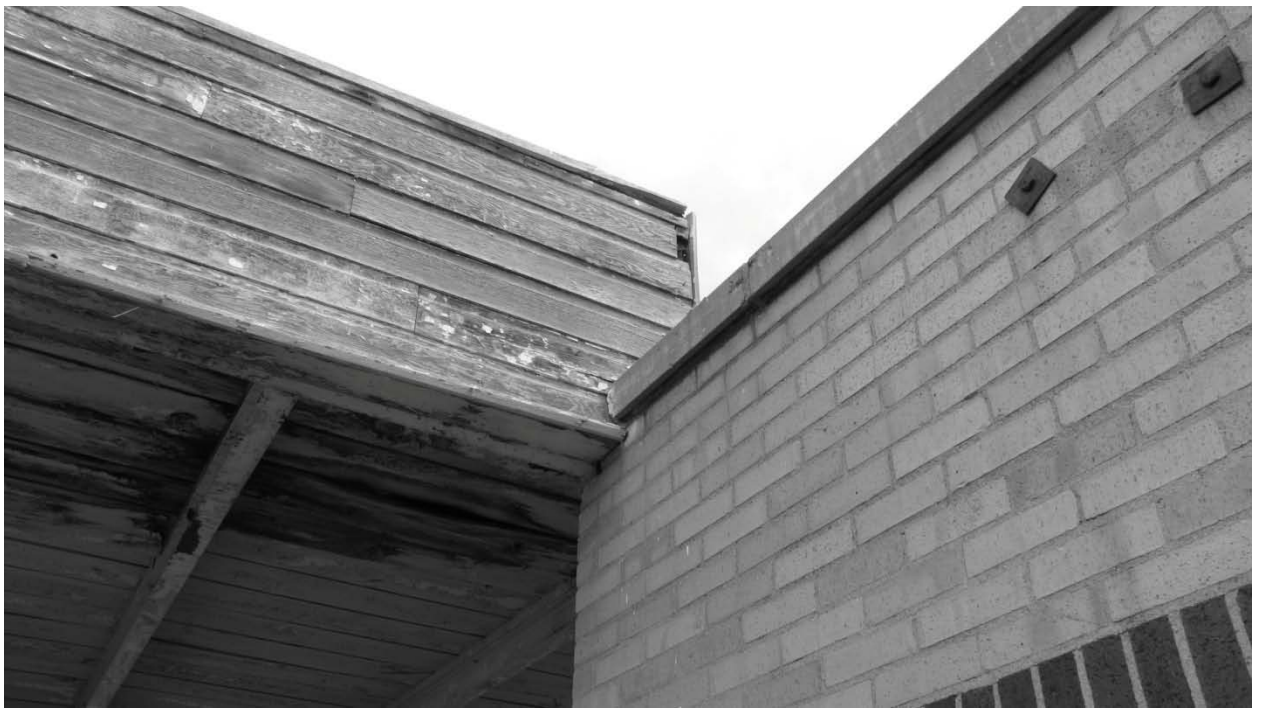
**Figure 8. Gas Station Intersection of Canopy and Station.**

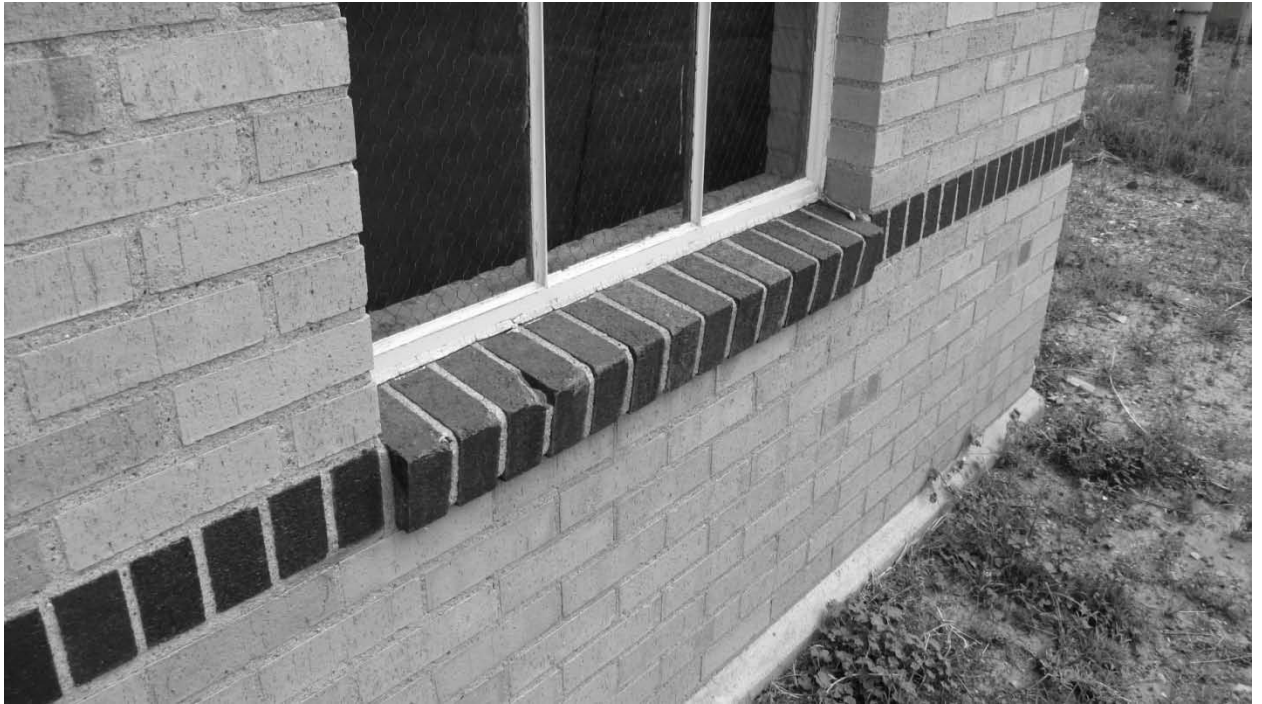
5. Decorative features and trim: The structure is utilitarian in nature and is largely devoid of decorative features with the exception of a chocolate colored brick soldier course which wraps the building at the level of the window headers and at the sill level.

**Figure 9. Gas Station Brick Sill Detail.**

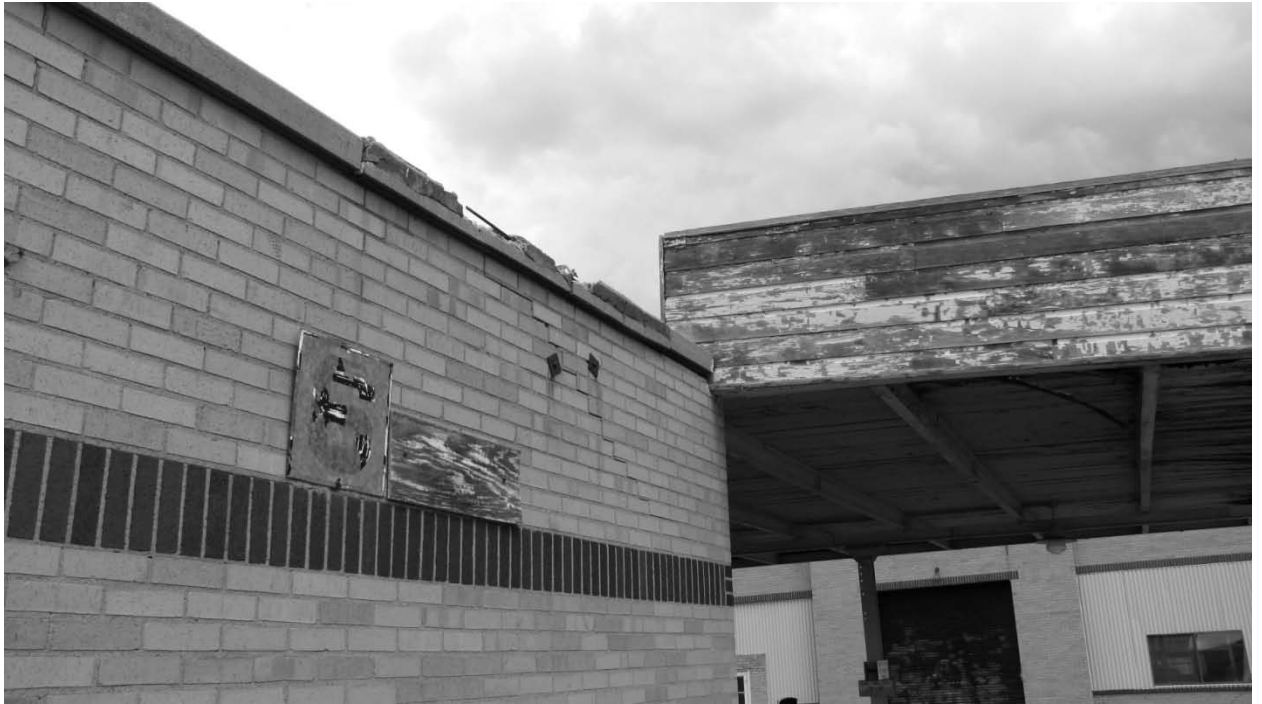
**Figure 10. Gas Station Showing Structural Damage.**
