HISTORICAL DATA ON STRUCTURES 6, 46 and 53

Fort Wingate Depot Activity **Building Status Survey**

Structure ID: B006 Date inspected: 12-Feb-2008

MOTOR FUEL STATION Building Present Use: Diesel drum storage

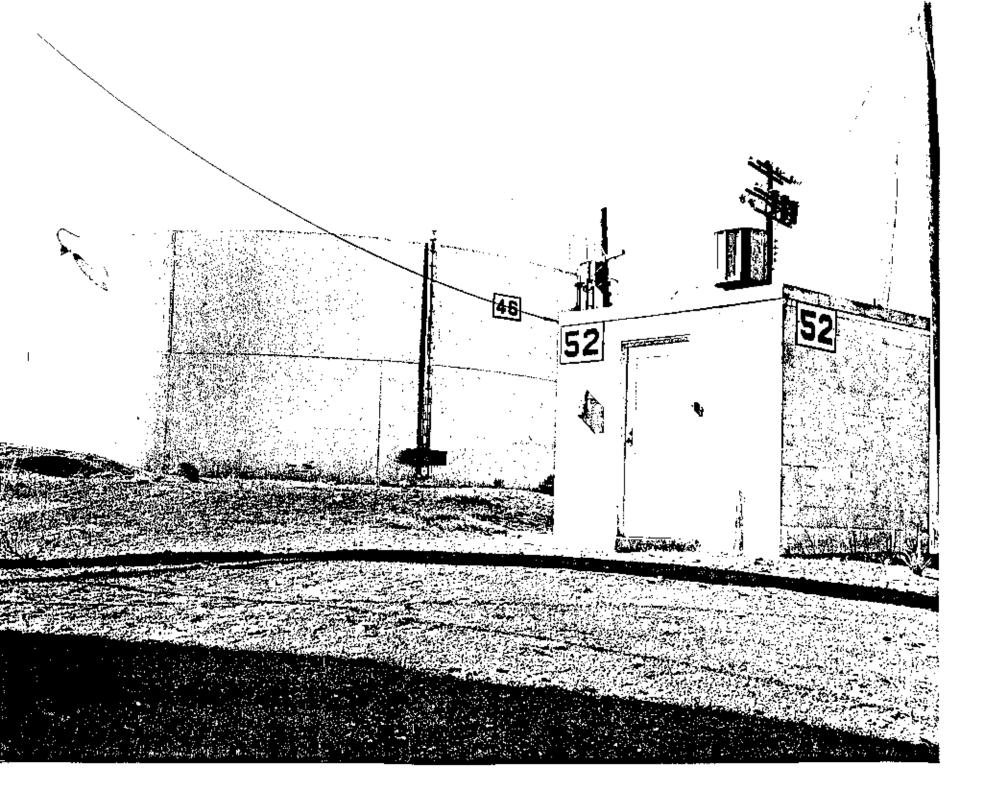
ANALY	SIS OF EXISTING BUILDINGS AND STE	RUCTURES
Building Designation:	Plan Numbers:	
low Callon Water Storage Reservoir	FIOD Dug. No. 340	
Present Use:	Year Constructed:	Real Property Value:
Water Storage	1943	£65,000 .00
Type of Construction:	Number of Stories:	Floor Elevation:
Reinforced Concrete	One	Ground <u>x</u> Car
Floor Construction:	Floor Load Limits:	Roof Construction:
Reinforced Concrete	Not Designated	Wood Frame
Type of Roofing:	Wall Construction:	Largest Door Opening:
5 Ply Built-up Asphalt	Rein Forced Concrete	<u> </u>
Foundation Construction:	Building Dimensions:	Gross Area (sq ft):
Reinforced Concrete	5918" x 5918"	
Net Area (sq ft):	Usable Space (sq ft):	Cubical Content (cu ft):
<u> </u>		100,000 Gallon Capacity
Ceiling Height (ft & in):	Type of Heating:	Type of Air Conditioning:

11.0"	None	None
Controlled Humidity:	Air Filtration:	Lightning Protection:
None	Wall Vents	Yes No 🔻
Electrical Power:	Type of Lighting:	Fire Protection System:
None	None	
Water Service: 1-3"	Sanitary Sewer:	Toilet Capacities:
Yes x No Size 2-6"	Yes No x	Men <u>O</u> Women <u>O</u>
This storage tank is located in the Admis being submitted to repalce the wood the project will be accomplished in the	framed roof with an aluminum frame and	
Page No.		Building Number(s) 47
OROKE Form 85 (One Time) 3 Feb 61	(Use Reverse Side For Remarks)

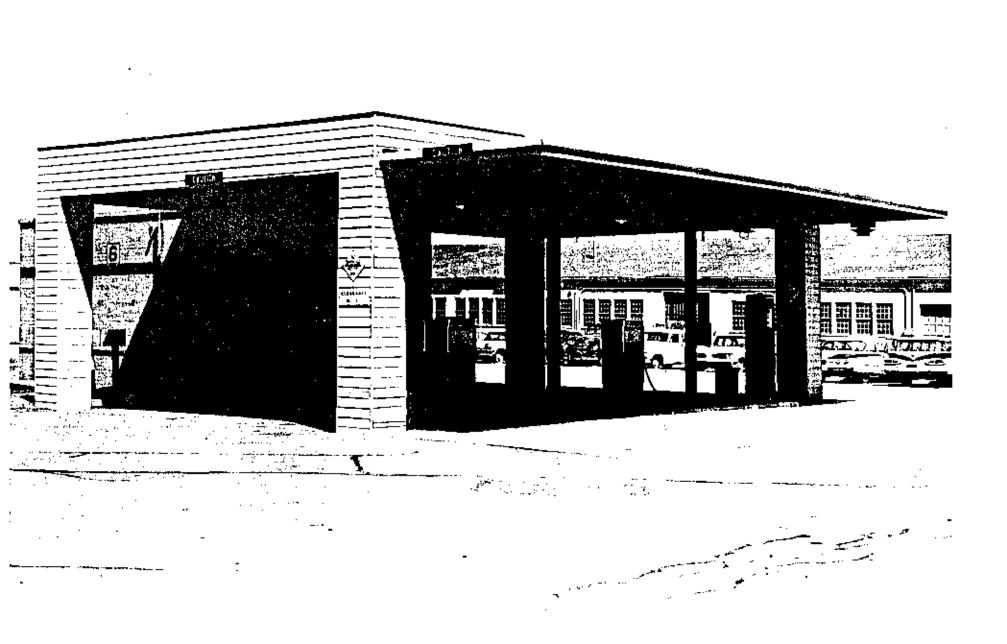
NEW MEXICO HISTORIC BUILDING INVENTORY FORM

Yes:		Date Surveyed: 8/25/93 By: Jeanne A. Schutt			County: McKinley	ID No. 054400006
Field Map: Church R	lock N	Number: 6	UTM Reference Zone 12	Easting 718715	Northir 39327	
Location Description: Behind and west of b	ouilding 5 on Navajo Blv	d.			City/Town: Fort Wingate Land Grant/F	e Army Depot Reservation:
Building Name: #6 Motor Fuel Station		Legal Description: U	Jnplatted E W	SEC	1/4 1/	/4 1/4
Film Roll: #530	Negative Nos. #24	Location of Negative Albuquerque District	s: USACE	Plan Shape:	20'0" x 20'0"	pump
				Date of Cons	truction Actual:	
				Use Present U		
Style Military Co	onstruction.	Foundation Material: Reinforced concrete.		Source: Fac Use Present Uni Historic M Condition: Excellent:	nknown otor Fueld Statio	on X
Style Military Co	onstruction.			Source: Fac Use Present Uni Historic M	nknown otor Fueld Statio Good: Deterio	X rating:
Architectual Features	s:	Reinforced concrete. Wall Material/Surface	9:	Source: Fac Use Present Un Historic M Condition: Excellent: Fair: Degree of Re Minor: Describe:	nknown otor Fueld Statio Good: Deterio	X orating: Major: N/A

Architectual Features	s:	Wall Material/Surface 8" Brick masonry.	9:	Source: Fac Use Present Un Historic M Condition: Excellent: Fair: Degree of Re Minor: Describe: Surroundings	nknown otor Fueld Statio Good: Deterio emodeling: Moderate:	X rating: Major: N/A area
Architectual Features	s:	Wall Material/Surface 8" Brick masonry.	9:	Source: Fac Use Present Un Historic M Condition: Excellent: Fair: Degree of Re Minor: Describe: Surroundings Relationship Similar: X	Good: Deterio emodeling: Moderate: Maintenance to Surroundings	X rating: Major: N/A area
Architectual Features One story building. I Comments: Equipped with two ga	s: Roof construction: steel asoline dispering units, nt, two 11,750 gallons g	Reinforced concrete. Wall Material/Surface 8" Brick masonry. decking. Type of roofing: as compressor and accessories asoline storage tanks, one 11	phalt and gravel.	Source: Fac Use Present Un Historic M Condition: Excellent: Fair: Degree of Re Minor: Describe: Surroundings Relationship Similar: X	Good: Deterio emodeling: Moderate: S: Maintenance to Surroundings Not Sin ntial: Yes: X Of: Nor	X rating: Major: N/A area : nilar:

Architectual Features One story building. If Comments: Equipped with two ga	s: Roof construction: steel asoline dispering units,	Reinforced concrete. Wall Material/Surface 8" Brick masonry. decking. Type of roofing: as compressor and accessories asoline storage tanks, one 11	phalt and gravel.	Source: Fac Use Present Un Historic M Condition: Excellent: Fair: Degree of Re Minor: Describe: Surroundings Relationship Similar: X District Poter Significance: Eligible: If eligible, wh Associated E	Good: Deterio emodeling: Moderate: S: Maintenance to Surroundings Not Sin ntial: Yes: X Of: Nor	X rating: Major: N/A area : nilar: No:
