**SUMMARY REPORT OF HISTORICAL
INFORMATION
PARCEL 22
FINAL**

**FORT WINGATE DEPOT ACTIVITY
McKinley County, New Mexico**

09 June 2008

**Contract No. W9126G-06-D-0016
Task Order No. 0001**

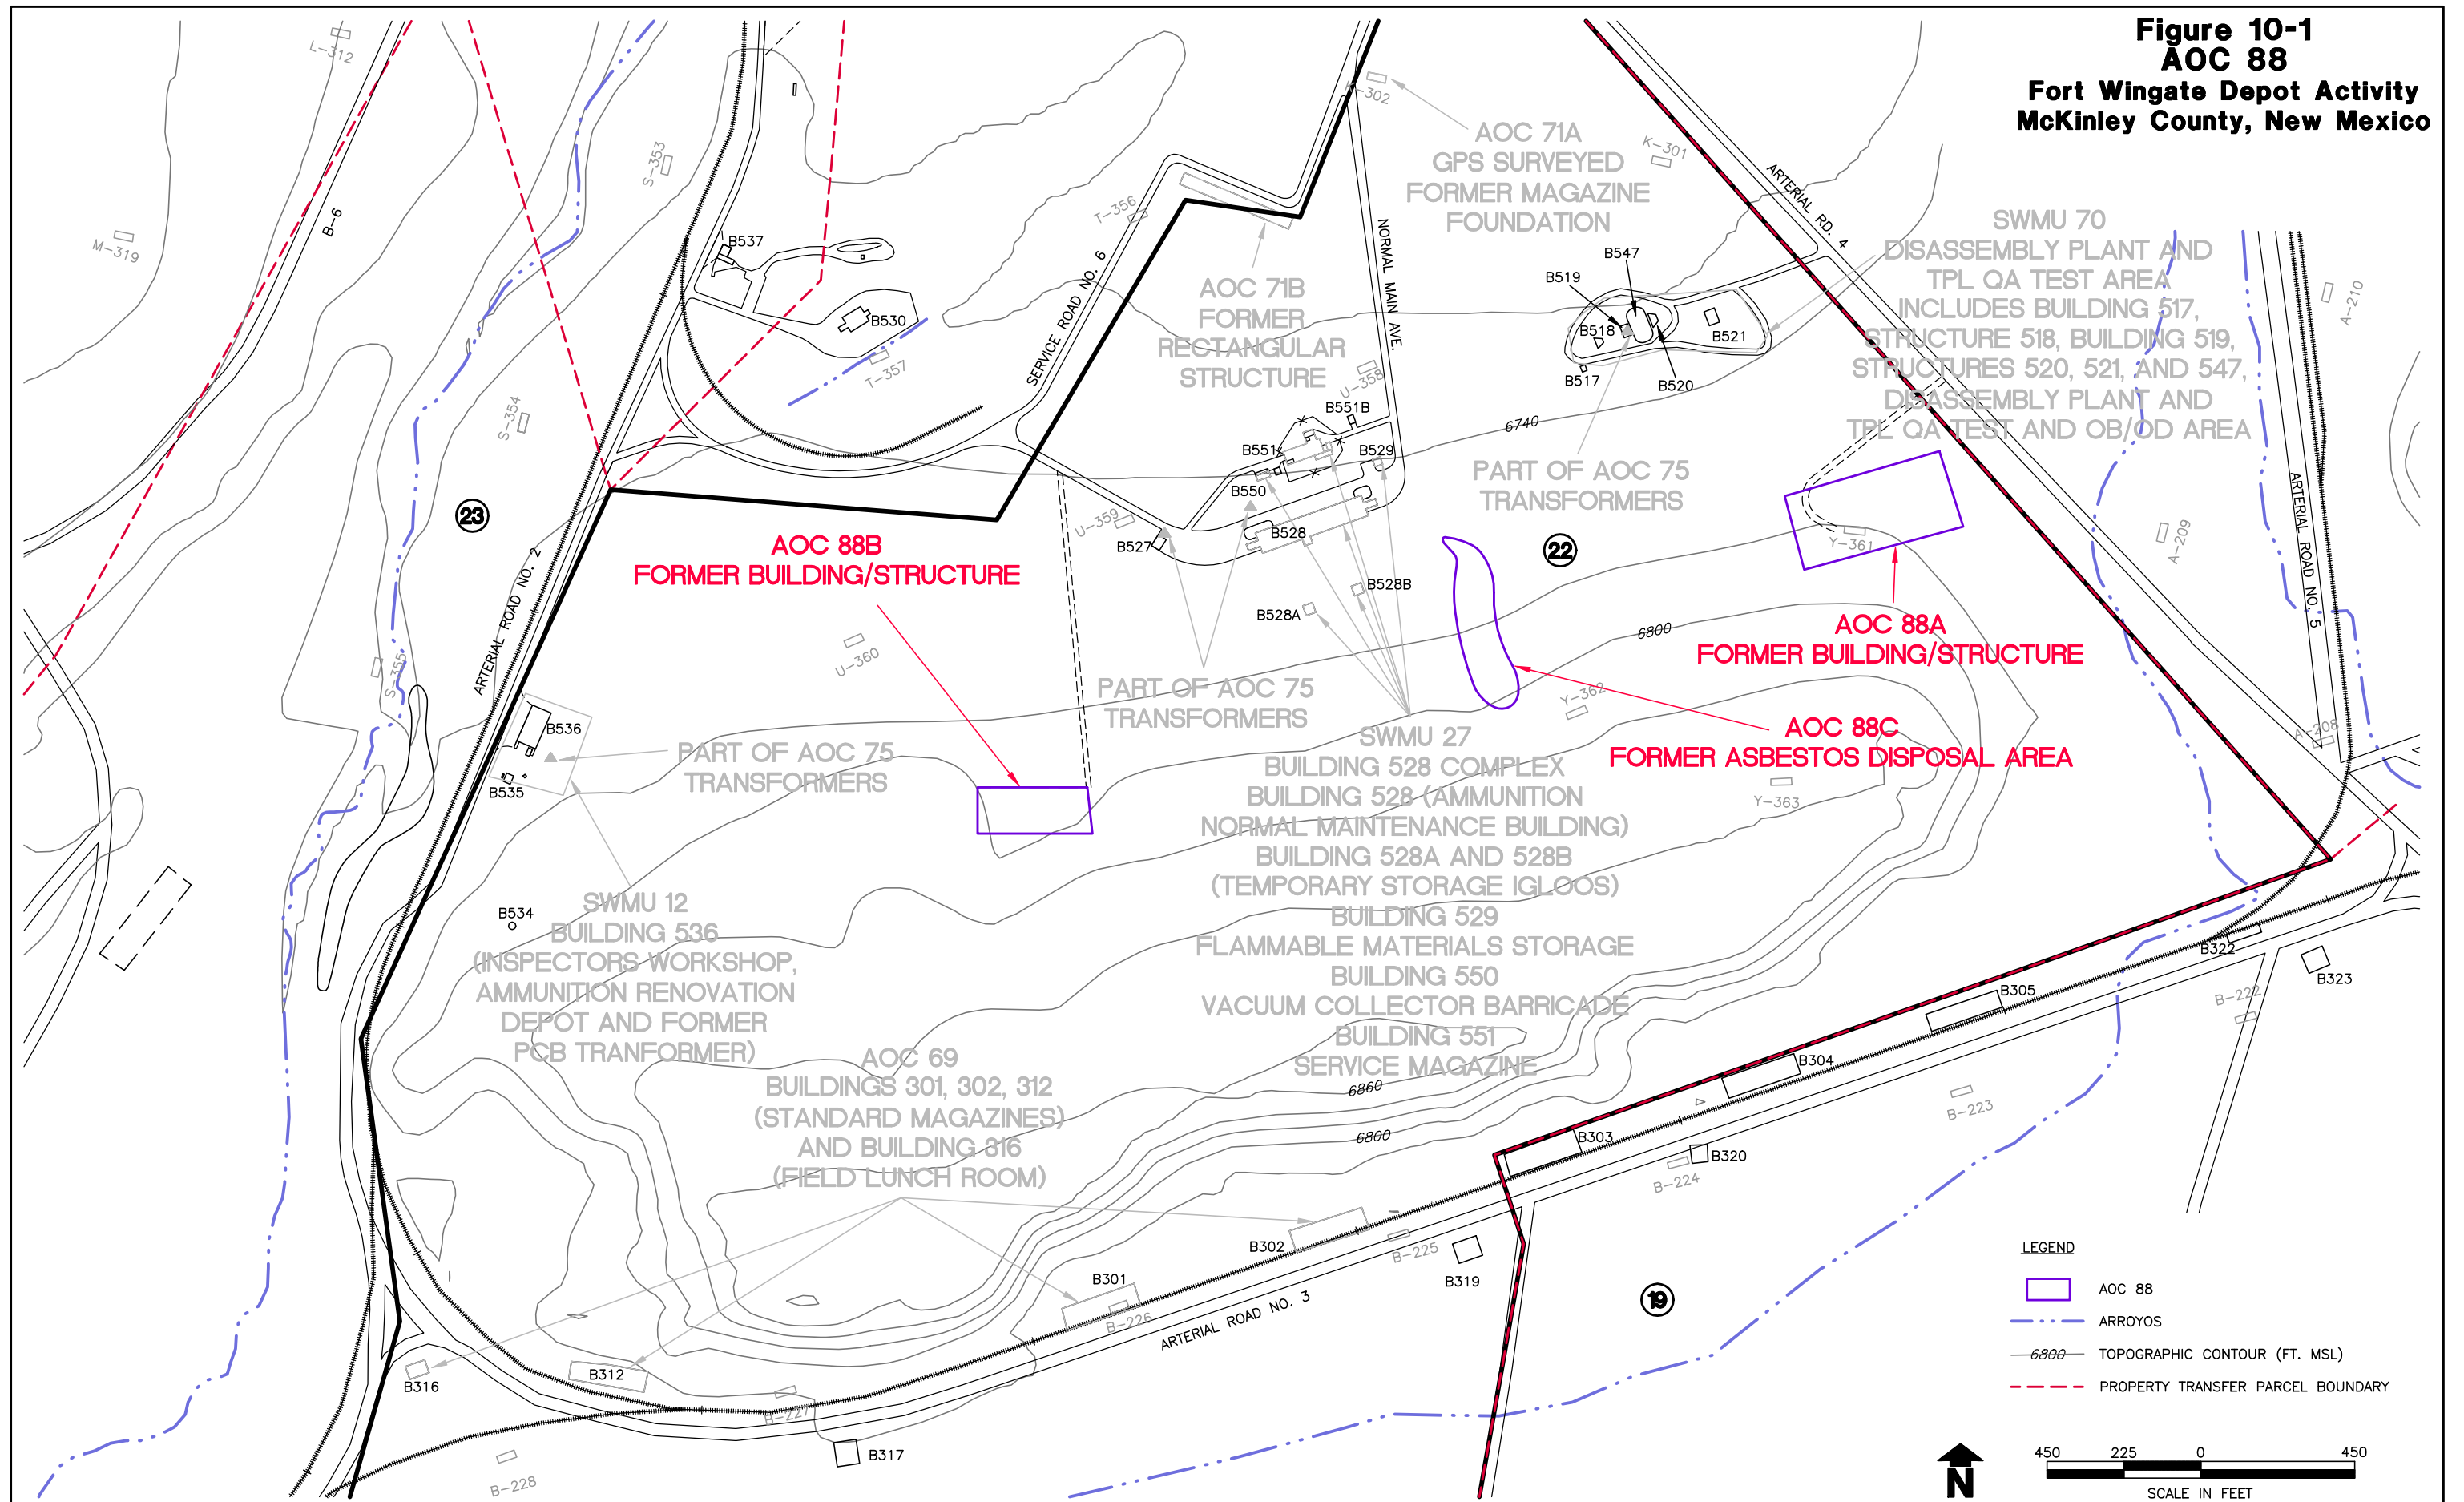
Figure 10-1
AOC 88
Fort Wingate Depot Activity
McKinley County, New Mexico

As noted in the aerial photo analysis report (ERI, 2006; Parcel 22 findings are included in Appendix B), a low building or building foundation was present at AOC 88A in the 1948 photo. The 1952 photo showed a graded area with probable disposal area at AOC 88A. In the 1966 photo, an access road leads to an area of light-toned material and disturbed ground at AOC 88A. In analysis of the 1973, 1978, 1985, and 1991 photos found that scarred and disturbed areas with probable debris present at AOC 88A. There were no significant findings for the remaining photos analyzed and no coverage in the 1991 photo.

A historical map from 1955 (FWDA Drawing No. A-3-4, included in Appendix J) shows AOC 88B as T-32 (X-15) and is noted as an X-Site with a 3,000 ton capacity. No feature is present in the AOC 88A location on historical map A-3-4.
