Historical Information Report

Parcel 6

Fort Wingate Depot Activity
McKinley County, New Mexico

23 February 2009

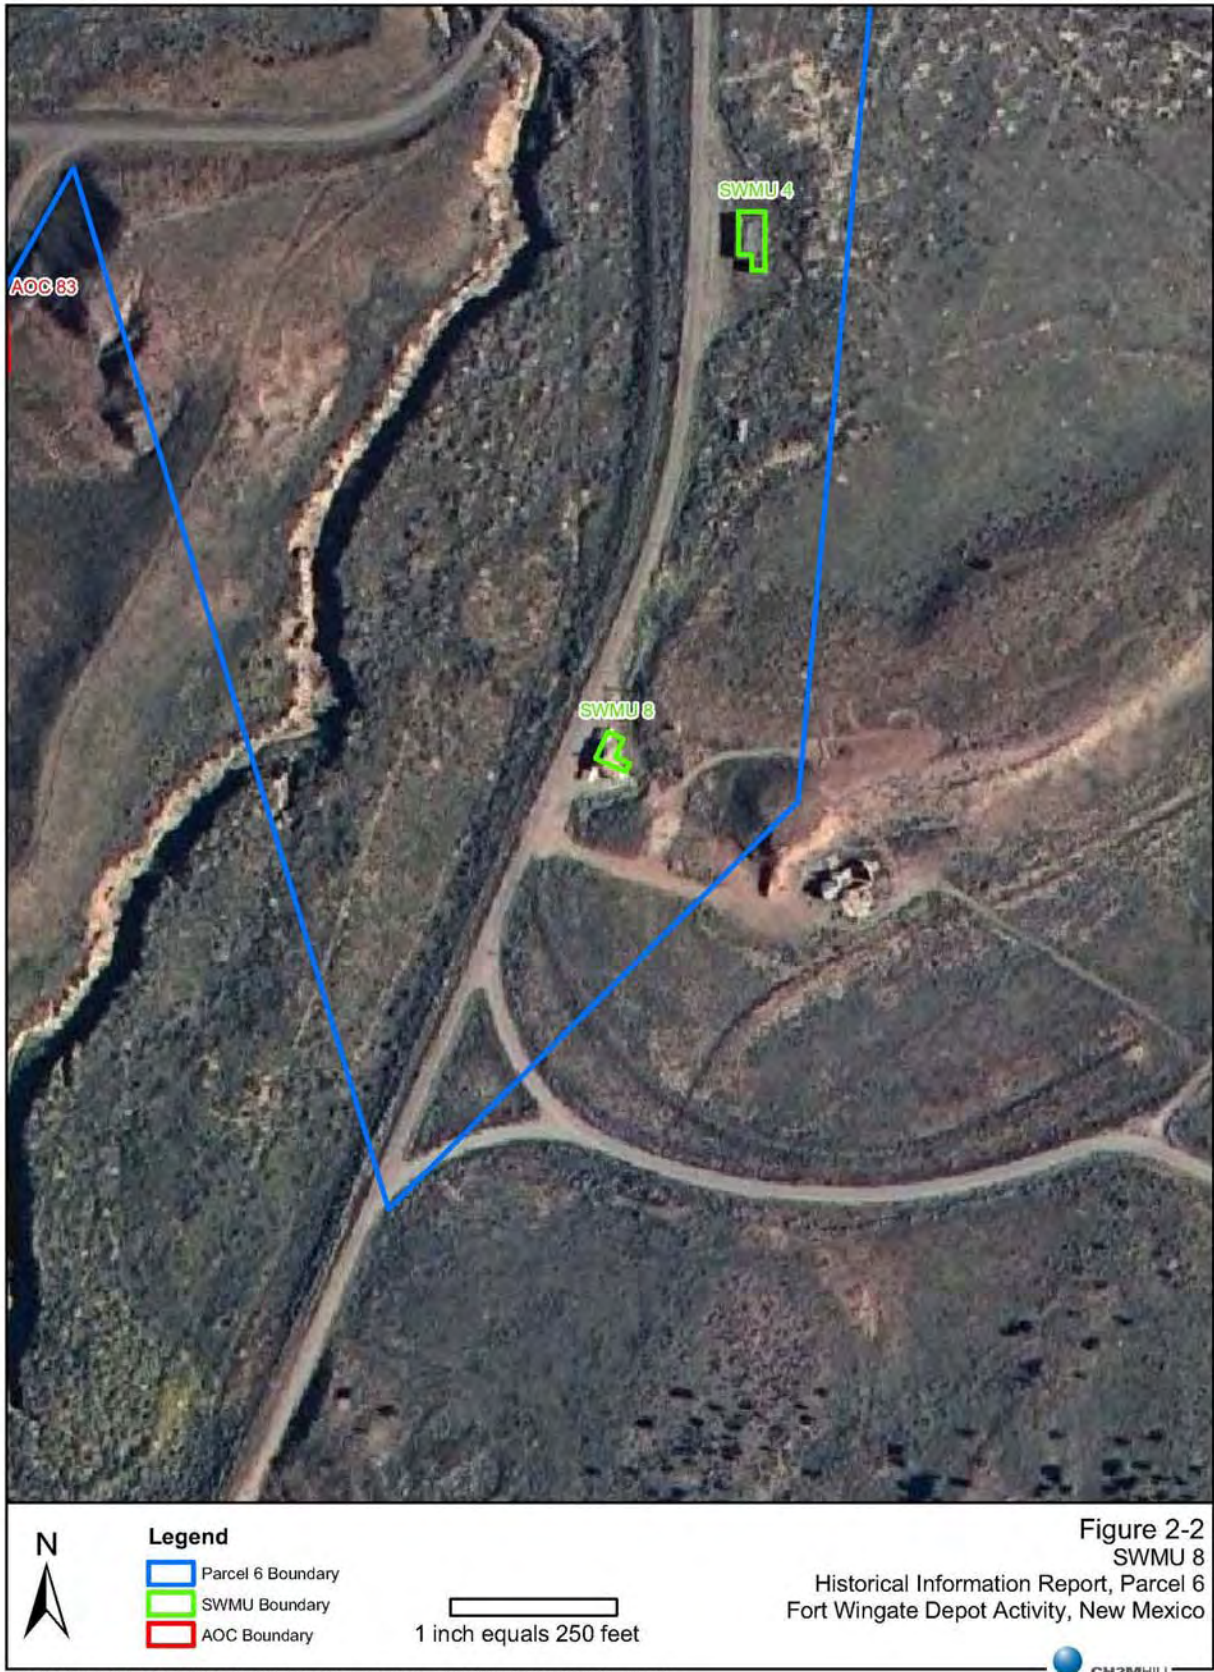
Figure 2-2
SWMU 8
Historical Information Report, Parcel 6
Fort Wingate Depot Activity, New Mexico

18 Building 537 is located on the east side of Arterial Road No. 2, northwest of Building 530 (former
19 Deactivation Furnace) and south of the Workshop Area (Figure 2-2). Building 537 was constructed in
20 1941 and is a 4,200 square foot brick structure with a reinforced concrete floor and basement based
21 on available as-built drawings (FWDA, 1961; Daniel, 1994).

30 Historical reports also indicate a small (approximately 12 feet wide by 17 feet long) foundation slab
31 was located approximately 50 feet east of Building 537 (TtNUS, 2000 and PMC, 2004). The
32 foundation slab had a center drain that discharged, via a 6-inch-diameter vitrified clay pipe, to an
33 earthen ditch between Building 537 and the slab (PMC, 2004). The foundation slab also had two
34 abandoned ¾-inch-diameter water lines on its western edge (PMC, 2004). However, no information
35 has been found in any Army records to identify this foundation slab or its operations. An aerial
36 photograph from 1958 shows the slab, but the building had already been removed (PMC, 2004).
37 Aerial photographs from 1948 and 1952 also show this feature but due to the resolution of these
38 photos it is unclear if this area is a building or just the slab (Appendix C2). This foundation slab was
39 removed in 2004 (PMC, 2004).

40 Building 537 had a septic tank west of the railroad tracks with an outfall to the arroyo prior to the
41 building's connection to the FWDA sanitary sewer system (PMC, 2004).

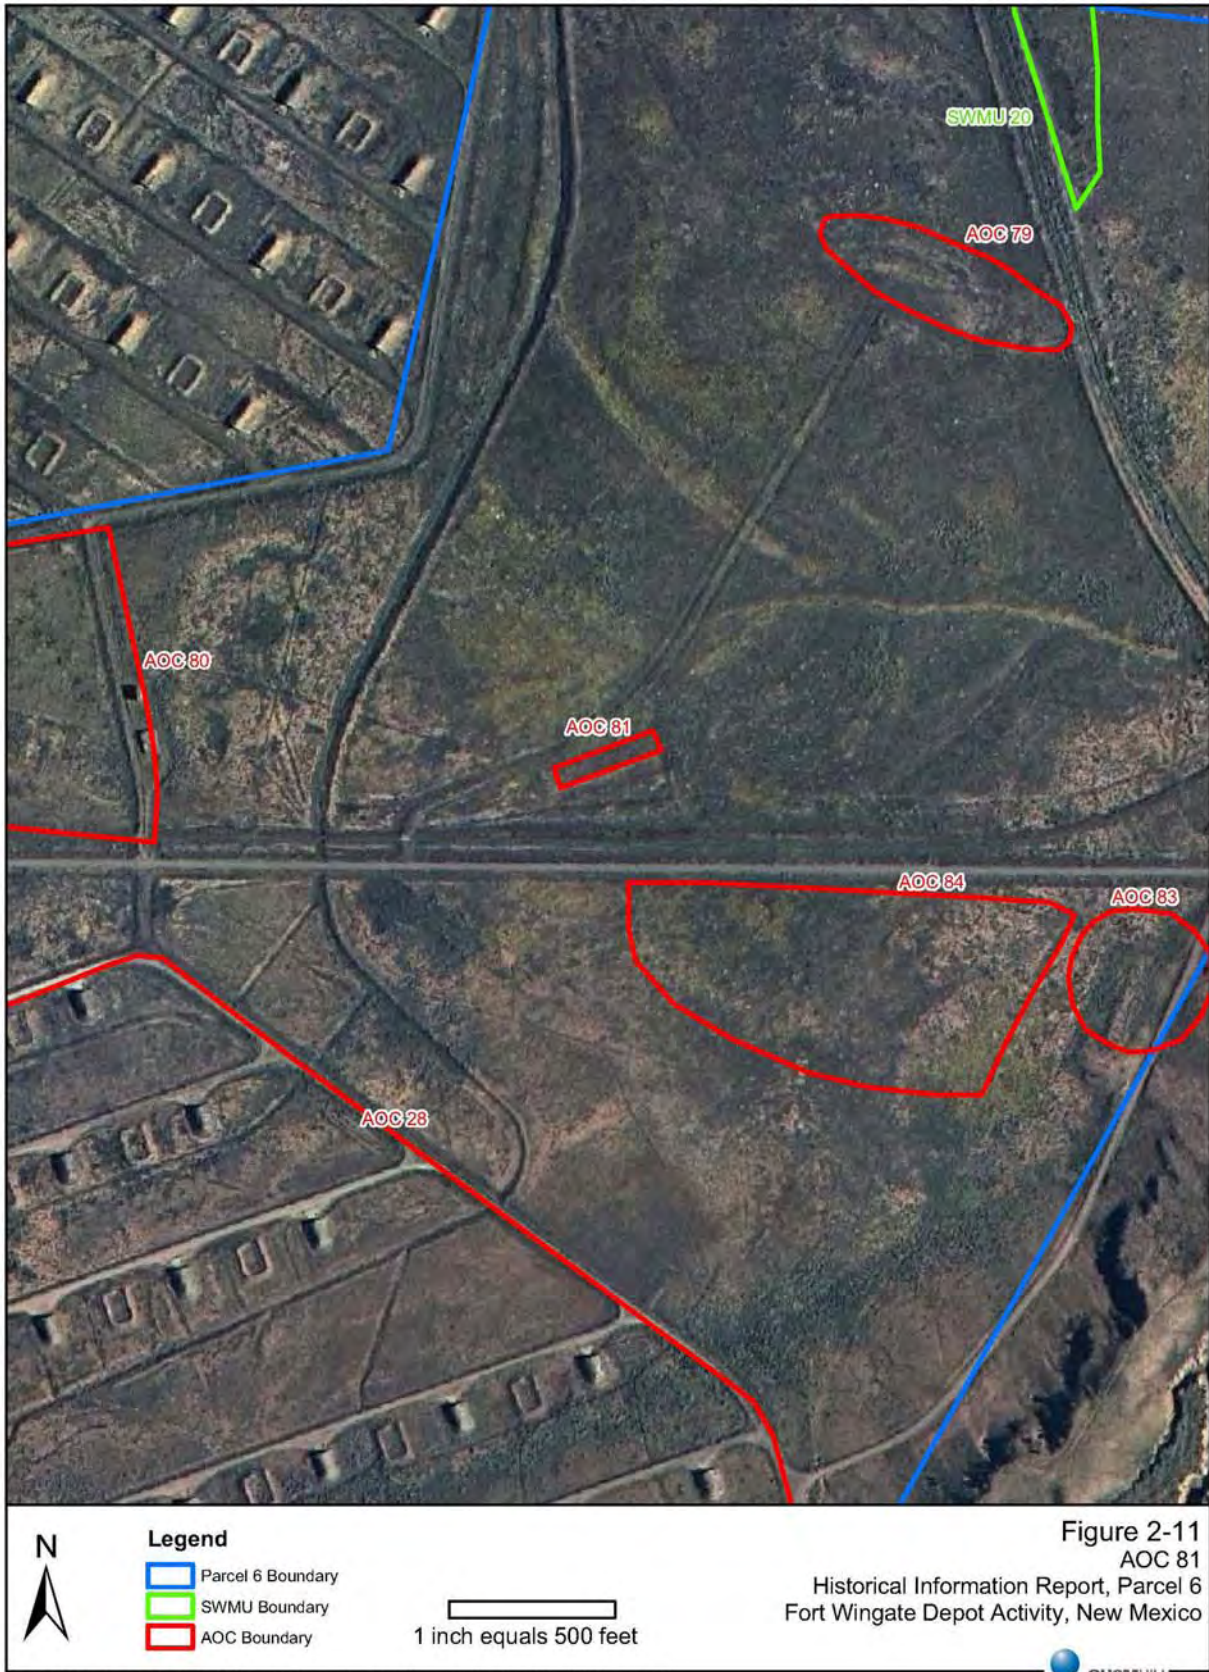
Figure 2-11
AOC 81
Historical Information Report, Parcel 6
Fort Wingate Depot Activity, New Mexico

10 This AOC is described as Feature 11 on the 1962 aerial photo (API-3) in the 1995 Archive Search
11 Report (Figure 2-11 and Appendix M3). The 1995 Archive Search Report lists the 1962 aerial photo
12 in a table without further description. Therefore this report has not been included in the previous
13 investigation section below. AOC 81 is located in the central portion of Parcel 6. Review of historical
14 aerial photographs indicates this site previously contained a rectangular building and a stained soil
15 area.
