**RELEASE ASSESSMENT REPORT
PARCELS 11, 12, 14 AND 25
DRAFT**

**FORT WINGATE DEPOT ACTIVITY
McKinley County, New Mexico**

28 August 2007

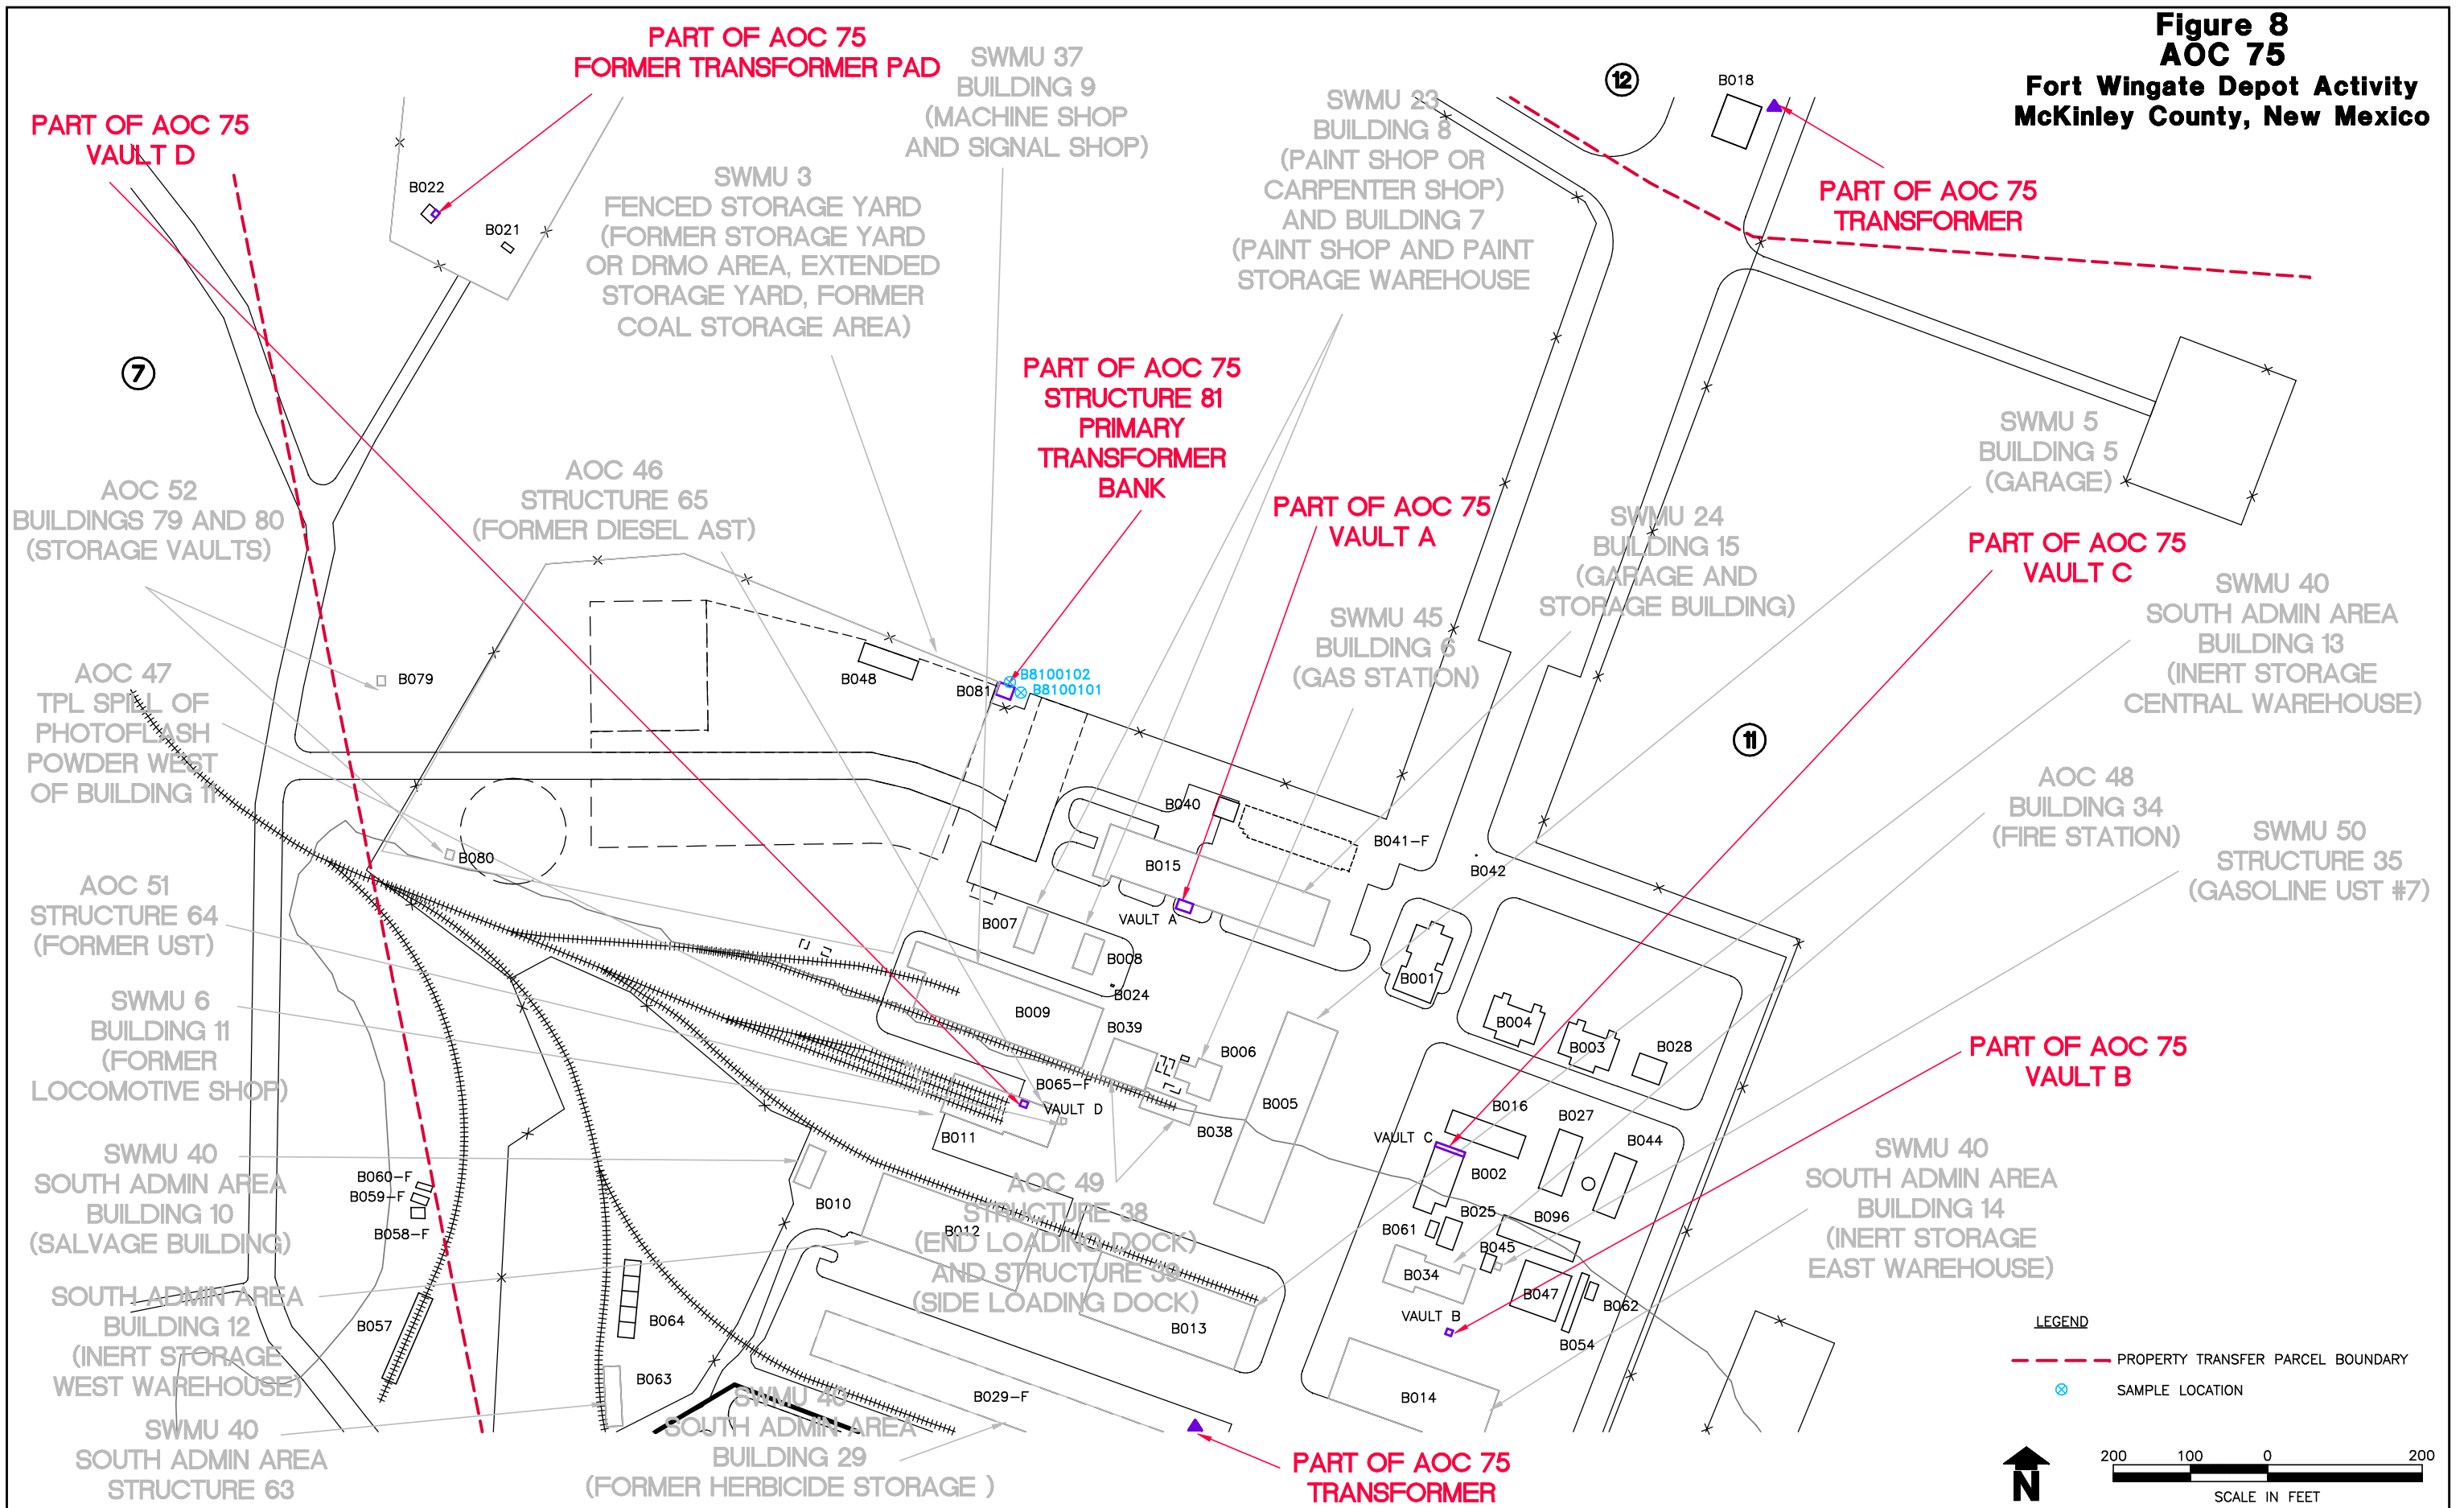
Figure 8
AOC 75

27 According to FWDA records (Appendix B), Vault A on the south side of Building
28 15 (Figure 8) contained three transformers which would have been classified as
29 “PCB-contaminated”, with PCB concentrations ranging from 58 to 280 ppm; the
30 three PCB-contaminated transformers were removed and manifested for off-site
31 disposal in January 1993. FWDA records also show that three “non-PCB-
32 transformers” were relocated to Vault A from Building 527 (Parcel 22) in
33 September 1992; these transformers are still in use.

4 According to FWDA records (Appendix B), Vault C on the north side of Building 2
5 (Figure 8) contained three electrical transformers. No information regarding the
6 PCB content of these transformers was available. FWDA records document
7 these transformers as “leaking” in June 1990; the transformers were removed
8 and manifested for off-site disposal in January 1991.

27 According to FWDA records (Appendix B), a single pole-mounted electrical
28 transformer was located at Building 29 (Figure 8). The transformer was
29 classified as PCB-contaminated with a PCB concentration of 240 ppm. This
30 transformer was removed and manifested for disposal in January 1993.

31 Two biased samples (B8100101 and B8100102) were collected from surface
32 soils adjacent to the concrete transformer pad and analyzed for PCBs. The
33 sample locations were chosen based on prevailing wind direction (from the west)
34 and locations of staining on the concrete pad. Sample locations are shown in
35 Figure 8 and Photos 53 and 54 (Appendix C).
