<p>Client Name: USACE</p>	<p>Project: HWMU Removal Action Completion Report</p>	<p>Project No. 16170613 & 60517380</p>
<p>Photo No. 1</p> <p>Description: Construction of Corrective Action Management Unit (CAMU) cells.</p>	 	
<p>Photo No. 2</p> <p>Description: Final grading of CAMU cells.</p>

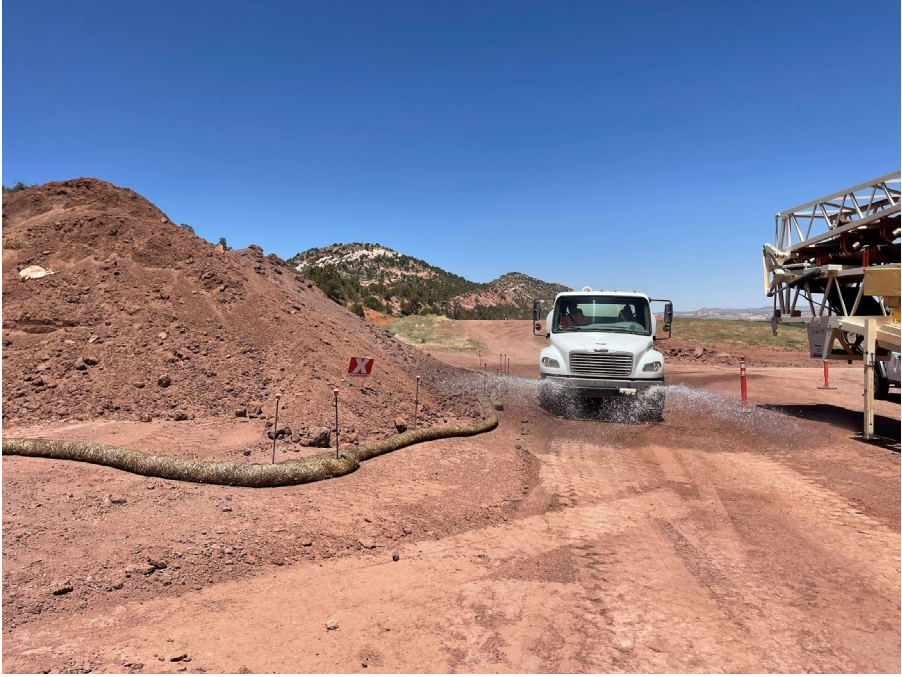
Client Name: USACE	Project: HWMU Removal Action Completion Report	Project No. 16170613 & 60517380
Photo No. 17 Description: SWPPP erosion controls.	 	
Photo No. 18 Description: Roadway watering and dust controls.

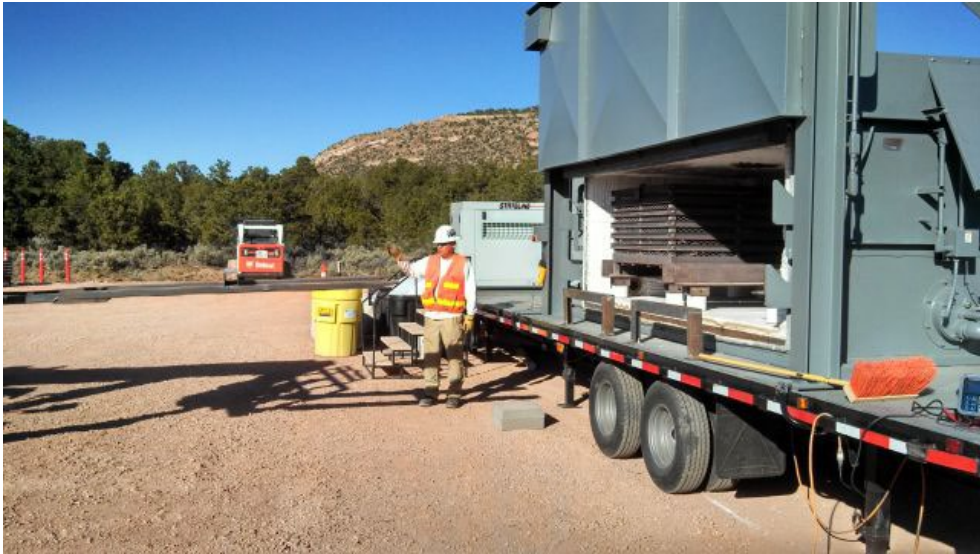
<p>Client Name: USACE</p>	<p>Project: HWMU Removal Action Completion Report</p>	<p>Project No. 16170613 & 60517380</p>
<p>Photo No. 31 Description: Second contract, front of the remote control building.</p>	 	
<p>Photo No. 32 Description: Loading Thermal Flashing Unit (TFU) prior to flashing cycle.</p>

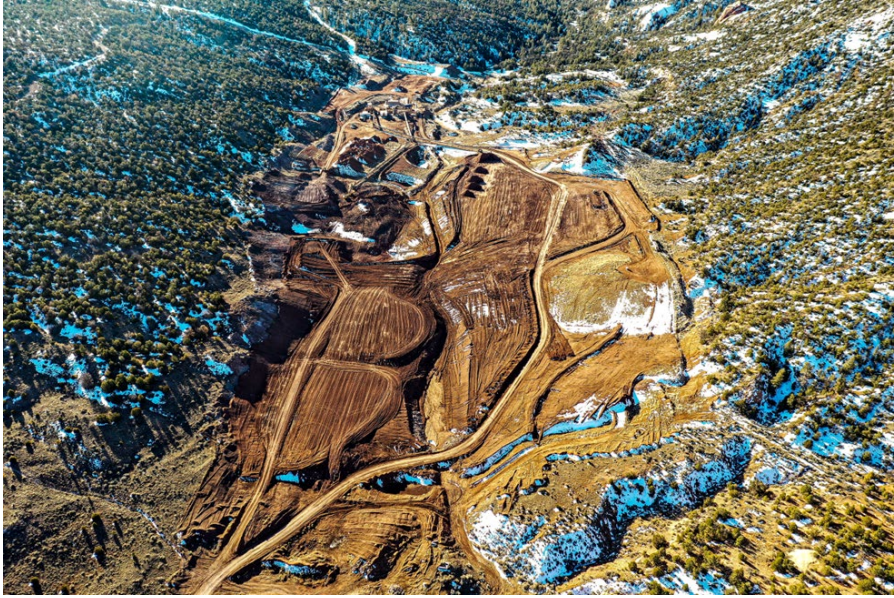
<p>Client Name: USACE</p>	<p>Project: HWMU Removal Action Completion Report</p>	<p>Project No. 16170613 & 60517380</p>
<p>Photo No. 39 Description: Aerial overview of HWMU during 2022 RA field operations.</p>

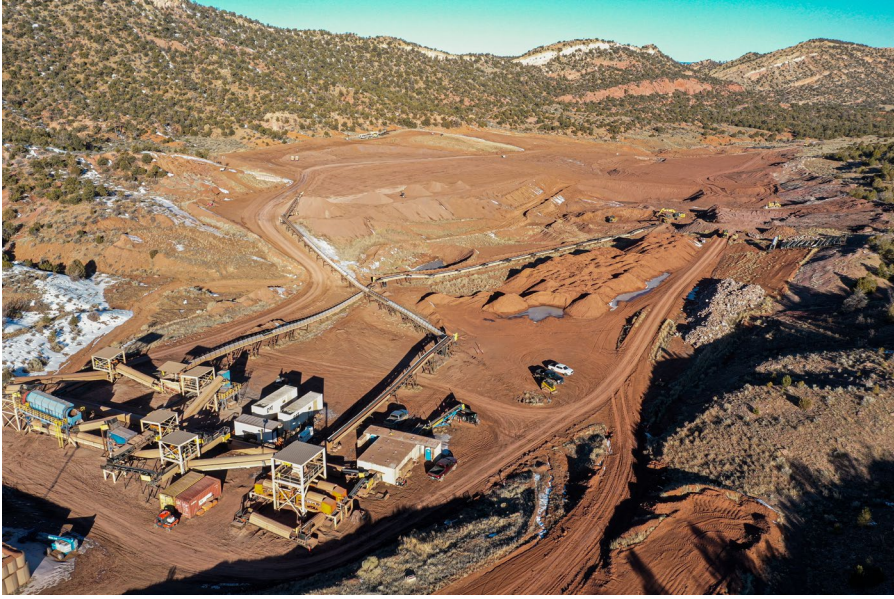
<p>Photo No. 40 Description: Aerial overview of HWMU during 2022 RA field operations.</p>

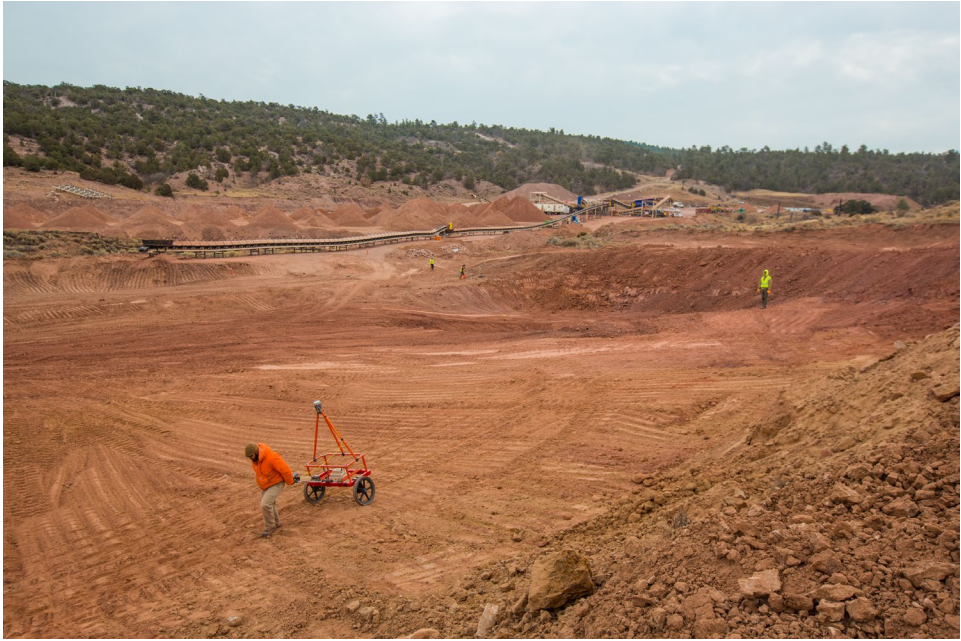
<p>Client Name: USACE</p>	<p>Project: HWMU Removal Action Completion Report</p>	<p>Project No. 16170613 & 60517380</p>
<p>Photo No. 41</p> <p>Description: Surface sweep of completed grid prior to post-excavation digital geophysical mapping (DGM).</p>	 	
<p>Photo No. 42</p> <p>Description: Post-excavation DGM of completed grid.</p>

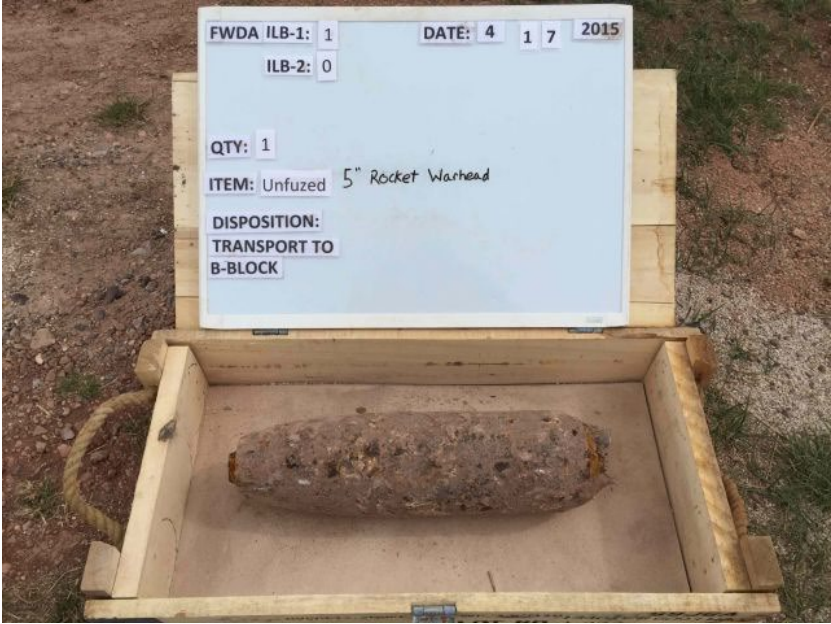
<p>Client Name: USACE</p>	<p>Project: HWMU Removal Action Completion Report</p>	<p>Project No. 16170613 & 60517380</p>
<p>Photo No. 49 Description: Example of munitions and explosives of concern (MEC) removed from processing plant.</p>

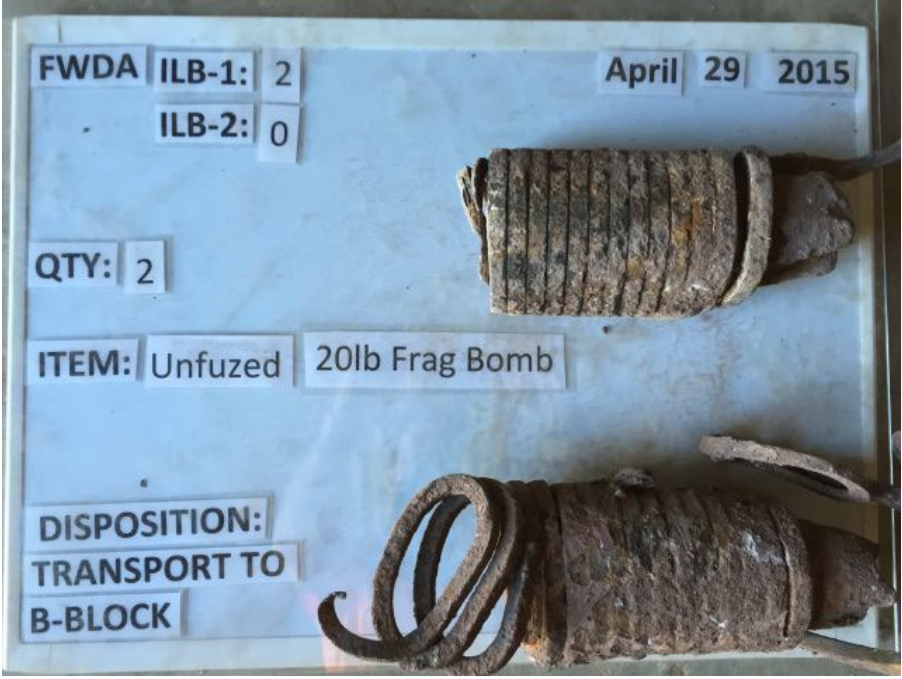
<p>Photo No. 50 Description: Example of MEC removed from processing plant.</p>

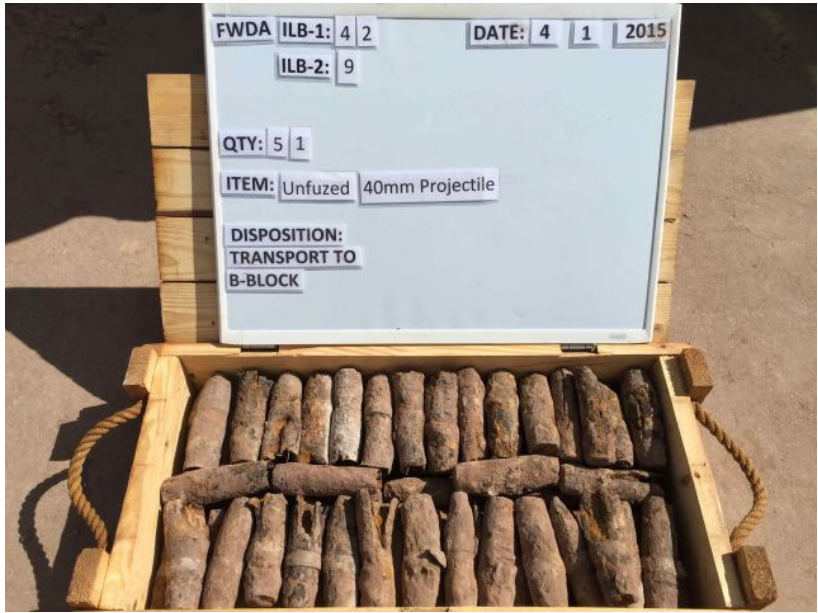
Client Name: USACE	Project: HWMU Removal Action Completion Report	Project No. 16170613 & 60517380
Photo No. 51 Description: Example of MEC removed from processing plant.

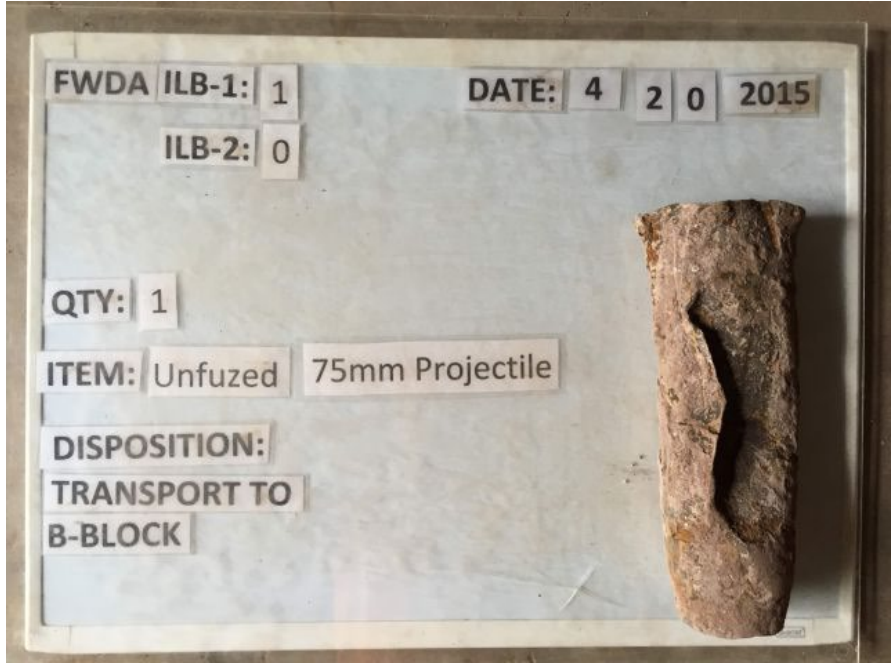
Photo No. 52 Description: Example of MEC removed from processing plant.

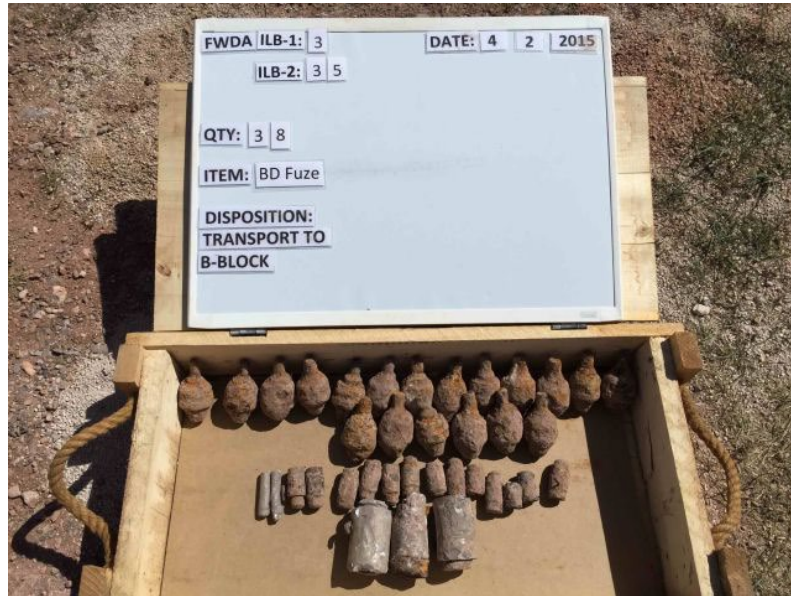
Photo No. 53
Description:
Example of MEC removed from processing plant.

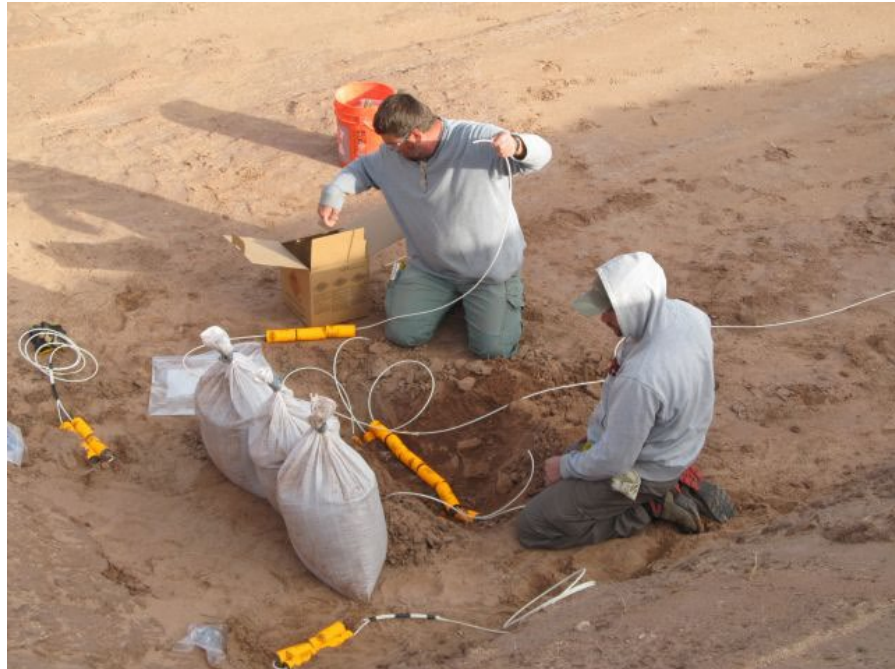
Photo No. 54
Description:
Preparing a MEC disposal shot.

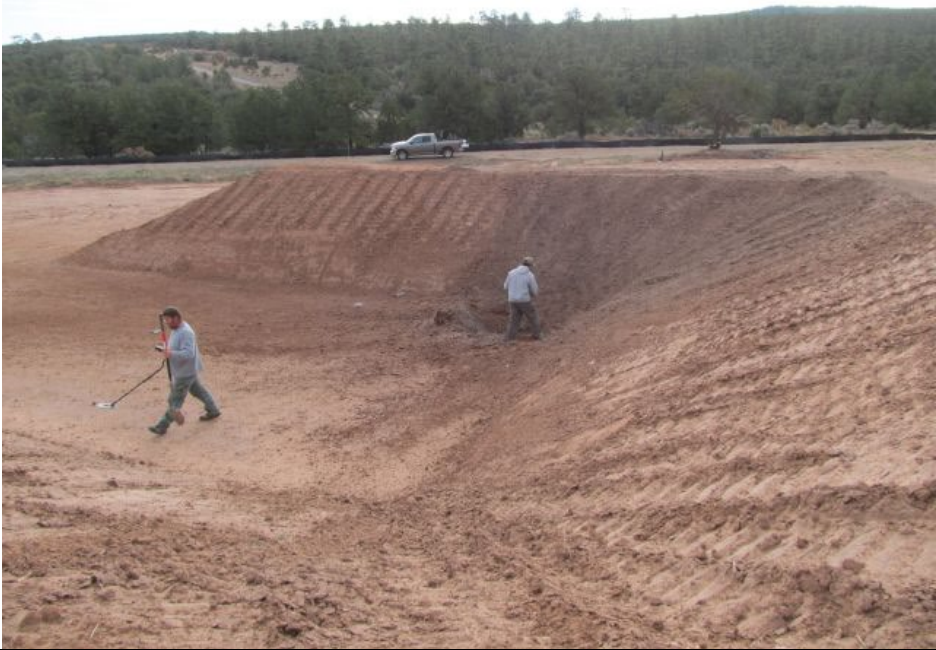
<p>Client Name: USACE</p>	<p>Project: HWMU Removal Action Completion Report</p>	<p>Project No. 16170613 & 60517380</p>
<p>Photo No. 57</p> <p>Description: Post MEC disposal shot inspection and cleanup.</p>

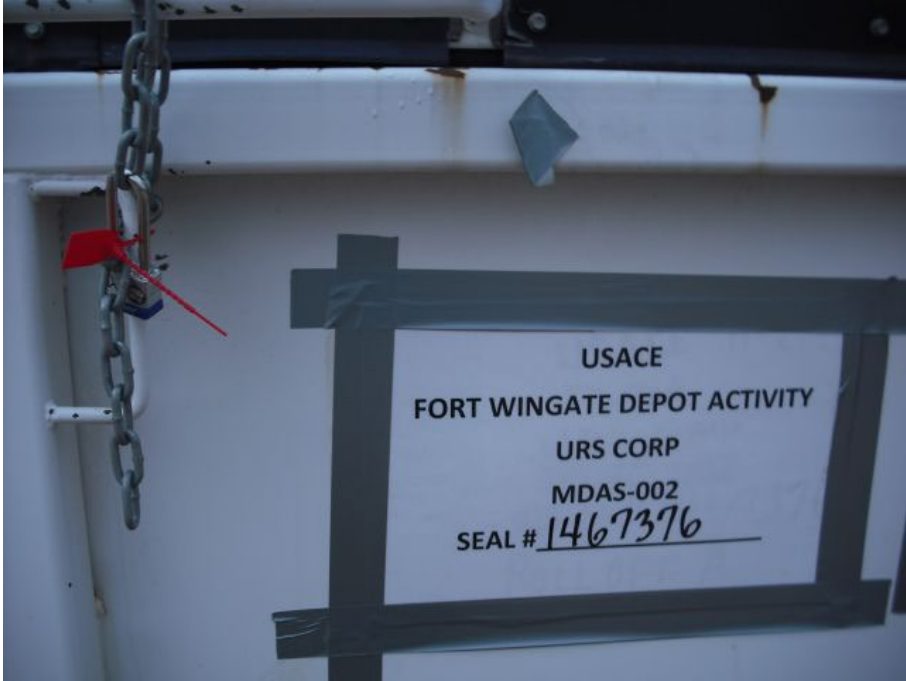
<p>Photo No. 58</p> <p>Description: MDAS container locked and sealed. Ready for offsite shipment.</p>

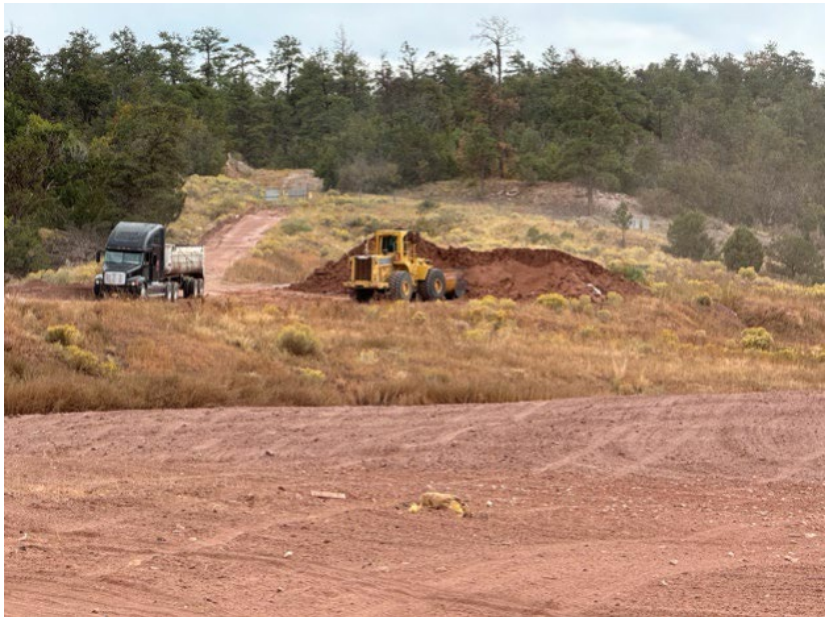
<p>Client Name: USACE</p>	<p>Project: HWMU Removal Action Completion Report</p>	<p>Project No. 16170613 & 60517380</p>
<p>Photo No. 59 Description: Loading contaminated soils onto trucks for final disposal</p>

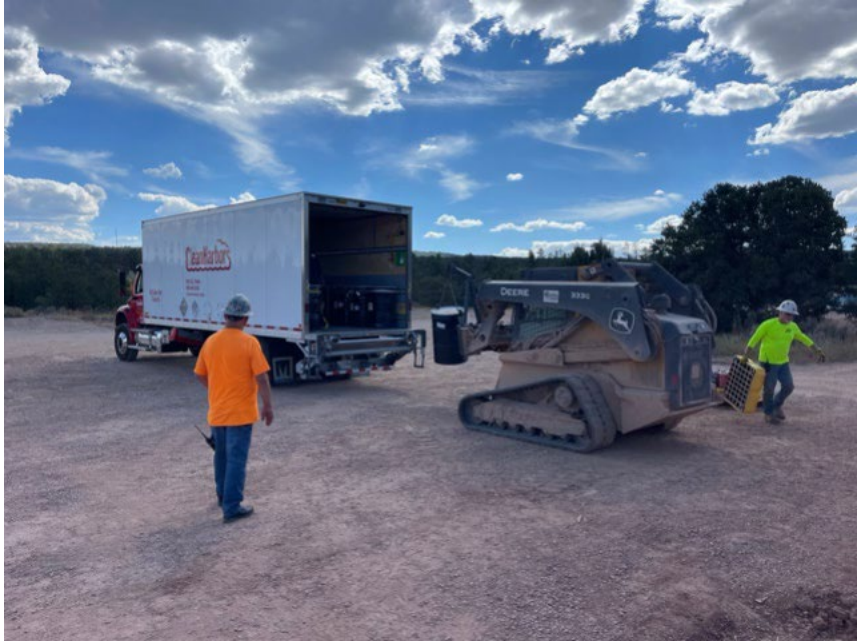
<p>Photo No. 60 Description: Final drum pickup and disposal by Clean Harbors.</p>

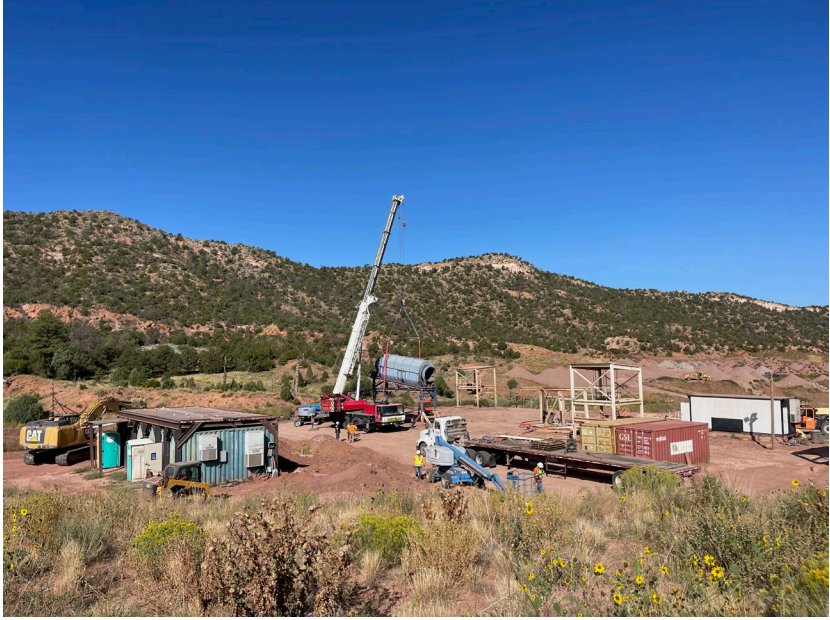
<p>Client Name: USACE</p>	<p>Project: HWMU Removal Action Completion Report</p>	<p>Project No. 16170613 & 60517380</p>
<p>Photo No. 61</p> <p>Description: Sift plant breakdown and demobilization crane operations.</p>
