# FORT WINGATE DEPOT ACTIVITY McKINLEY COUNTY, NEW MEXICO

# SURVEY OF BUILDINGS IN THE ADMINISTRATION AND WORKSHOP AREAS

U.S. ARMY CORPS OF ENGINEERS FORT WORTH DISTRICT

**April 9, 2008**

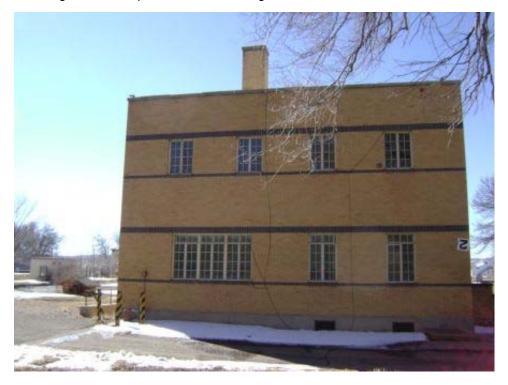
LIVING QUARTERS, DISPENSARY AND WATER TREATMENT PLANT

Building 2 North side of Building 2. Note transformer vault on right (northwest) corner.

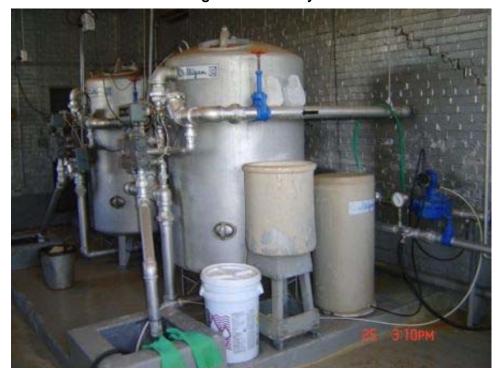
LIVING QUARTERS, DISPENSARY AND WATER TREATMENT PLANT Building 2 Interior view showing water treatment equipment.

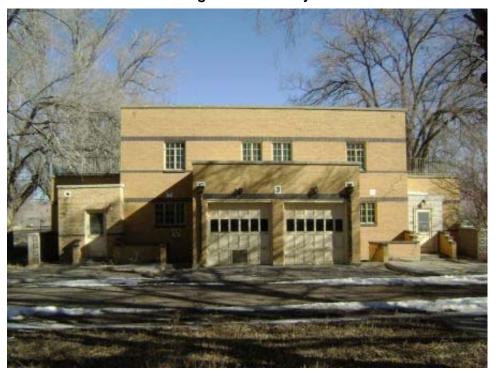
#### **EAST N.C.O. QUARTERS**

Building 3 South side of building looking north. Note transite siding on rear entry enclosures.

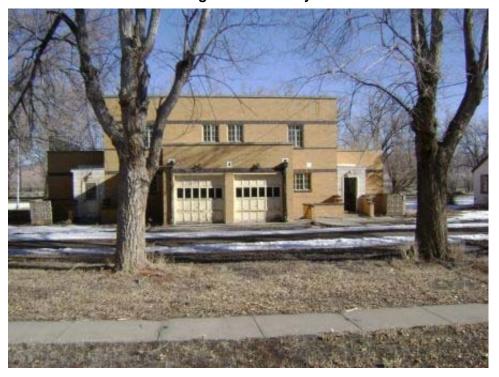
#### **WEST N.C.O. QUARTERS**

Building 4 South side of building looking north. Note transite sided enclosure additions at rear entry doors.

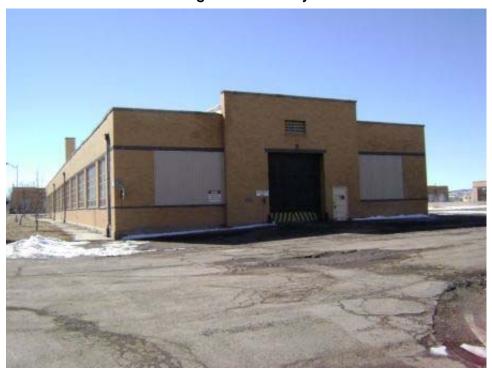
#### FORMER MAINTENANCE GARAGE

Building 5 North side looking south. Note electric powered overhead door.

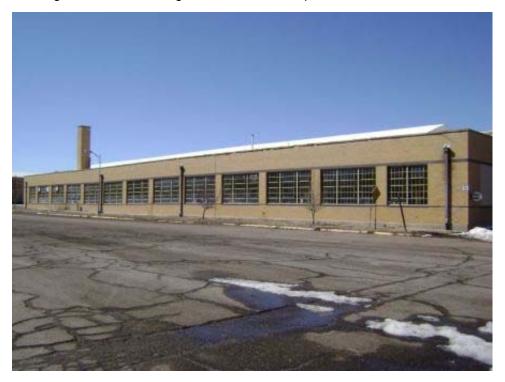
#### FORMER MAINTENANCE GARAGE

Building 5 East side of building from northeast corner. Note stack for gas fired boiler (inactive) for steam/heat.

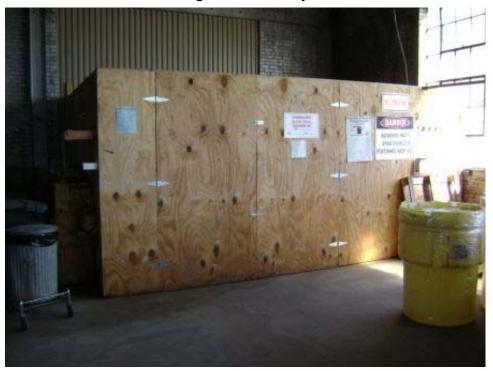
FORMER MAINTENANCE GARAGE

Building 5 "90 Day Storage" area located at north end of Building 5.

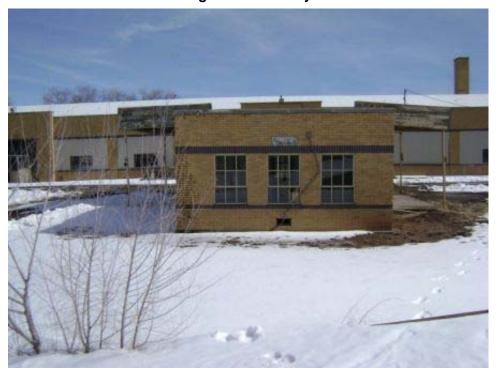
#### **MOTOR FUEL STATION**

Building 6 West side of building looking east. Building 5 in background. Former fuel tank sites (removed) are in foreground and to left and right of Building 6.

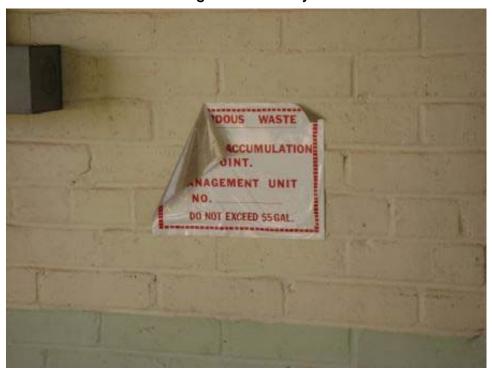
#### **PAINT SHOP**

Comments: Other regulated materials potentially present in trough along interior west wall and in sump. Floor stained. Placard indicates building used as hazardous waste accumulation

Building 7 Interior of building at location of former hazardous waste accumulation point (south wall).

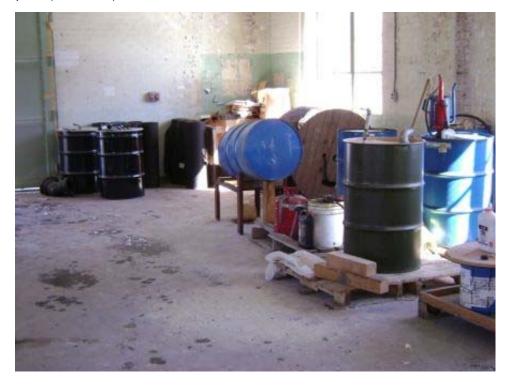
#### **PAINT SHOP**

Building 7 Interior of Building 7 showing contents as of March 2008. Drums contain lube oil or are empty.

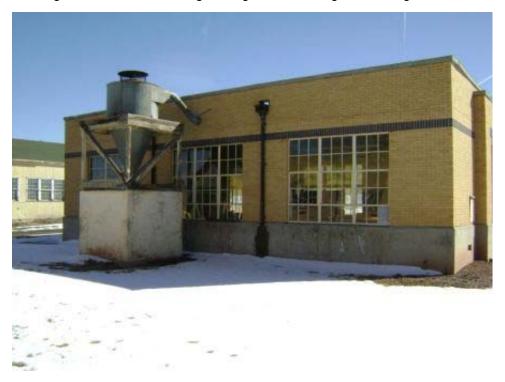
#### **CARPENTER SHOP**

Cyclone dust collector present, not functional.

Building 8 Southwest corner looking north east. Building 15 in background. Cyclone dust collection system remains, currently not operational.

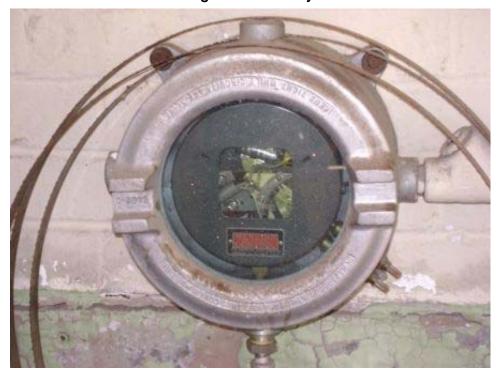
Building 8 Mercury bulb thermostat in vapor tight enclosure used to control steam heat system. All systems are not operational.

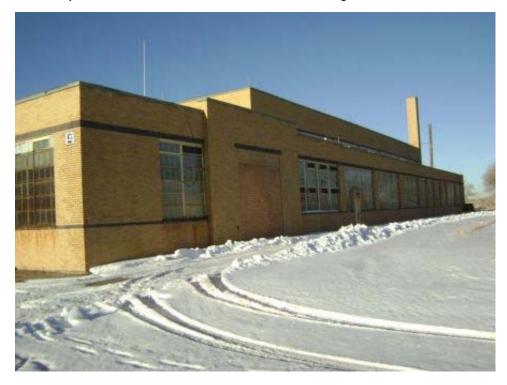
Building 9 North east corner looking southwest at north side of building.

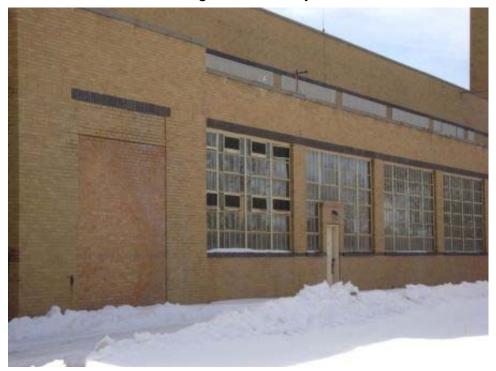
Building 9 North side of building showing bricked overhead door.

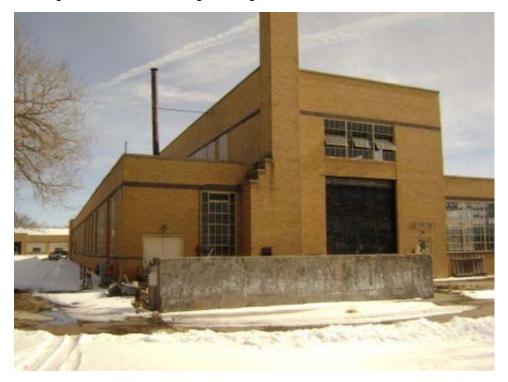
Building 9 Northwest corner looking at west end of building. Note low concrete wall surrounding "scrap" storage area.

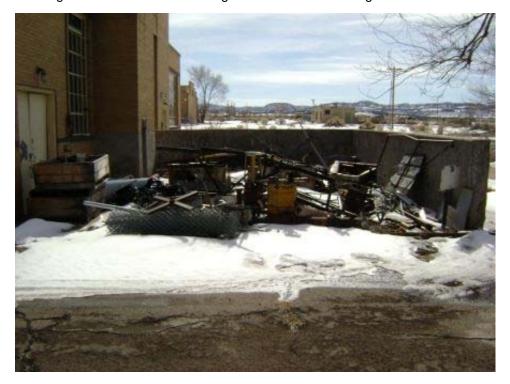
Building 9 Scrap storage area at west end of building.

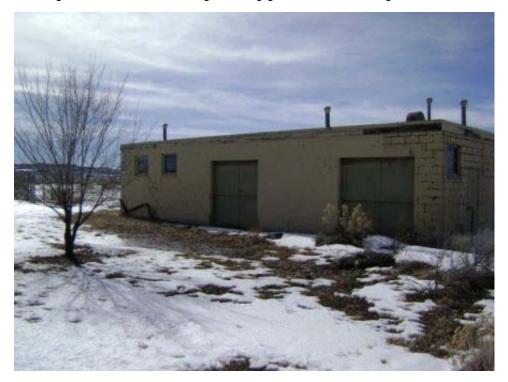
Building 10 East side of building showing double shop doors. Doors to right (north end) open to a shop bay converted to restroom. Building electrical panel located in same area.

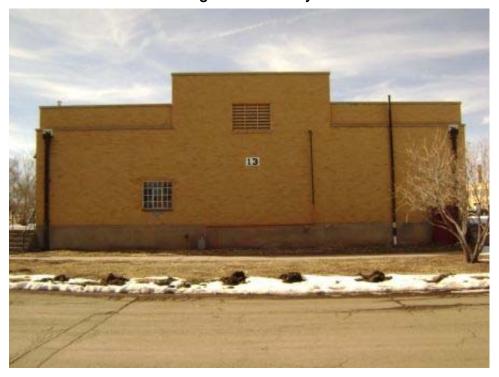
Building 13 East end of building. Note window added for office area.

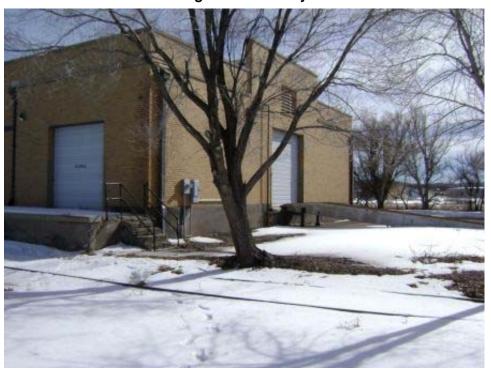
Building 13 Northwest corner of building looking southeast showing West side of structure. Note condition of steps and dock.

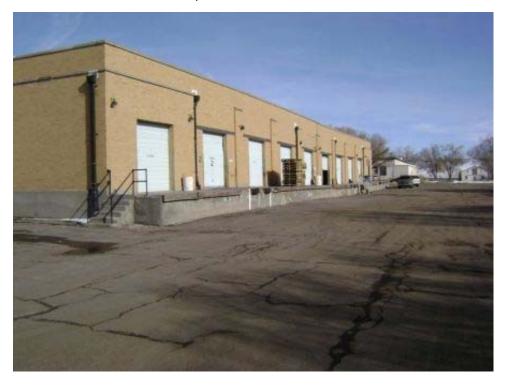
Building 13 Southwest corner of building looking east showing south side of structure. Note bricked bay at far (east) end with personnel door and window added for office area. Building 14 (left) and Building 17 (right) in background.

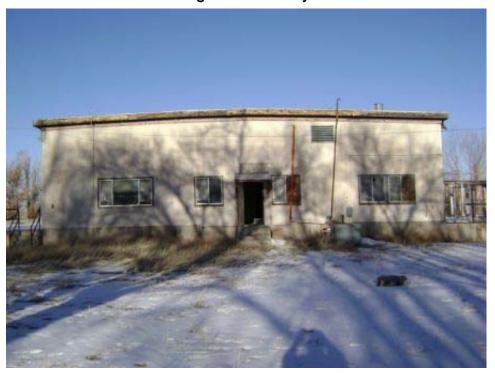
one (1) air conditioner compressor outside of building. Roof in poor condition and potential for mold throughout building, especially in the southwest corner. Asbestos containing material in floor tile, sprayed-on plaster, and exterior wall siding. Loading docks (10' 0"

Building 14 East end of building looking west. Note AC condenser unit and gas regulator. Aluminum horizontal slide windows typical.

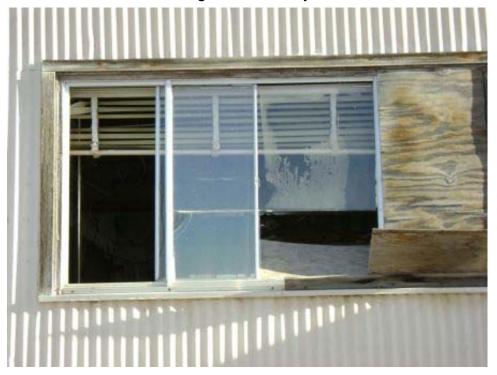
Building 14 Poor condition of window and trim typical.

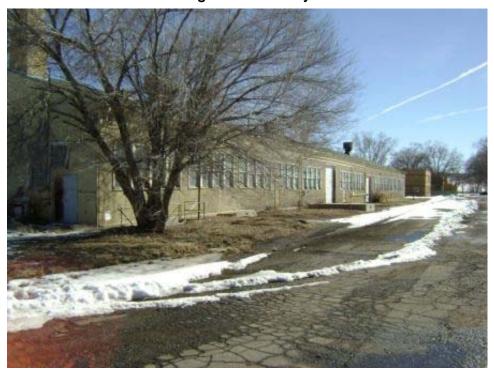
Building 15 Southwest corner looking Northeast. Note boiler room entrances

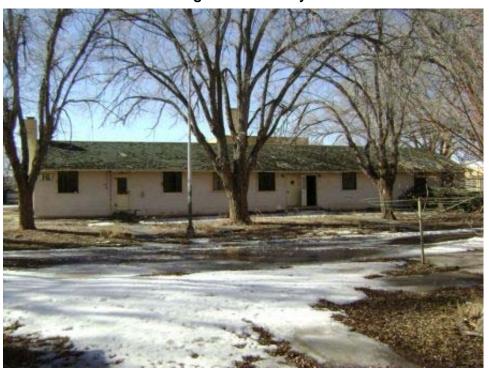
Building 16 North side of building looking south. Note poor condition of roof shingles.

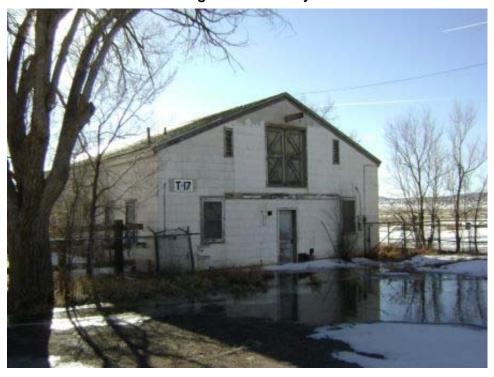
Comments: Roof is in poor condition. Some damaged/missing transite shingles from siding.

Building 17 West end of building looking east. Note missing/damaged transite shingle and poor condition of roof.

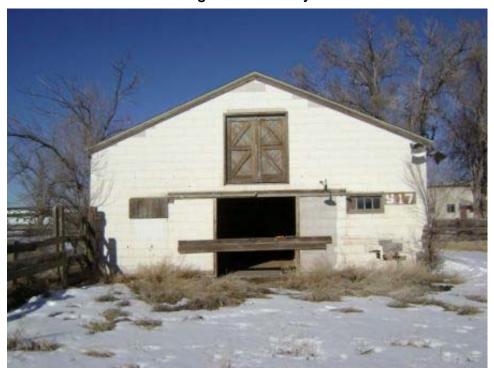
Building 17 East end of building. Note damaged transite siding at gas service entrance.

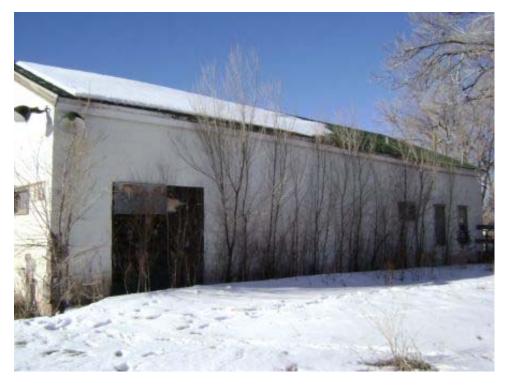
Building 17 Northeast corner looking west at north side of building. Note sealed double door allowing extra stall space inside.

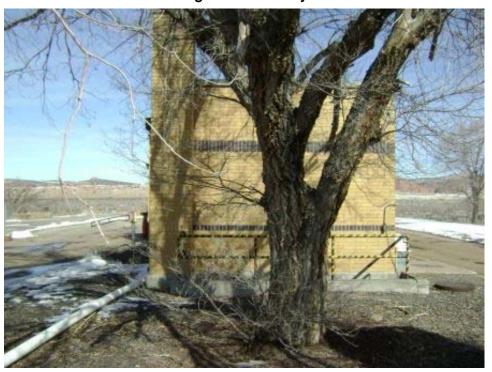
Building 18 South side of structure looking north. Note stairs to basement mechanical room.

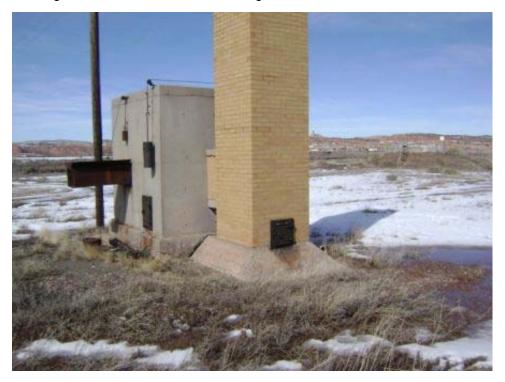
Building 21 Southeast corner looking at east and south side of structure showing stack cleanout.

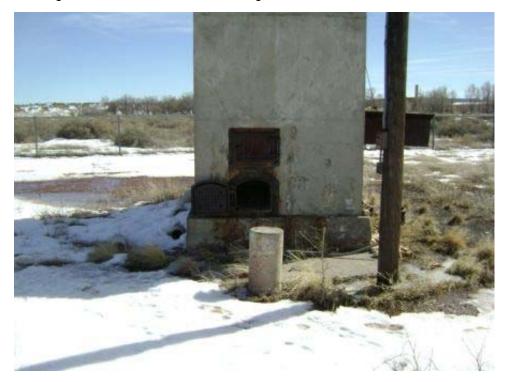
Building 21 West side of structure looking east. Note cleanout door and disconnected electric service.

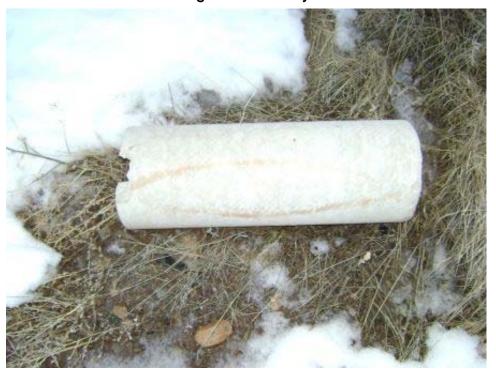
Building 21 Portion of cement asbestos pipe next to incinerator.

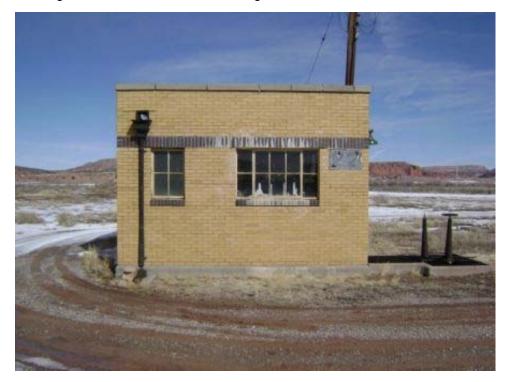
Building 22 South side of structure looking north.

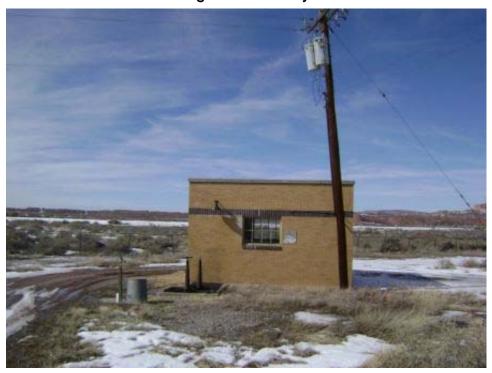
Building 22 East side of structure looking west. Note grates and valve standards for plant operations.

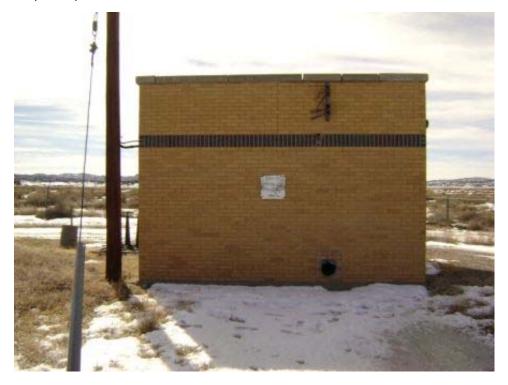
Building 22 North side of structure looking south.

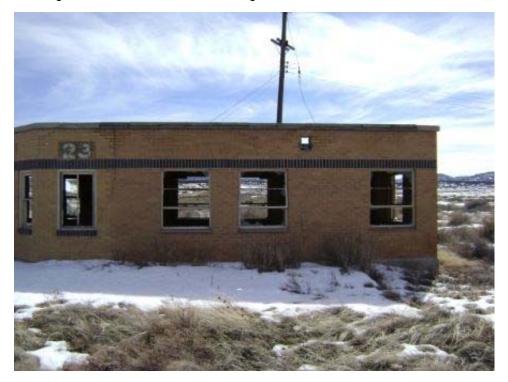
Building 23 North side of structure looking south. Note disconnected power pole guy wire.

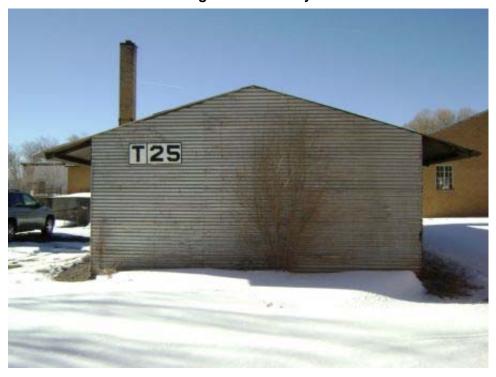
Building 25 North side of structure looking south. Building 34, Fire station in background.

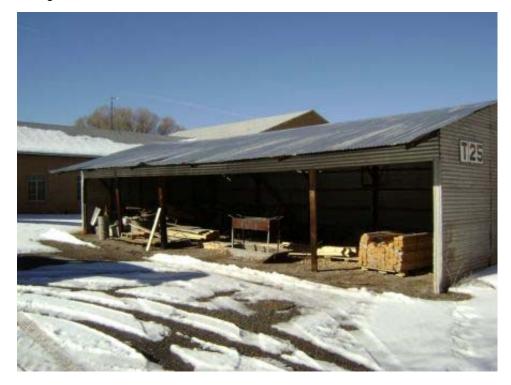
Building 25 Northeast corner looking southwest at east side of structure. Building 34, Fire station in background.

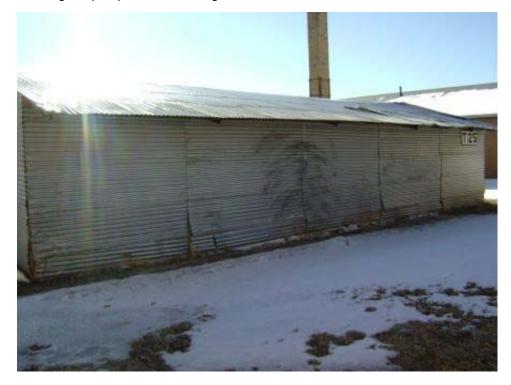
Building 25 Northwest corner looking southeast at west side of structure. Building 34, Fire station in background.

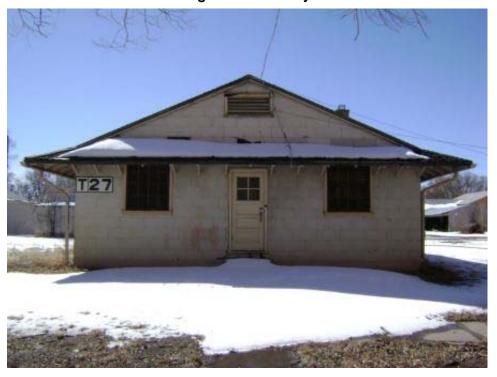
Building 27 North end of building looking south.

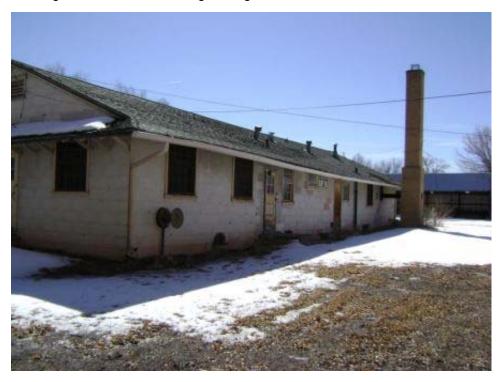
Building 27 Northwest corner looking southeast at west side of structure. Building 96 in background.

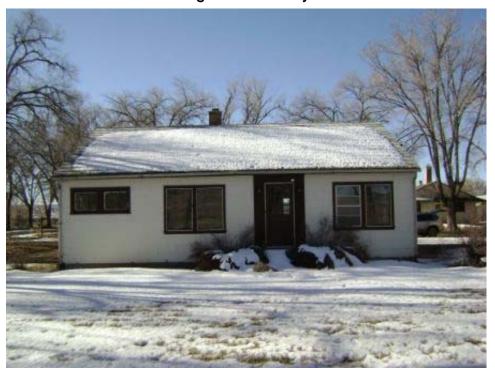
Building 28 North side of structure looking south. Building 27 in background.

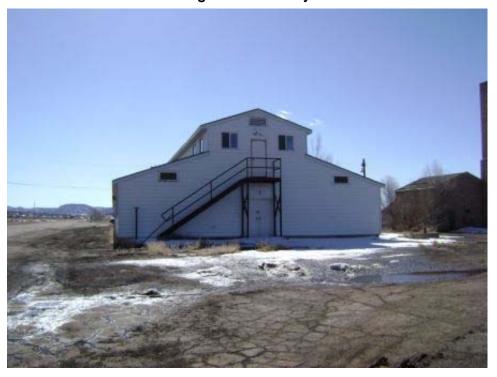
Building 30 North side of structure looking south. Building 36, Central steam plant to right.

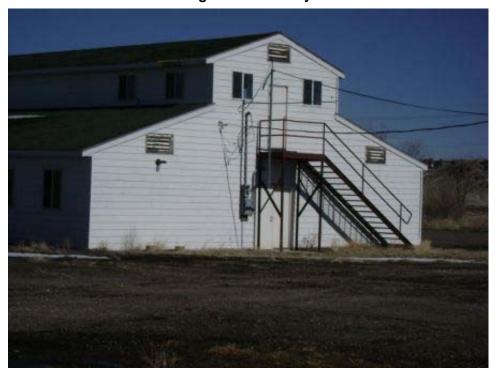
Building 30 South side of structure looking north. Note electric service location.

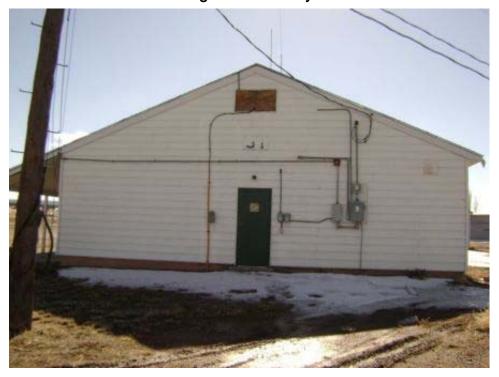
Building 31 North end of structure. Note metal siding over transite shingles.

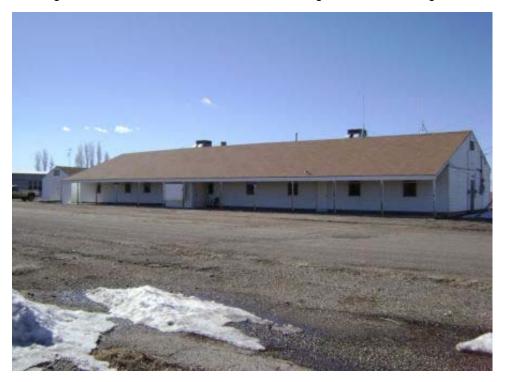
Building 31 East face of structure, main entrance. East facing roof in good condition.

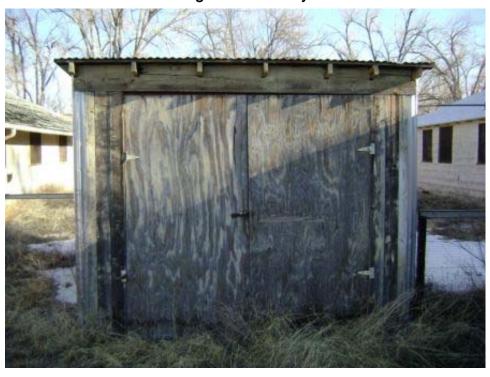
Building 32 South side of structure. Corrugated metal shed for coal storage. Doors in poor shape.

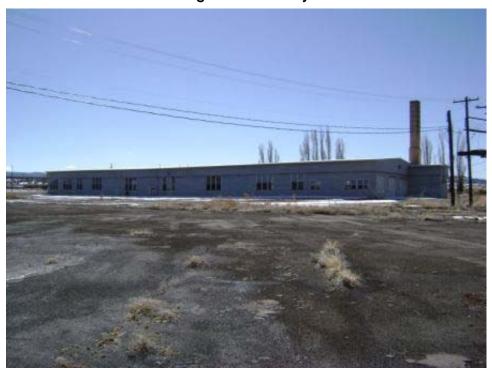
Building 33 North side of structure. Note aluminum replacement type windows.

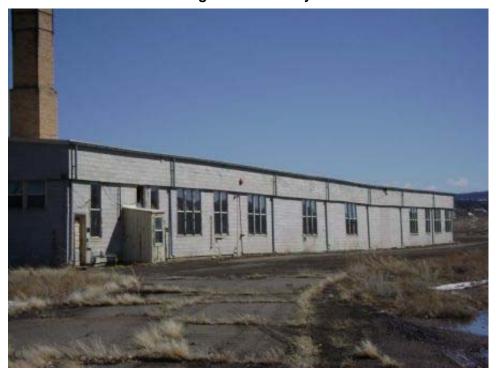
Building 33 South side of structure. Note gas service entrance (not active).

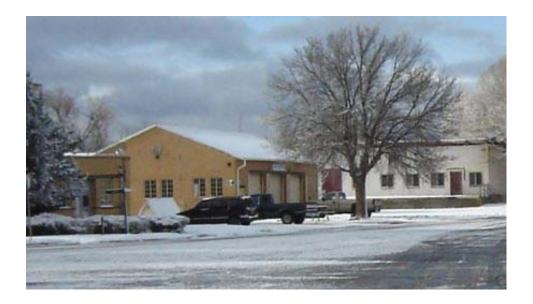
Building 34 Northwest corner looking southeast. Building 14 in background. Note 3 overhead doors. Small tent shaped structure in foreground is well house for Well #1.

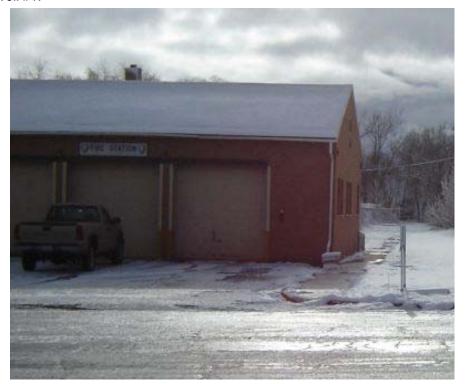
Building 34 Front view of overhead doors

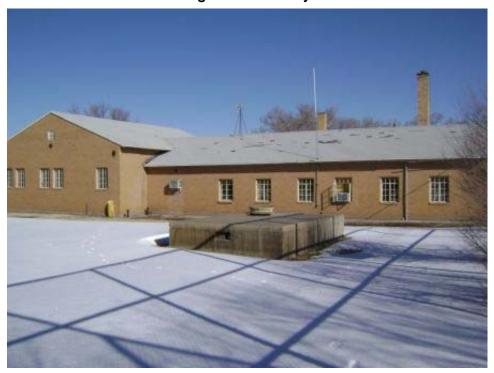
Building 34 South side of structure. Note transformer vault in foreground.

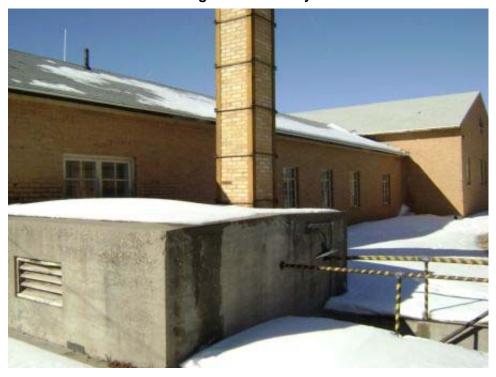
Building 34 North side of structure showing boiler room and entrance stairs.

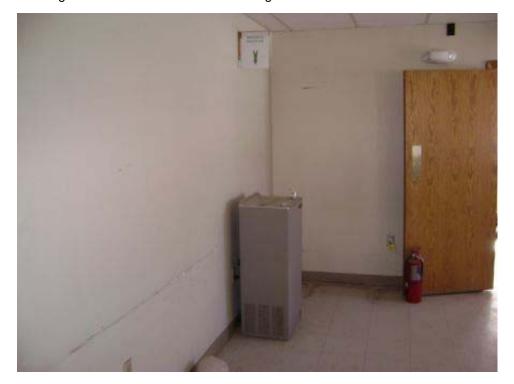
Building 34 Typical interior condition of Building 34. Note water fountain.

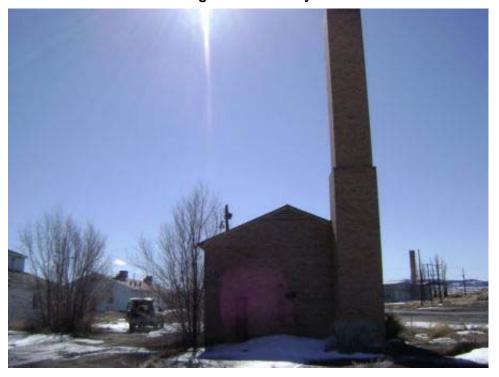
Building 36 North side of structure. Steam piping port in center of wall.

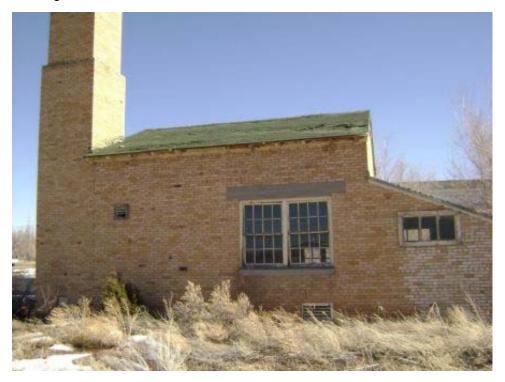
Building 36 West side of Building 36. Note poor condition of roofing.

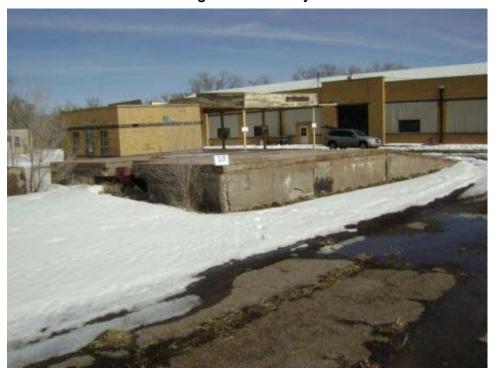
Building 38 End loading dock. Building 6 and Building 5 in background.

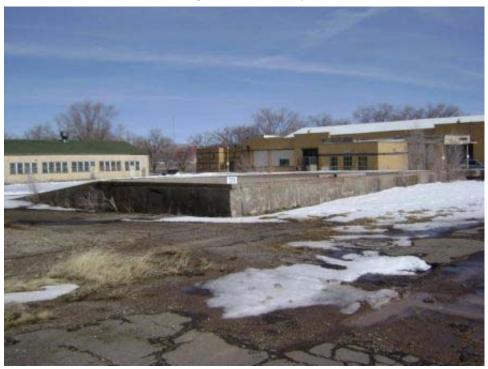
Building 39 Side loading dock. Buildings 15, 1, 6, and 5 in background.

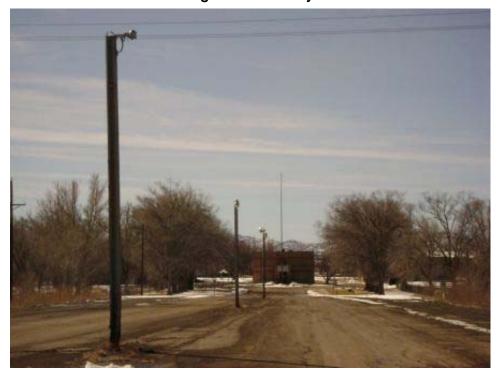
**FLAG POLE**Building 42 Flagpole.

Comments: 75' high, missing hoisting equipment

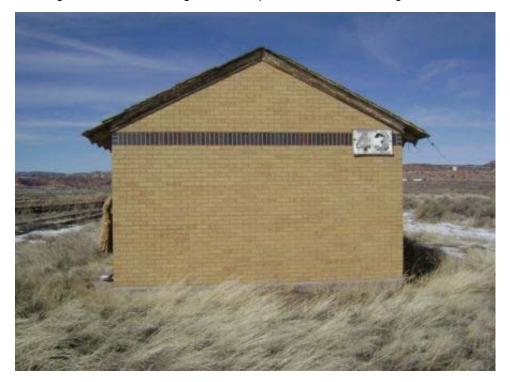
Building 43 South side looking North. North side identical. Note disconnected electrical service.

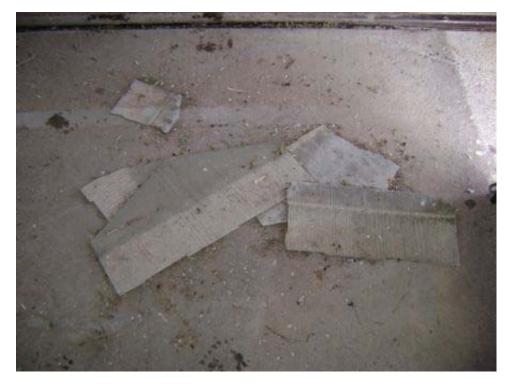
**RAILROAD TOOL HOUSE**

Building 43 Transite siding debris inside building.

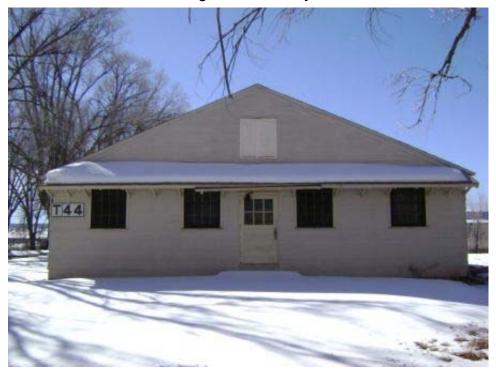
#### FAMILY LIVING QUARTERS (DUPLEX)

Building 44 North end of structure looking south. Note siding over transite shingles.

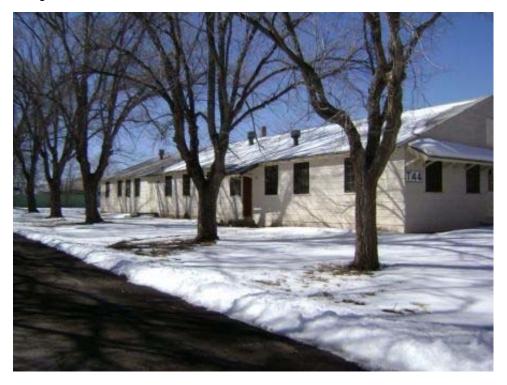
FAMILY LIVING QUARTERS (DUPLEX)

Building 44 East side of structure looking from northeast corner.

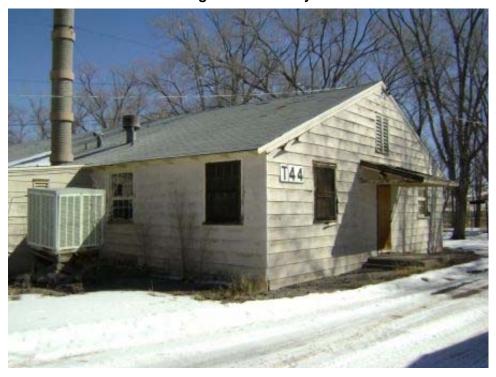
#### FAMILY LIVING QUARTERS (DUPLEX)

Building 44 South side of structure looking from southwest corner. Note cement asbestos pipe chimney on mechanical room and evaporative cooler.

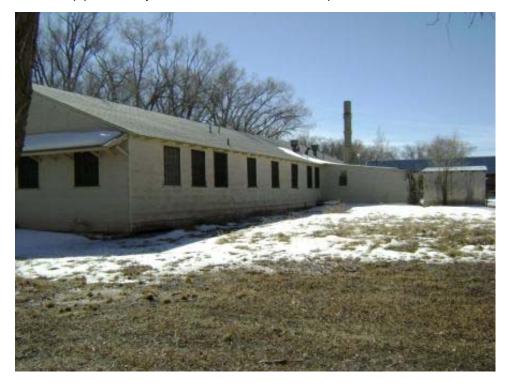
#### **FAMILY LIVING QUARTERS (DUPLEX)**

Building 44 West side of structure looking from northwest corner. Note mechanical room and cement asbestos chimney. Corrugated metal shed is Building 32

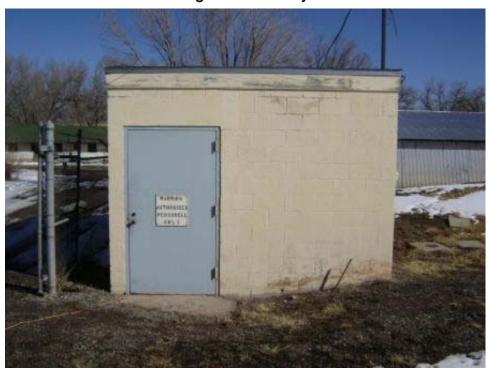
#### **PUMP HOUSE**

Building 45 South side of structure looking north. Former UST site to right. Note monitor well.

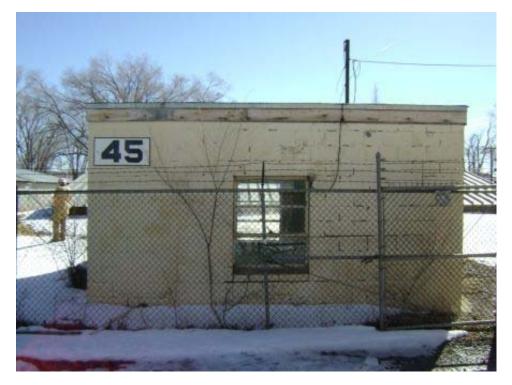
#### **PUMP HOUSE**

Building 45 West side of structure. Building 47, water storage, is in background.

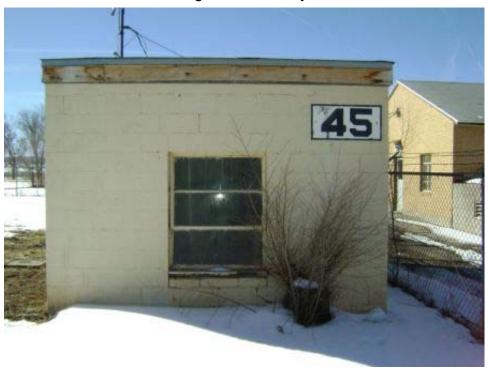
PUMP HOUSE

Building 45 North side.

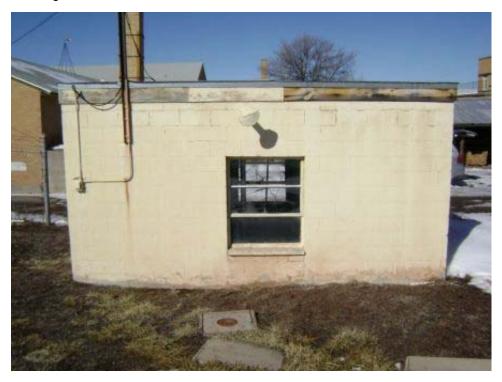
**PUMP HOUSE**

Building 45 West side. Monitor well in foreground.

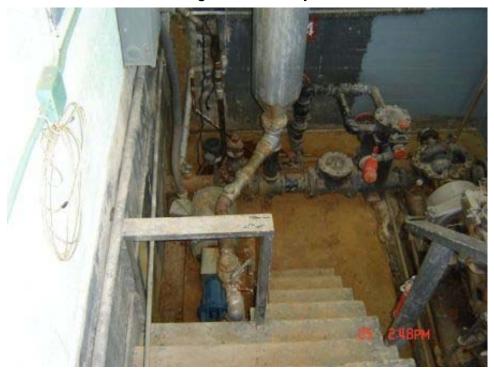
**PUMP HOUSE**

Building 45 Interior. Electric powered pump to left of stairs, gasoline powered pump to right.

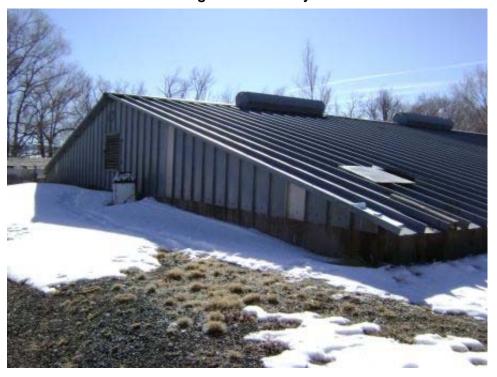
100M GALLON WATER STORAGE RESERVOIR

Building 47 North side.

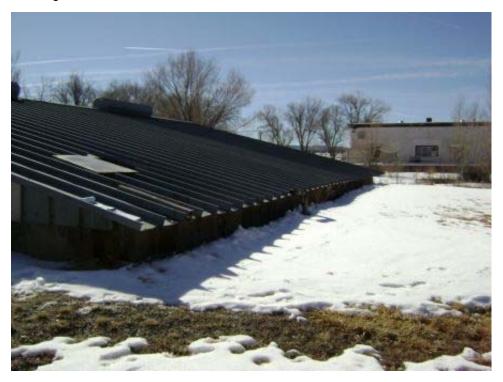
100M GALLON WATER STORAGE RESERVOIR

Building 47 West side.

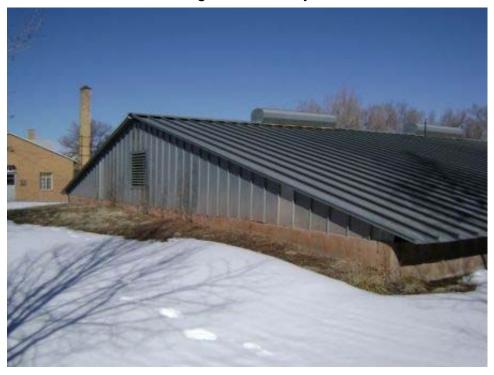
100M GALLON WATER STORAGE RESERVOIR

Building 47 South side.

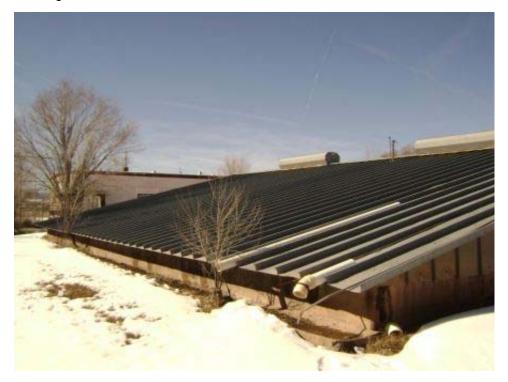
100M GALLON WATER STORAGE RESERVOIR

Building 47 East side.

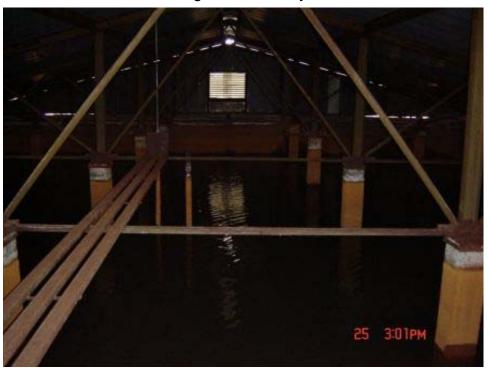
100M GALLON WATER STORAGE RESERVOIR

Building 47 Interior of water storage structure.

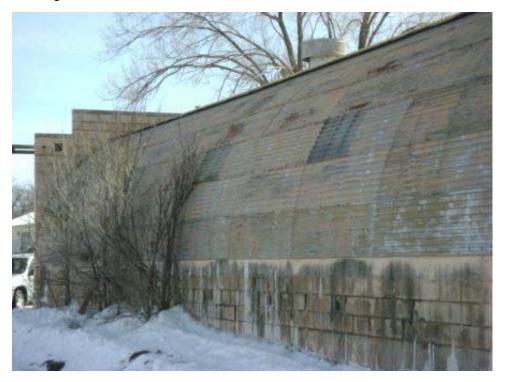
**HEAVY IMPLEMENT BUILDING**

Building 48 North side. Note translucent panels for interior lighting.

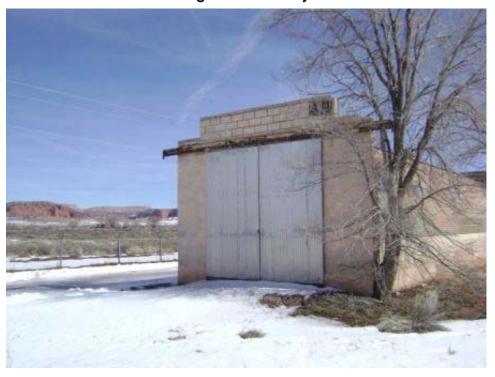
**HEAVY IMPLEMENT BUILDING**

Building 48 West end.

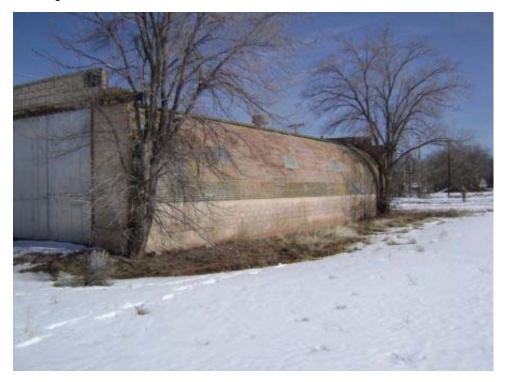
**HEAVY IMPLEMENT BUILDING**

Building 48 South side.

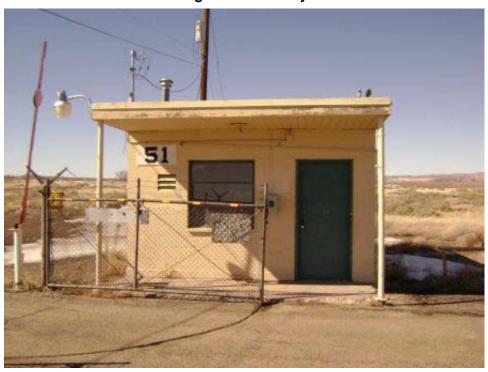
#### MATCH GUARD BUILDING

Comments: Other regulated materials present in fluorescent lights & ballasts. Roof leaks, mold in

Building 51 West side.

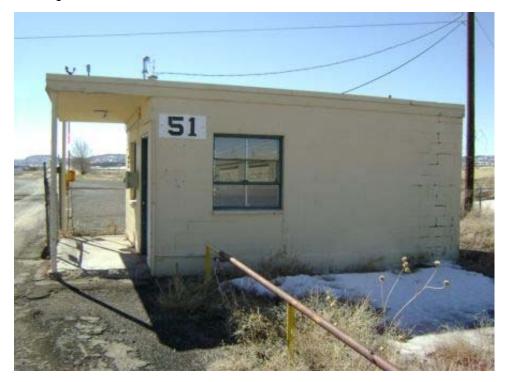
#### MATCH GUARD BUILDING

Building 51 North side. Note gas service entrance.

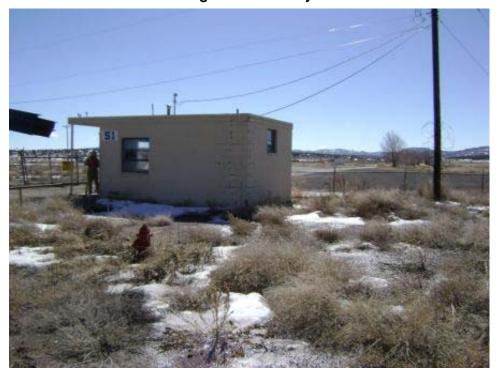
#### MATCH GUARD BUILDING

Building 51West (rear of structure) and north side.

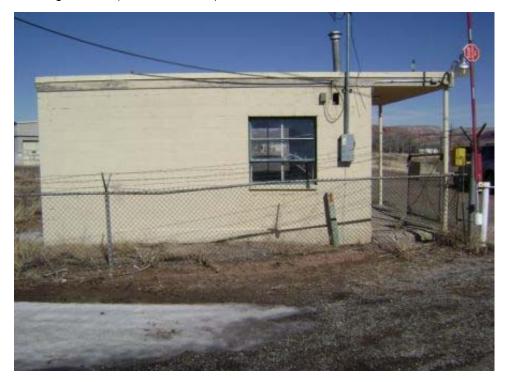
#### MATCH GUARD BUILDING

Building 51 South side. Note electric service entrance.

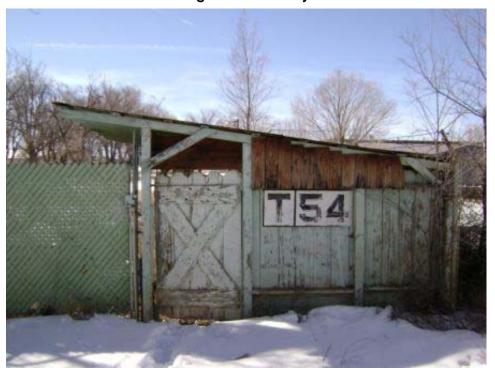
**RECREATION SHELTER**

Building 54 North end. Note condition of paint.

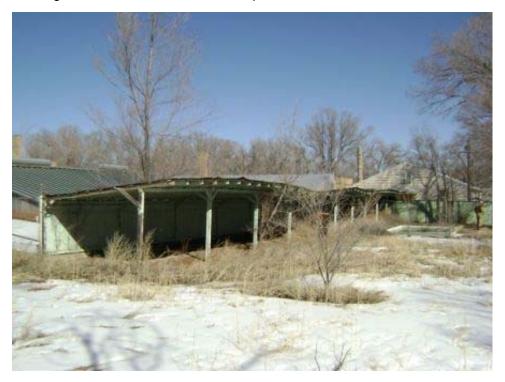
**RECREATION SHELTER**

Building 54 South (short) and east sides. Building 47 to left, 44 behind fence.

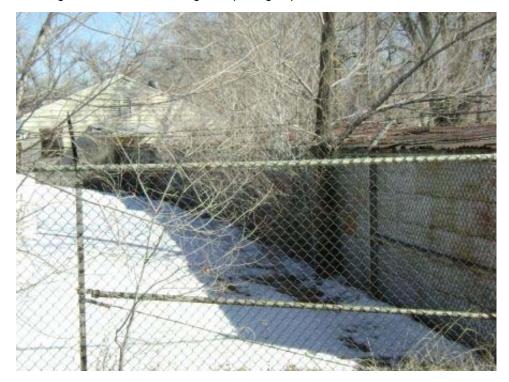
#### **RECREATION SHELTER**

Building 54 West side adjacent fence around water reservoir and pump house (Buildings 47 and 45).

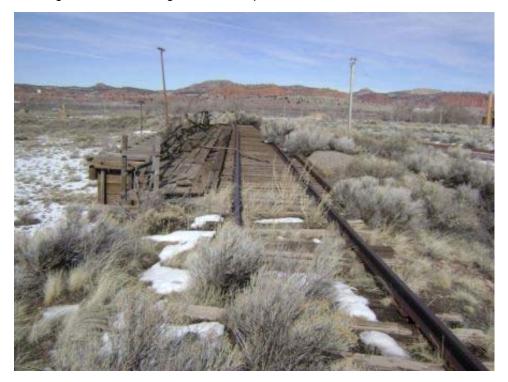
**COAL CHUTE/BIN AND TRESTLE**

Comments: Catwalk in poor condition.

Building 57 Looking north from south end of trestle.

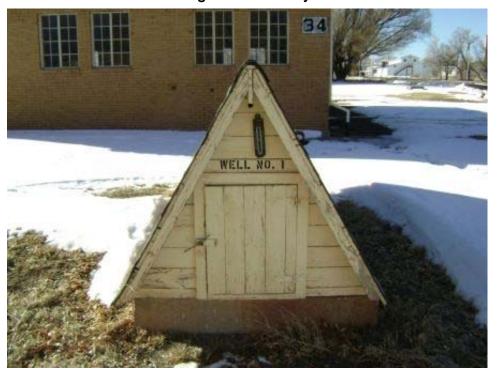
WATER WELL HOUSE NO. 1

Building 61 North side showing access hatch. Building 34 in background.

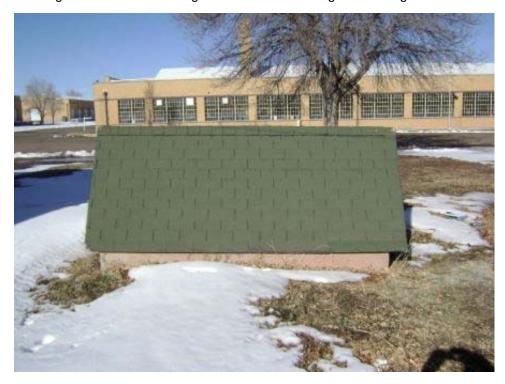
WATER WELL HOUSE NO. 1

Building 61East side looking west. Building 5 in background.

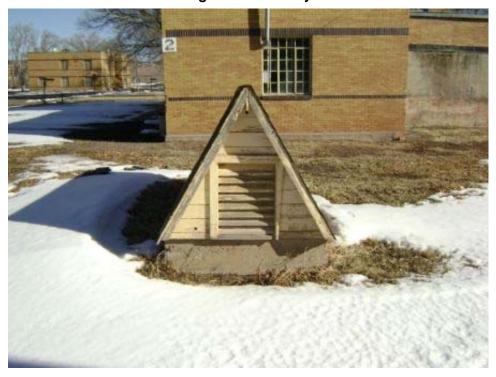
WATER WELL HOUSE NO. 1

Building 61South side looking north. Building 2 in background.

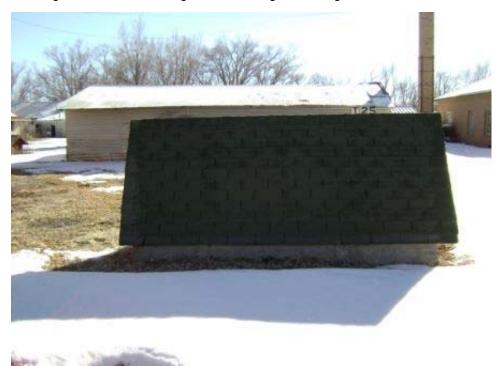
WATER WELL HOUSE NO. 1

Building 61 West side looking east. Building 25 in background.

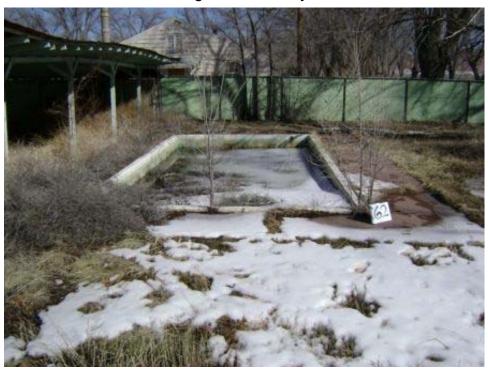
WADING POND

Building 62 Wading pond approximately 2' deep at far end.

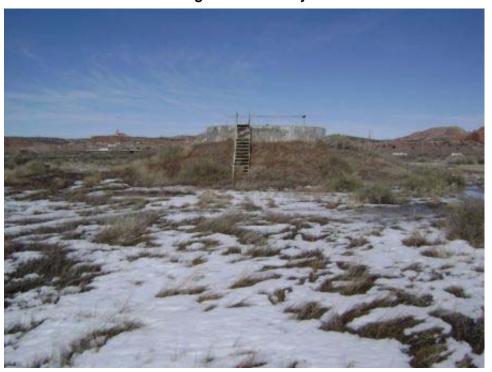
IMHOFF TANK/SEWAGE DISPOSAL PLANT
Building 63 Imhoff tank at sewage treatment plant.

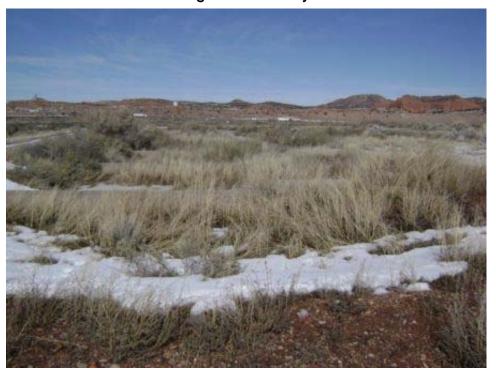
**SLUDGE BED**Building 73 Sludge beds looking north.

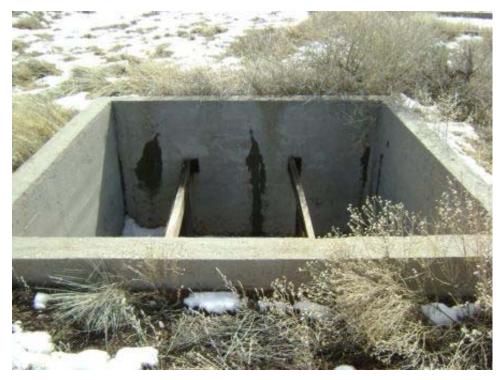
**SLUDGE BED**Building 73 Sludge beds. Diverter box at northeast corner.

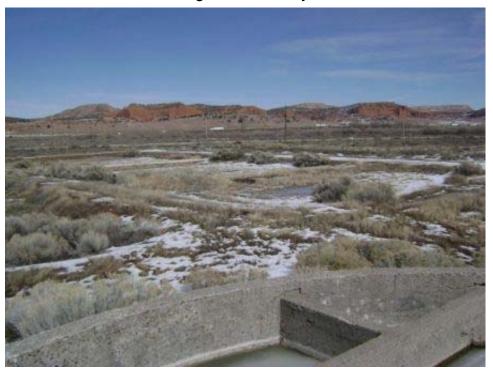
**AERATION/SETTLING PONDS**Building 74 Aeration/Settling ponds.

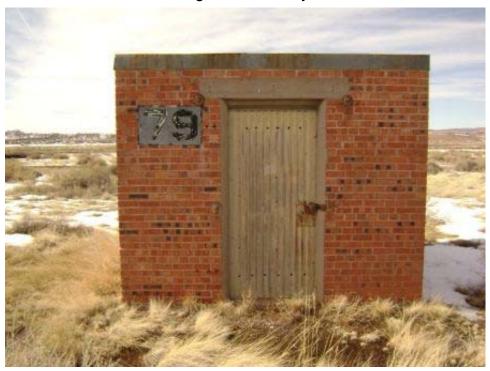
STORAGE VAULT
Building 79 East side looking west.

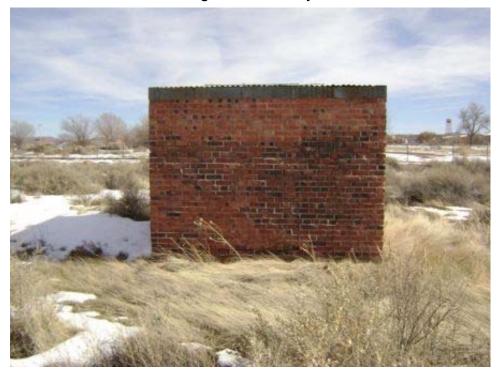
STORAGE VAULT
Building 79 West side looking east.

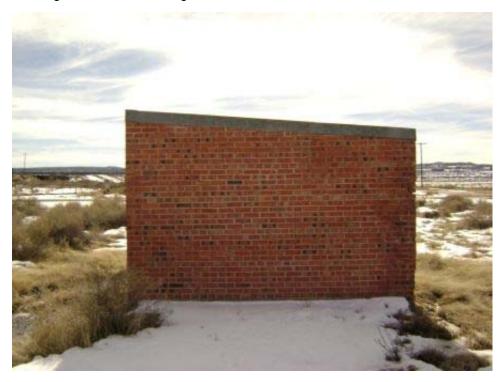
STORAGE VAULT
Building 79 North side looking south.

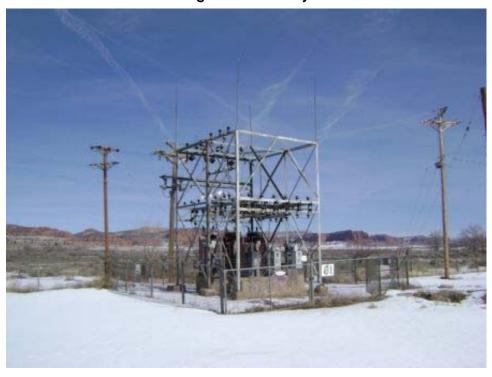
PRIMARY ELECTRICAL SUBSTATION

Comments: Three (3) 200 KVA transformers, three (3) 13.8 KVA transformers

Structure (Building) 81 Main substation. View looking northeast.

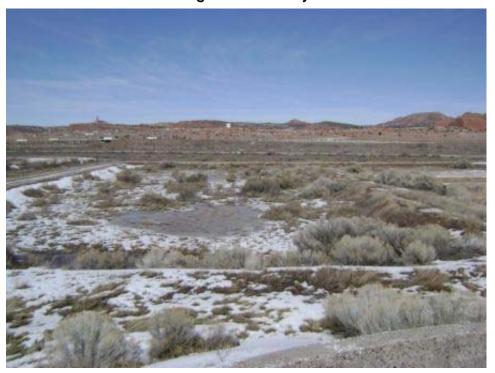
**CONTACT BASIN**

Building 82 Sewer plant contact basin. View looking north.

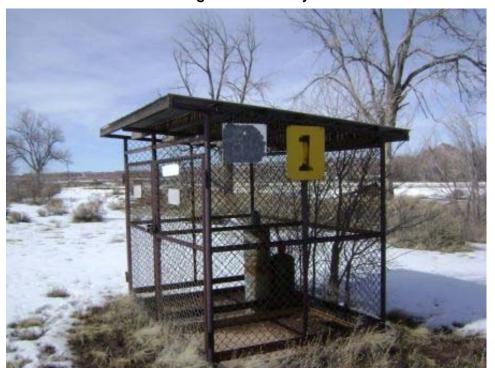
ACETYLENE STORAGE BUILDING

Building 86 Acetylene bottle storage. View looking west.

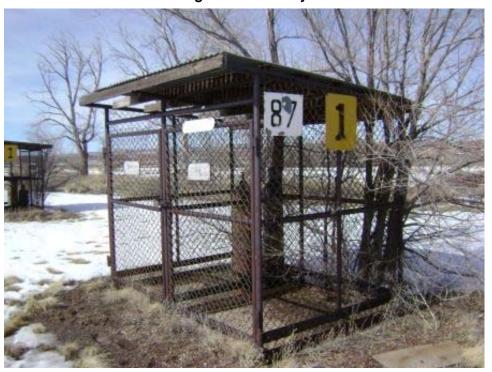
#### **OXYGEN STORAGE BUILDING**

Building 87 Oxygen bottle storage. View looking west. Building 86, acetylene bottle storage, in background.

Comments: 4' 6" Roof overhang on open end.

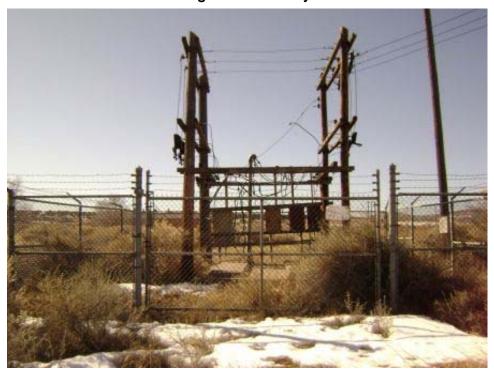
**SUBSTATION**

Comments: Surrounded by chain link fence (30' 6" x 26' 6")

Deactivated B503 Substation South side looking north. Building 515 in background.

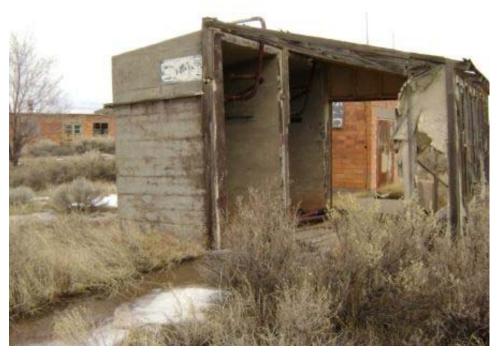
#### PRIMARY COLLECTOR BARRICADE

Building 509 Southwest corner looking northeast. Building 522 in background to left, 510 to right through opening. Wood and plastic sheeting portion of structure were temporary construction added after initial construction.

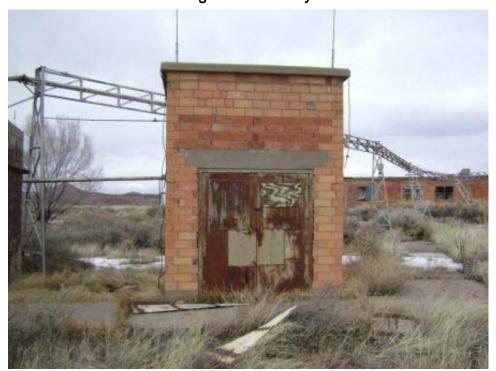
#### **VACUUM PRODUCER BUILDING**

Comments: Presumed asbestos containing material in overhead pipe gasket.

Building 510 South side looking north. Building 522 in background. Note vacuum lines and support structure remain.

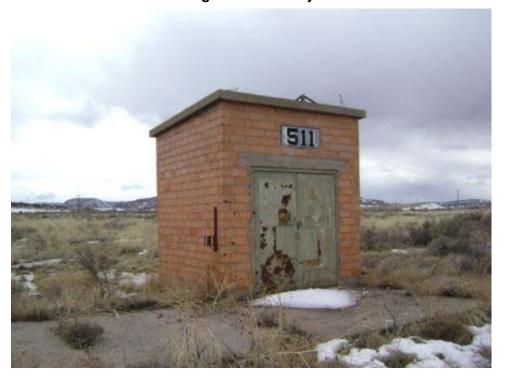
SERVICE MAGAZINE

Comments: Building sealed, no interior inspection.

Building 511 South and east side.
