# FORT WINGATE DEPOT ACTIVITY McKINLEY COUNTY, NEW MEXICO

# SURVEY OF BUILDINGS IN THE ADMINISTRATION AND WORKSHOP AREAS

U.S. ARMY CORPS OF ENGINEERS FORT WORTH DISTRICT

**April 9, 2008**

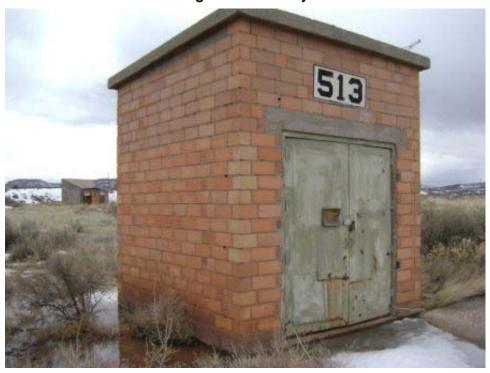
Building 513 North and east side. Building 514 in background.

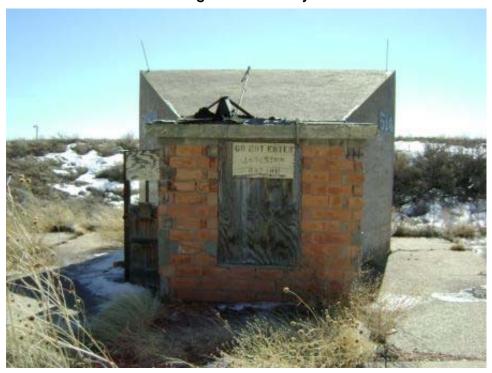
Building 514 North side looking south. Note poor condition of brick.

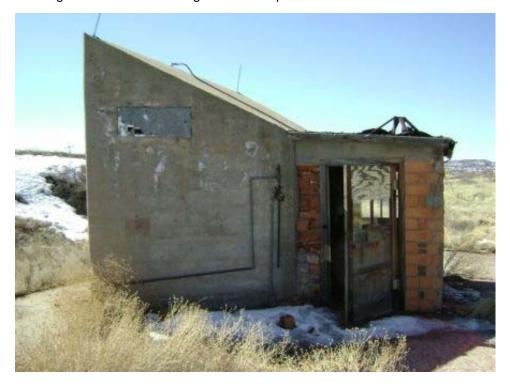
Building 514 East side looking west.

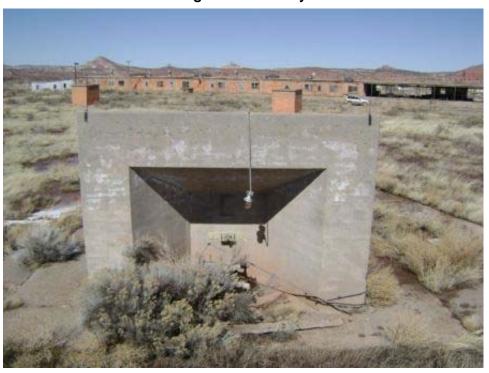
Building 514 South side looking north. Deboostering machinery has been removed

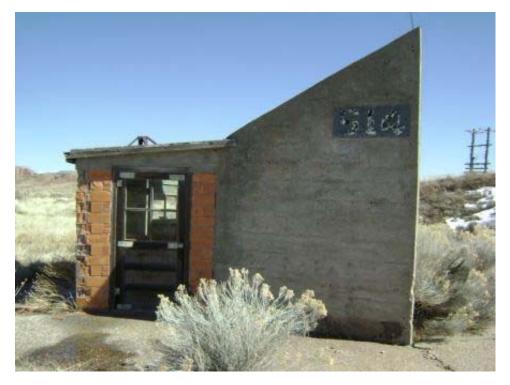
Building 514 West side looking east. Brick portion house deboostering machinery control room is in extremely poor condition.

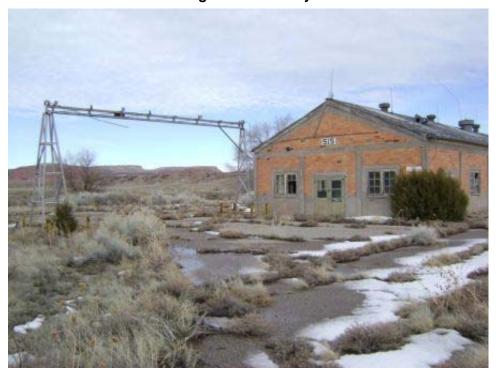
Building 515 West end looking northeast. Overhead structure carried steam lines for steam plant located north of Building 503.

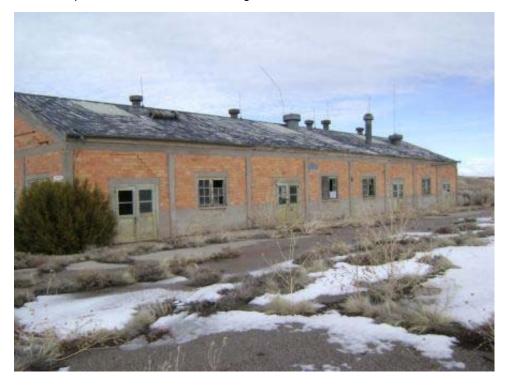
Building 515 South side of building. Note condition of roof materials and wall tiles.

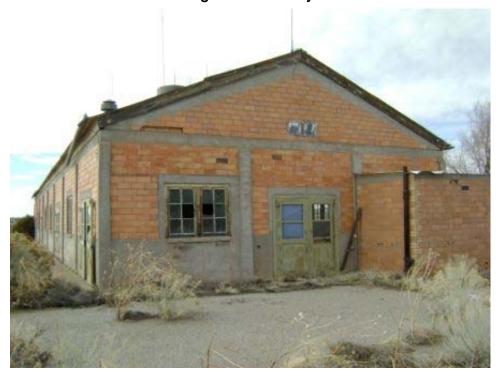
Building 515 East end of structure looking west. Shed structure contains restroom facilities.

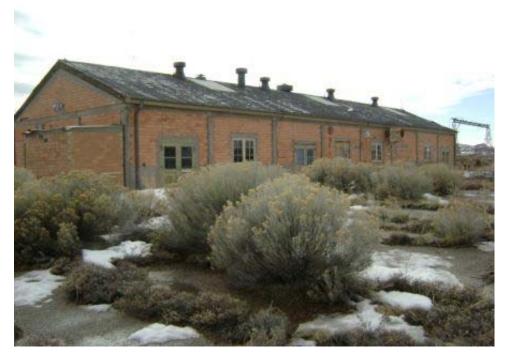
Building 515 North side of building.

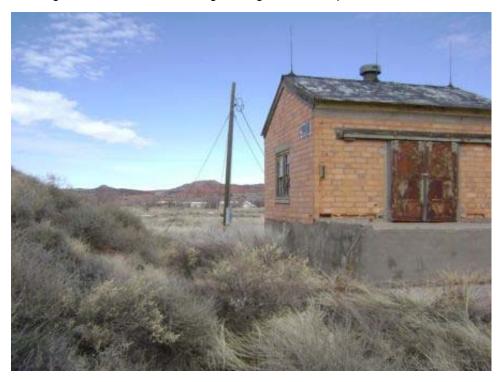
Building 516 West side of building looking north.

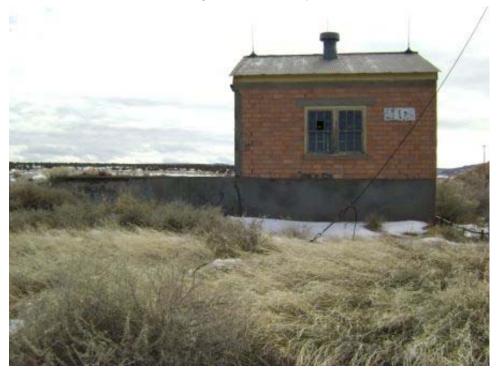
Building 516 North side of building looking south. Ramp to left leads to entrance to Building 522.

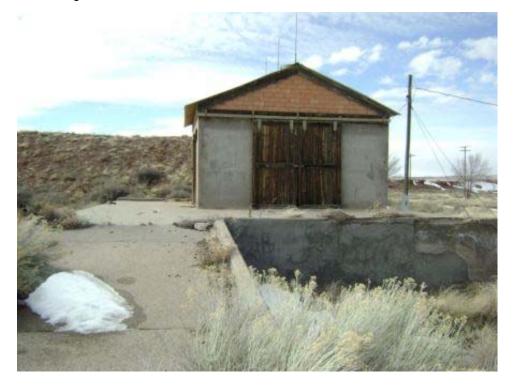
Building 516 East side looking west.

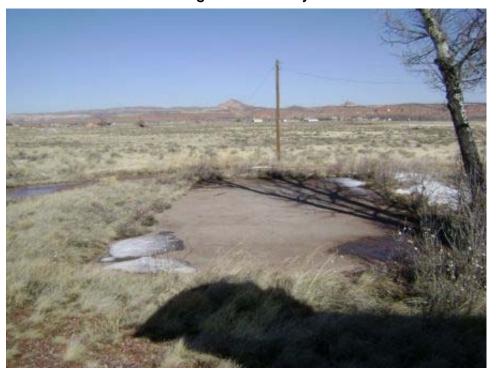
Building 517 Slab View looking northwest.

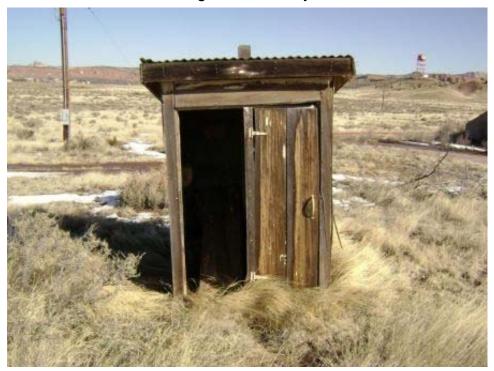
**LATRINE**Building 517L Latrine at QA Test Area/Building 517. South side looking north.

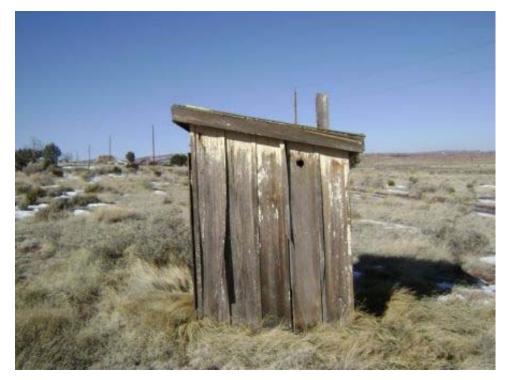
**LATRINE**Building 517L East side looking west.

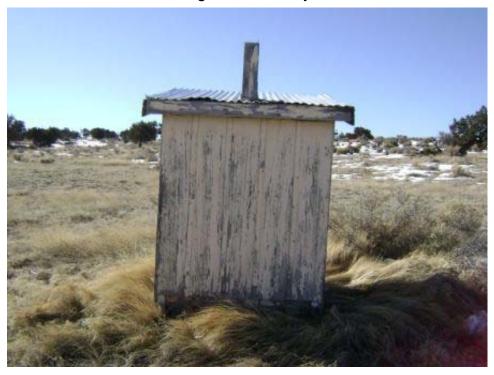
**LATRINE**Building 517L North side looking south.

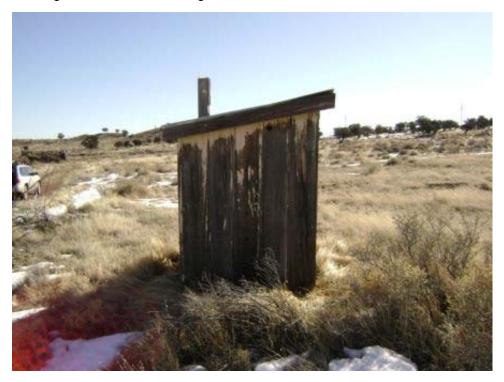
**LATRINE**Building 517L West side looking east.

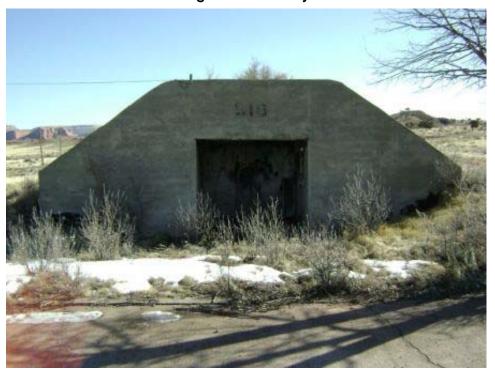
Building 518 South side looking north.

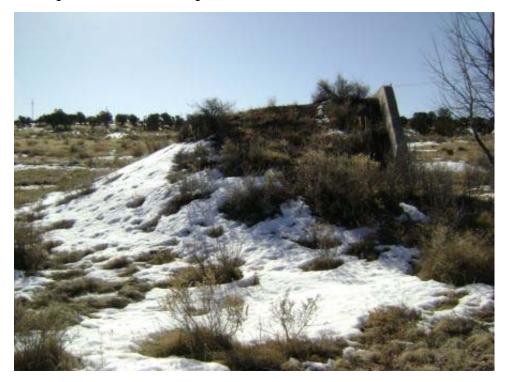
Building 518 West side looking east.

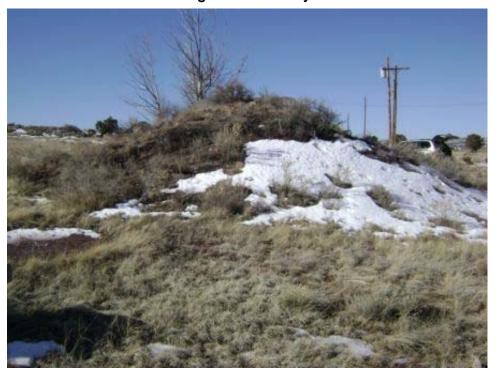
Building 518 North side looking south.

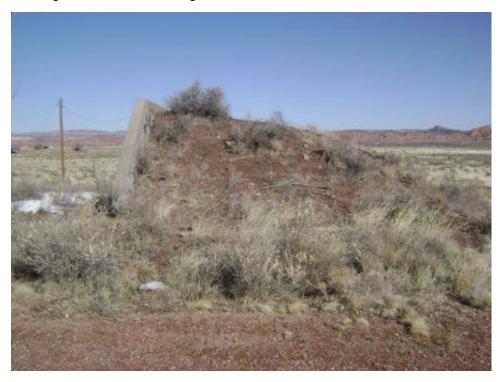
Building 518 East side looking west.

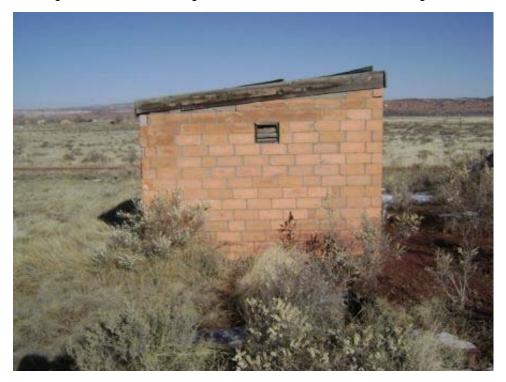
Building 519 East side looking west.

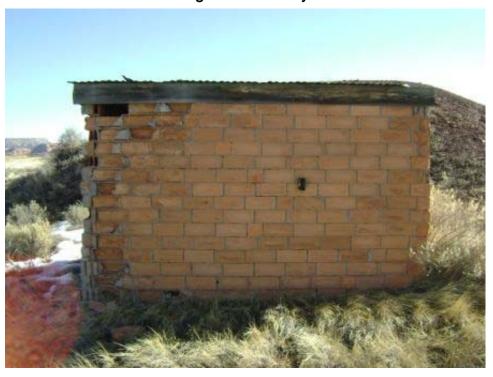
Building 519 South side looking north. Note condition of wall tiles on southwest corner.

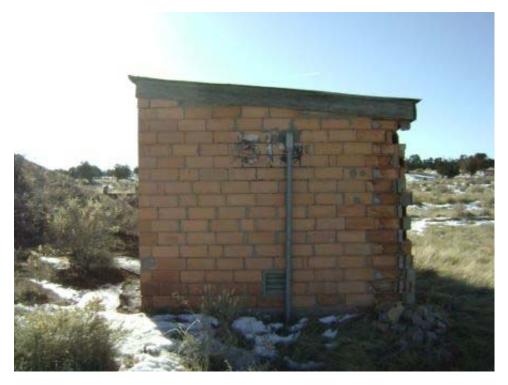
Building 519 West side looking east.

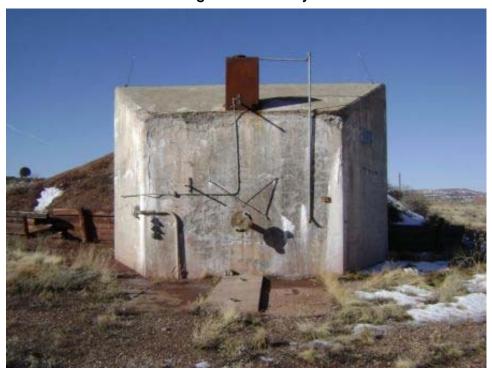
Building 520 North side looking south. Note deterioration of concrete.

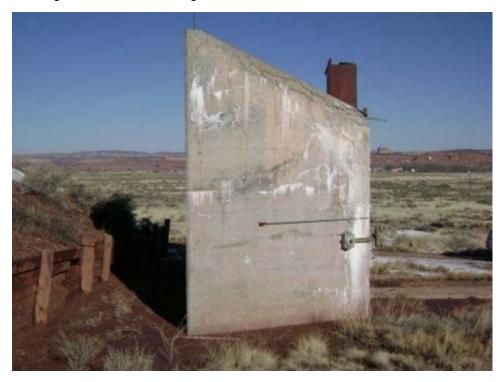
Building 520 East side looking west.

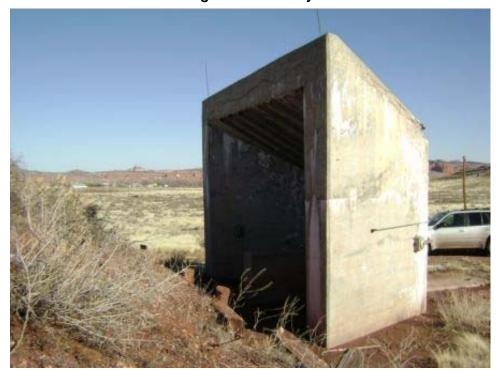
Building 520 South side

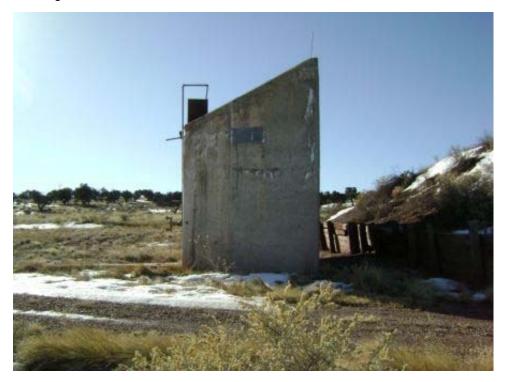
Building 520 West side looking east.

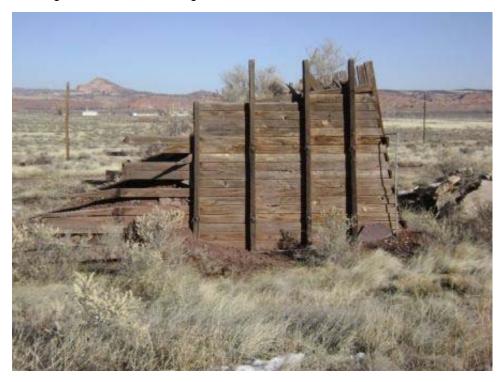
Building 521 East side looking west. Note condition of timbers.

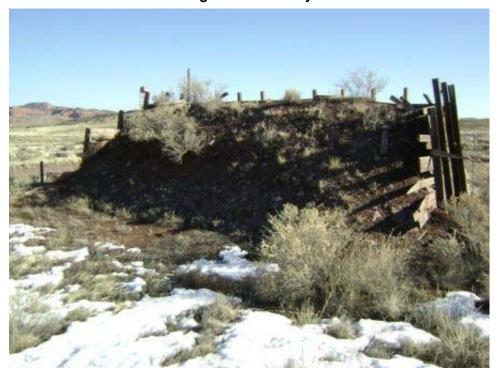
Building 521 South side looking northwest.

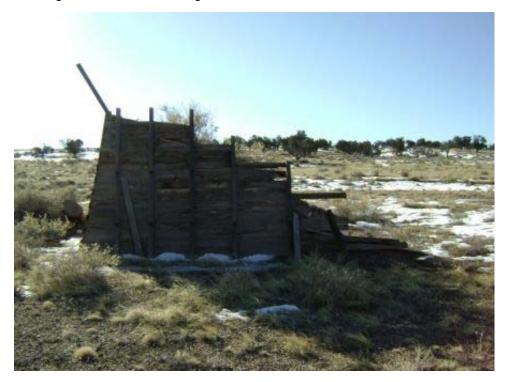
Building 521 West side looking east. Note condition of timbers.

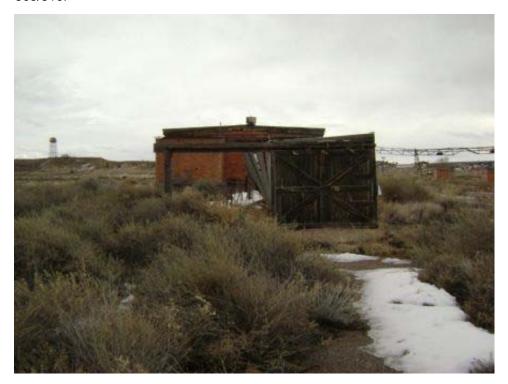
Building 522 West end of building. Note deterioration of covered ramp into building.

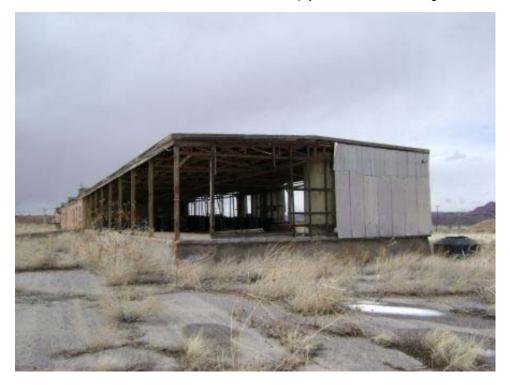
Building 522 East end of building looking west.

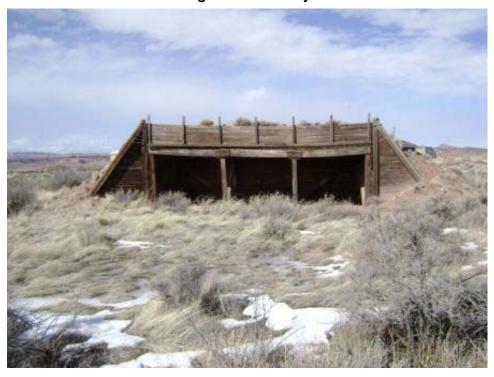
Comments: One (1) brace down.

Building 524 South side looking northwest. Building 541/542 in background. Note sag due to missing support.

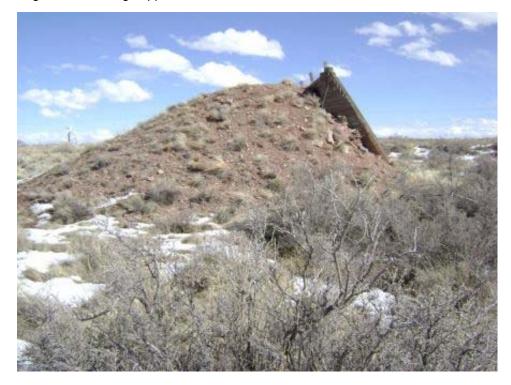
Building 524 West side looking east.

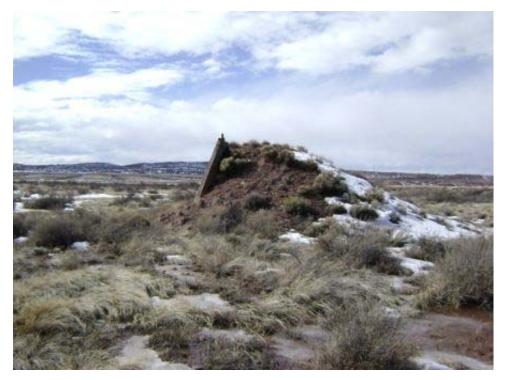
**SAFETY SHELTER**Building 524 East side looking west.

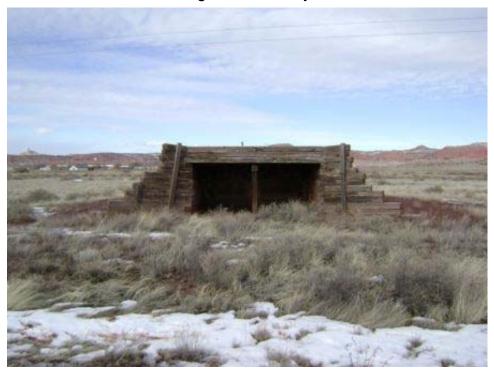
Comments: Earth cover severly erroded and no longer covers top of structure.

**SAFETY SHELTER**Building 526 South side looking north.

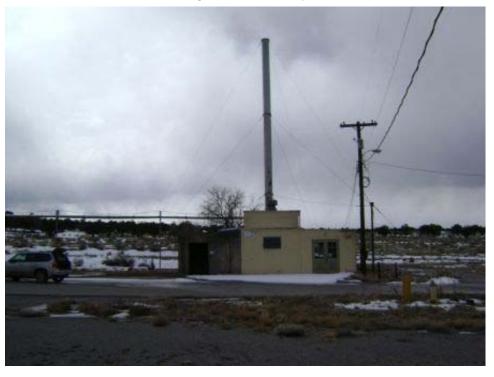
HEATING PLANT/AMMUNITION NORMAL MAINTENANCE BUILDING

Building 527 North side looking south. Note steel boiler stack. Elevated insulated steam lines extend to Building 528.

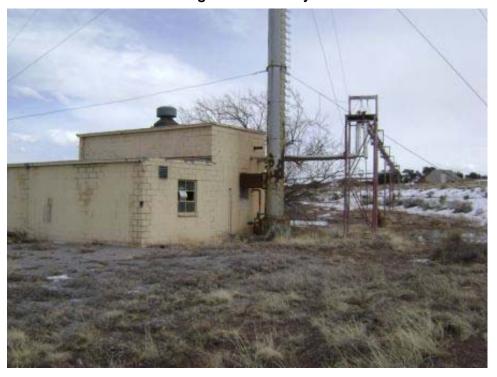
HEATING PLANT/AMMUNITION NORMAL MAINTENANCE BUILDING

Building 527 South side looking northeast. Note gas service entrance adjacent to boiler stack.

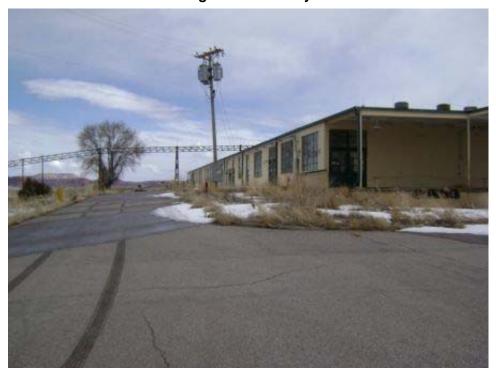
#### AMMUNITION MAINTENANCE SHOP BUILDING

Building 528 North side of building looking east. Note overhead line to Building 550.

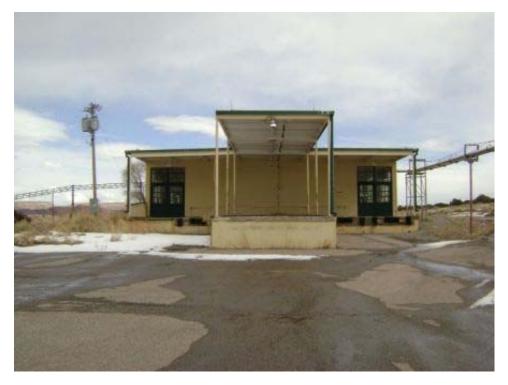
#### AMMUNITION MAINTENANCE SHOP BUILDING

Building 528 West side of building looking east. Note overhead line on left to Building 550 and overhead steam lines on right from boiler in Building 527.

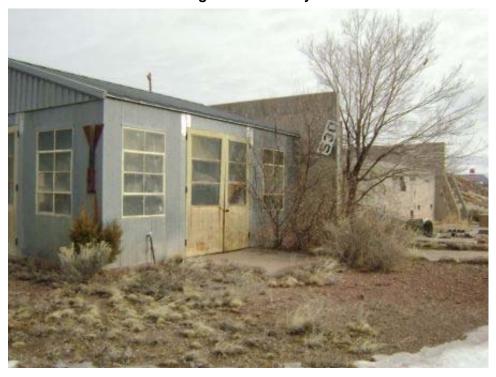
#### FORMER DEACTIVATION FURNACE

Building 530 South side of building looking northeast. Sumps/pits located in concrete apron adjacent to CMU block portion of structure.

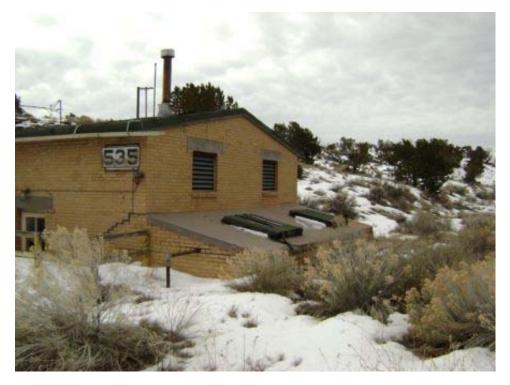
HEATING PLANT/INSPECTORS WORKSHOP

Building 535 West side of structure looking south. Note coal bunker.

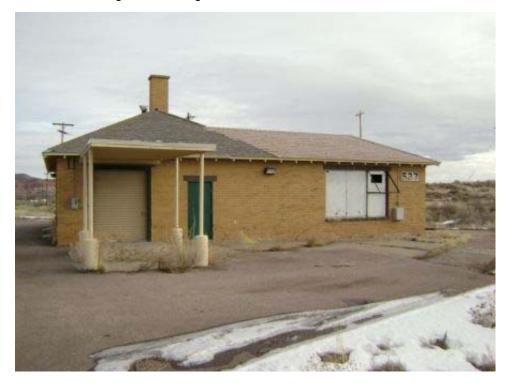
#### **PESTICIDE STORAGE**

Building 537 South side looking north. Note change in roofing material and material used as glass replacement.

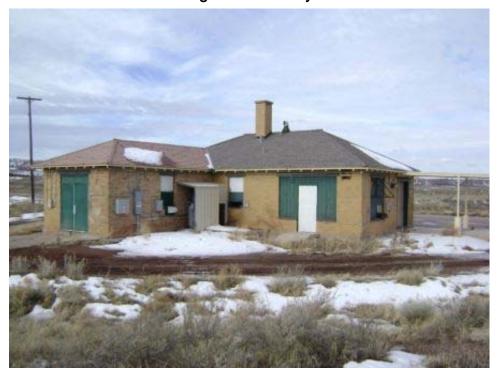
#### **PESTICIDE STORAGE**

Building 537 East side looking west. Note air compressor and hydraulic power unit under shed cover. Concrete pad adjacent shed cover, below small window houses coal loading manholes leading to basement coal storage.

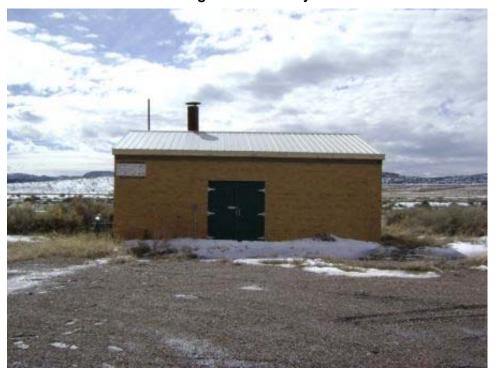
HEATING PLANT/AMMUNITION WORKSHOP

Building 541 North side of structure looking south. Note metal roofing.

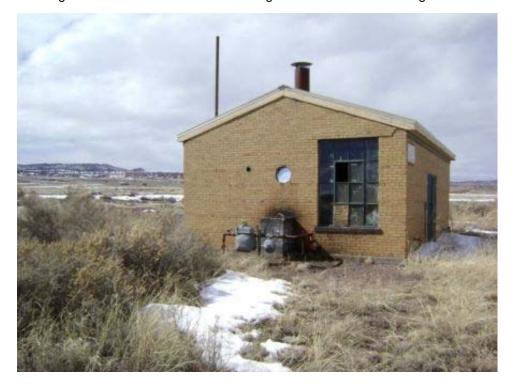
Building 541 East side of building looking west. Note old boiler stack base and opening in wall. Gas service for this facility is metered.

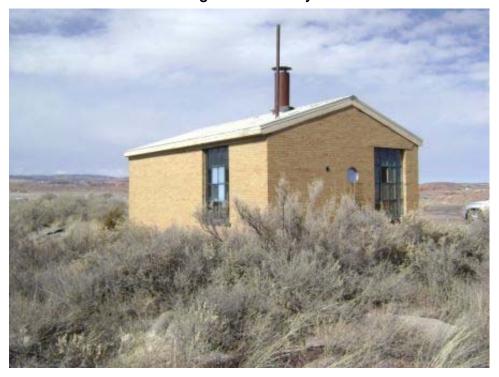
Building 541 South side looking west.

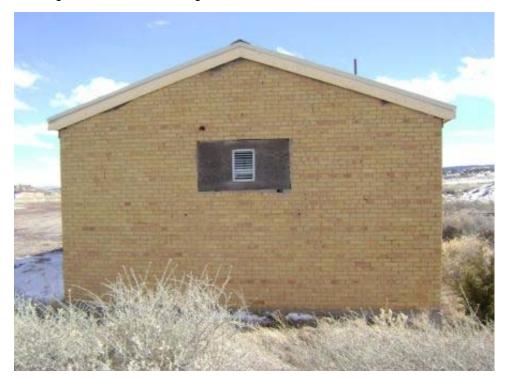
Building 541 West side looking east.

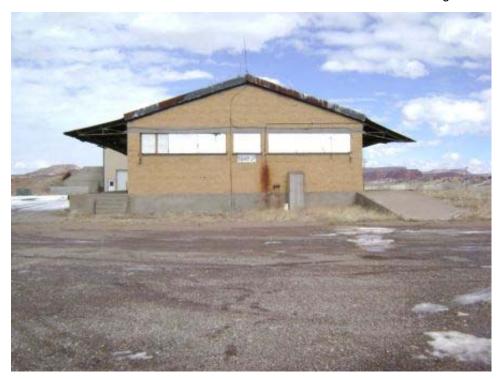
Building 542 South side looking north.

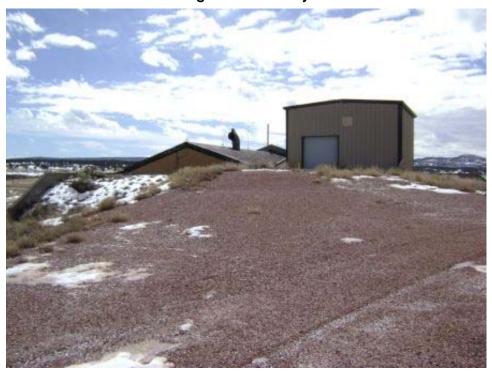
**B542 ANNEX**Building 542A North side looking south. Upper portion of 542A. 542 to left.

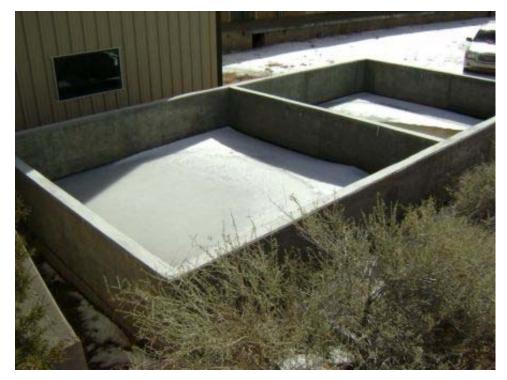
**B542 ANNEX**Building 542A Reservoir/holding tanks.

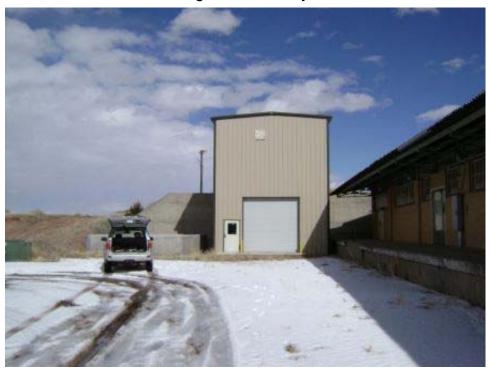
Building 543 South side looking north. 543 is concrete retaining wall to rear of buildings.

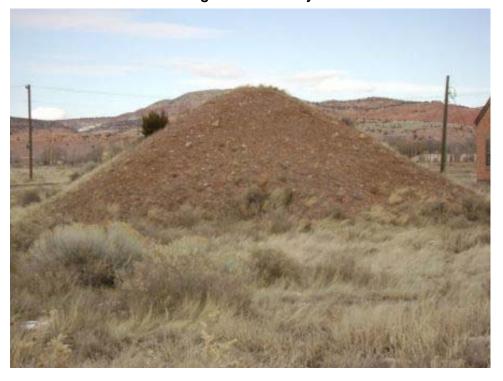
**EARTH BARRICADE**Building 544 South side looking north.

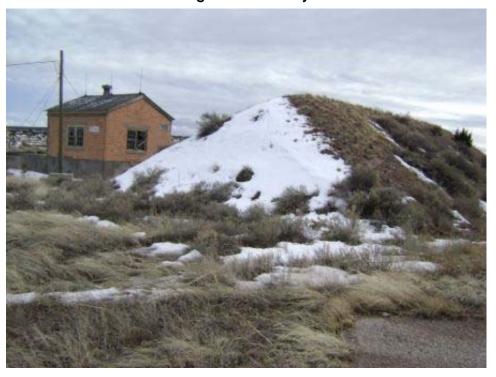
Building 544 North side looking southeast. Building 516 in background.

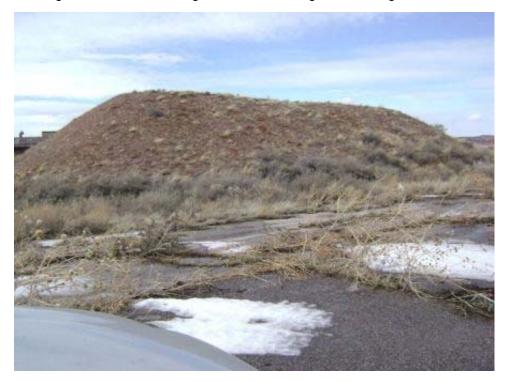
Building 544 East side looking northwest.

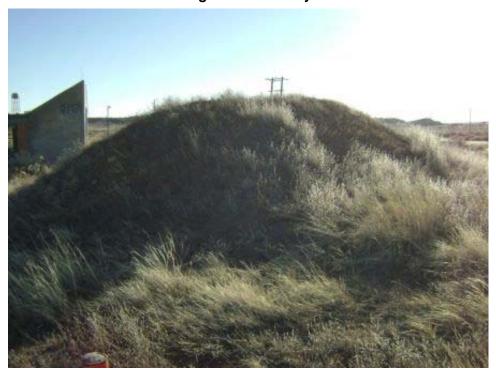
Building 545 West side looking east. Building 514 to left.

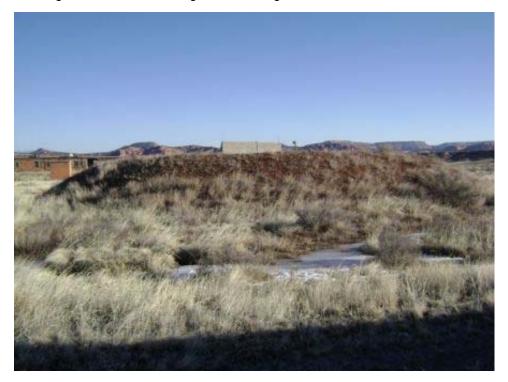
Building 545 South side looking north. Building 514 behind berm, 512 and 522 in background.

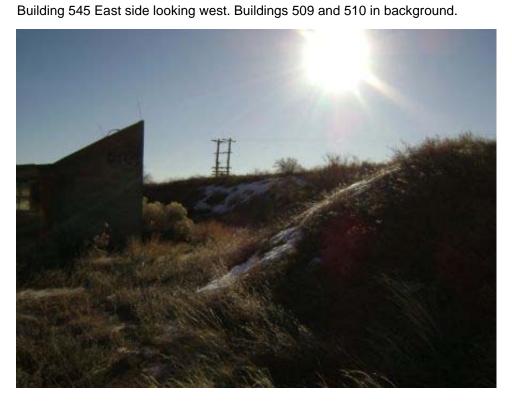
Building 545 North side looking east.

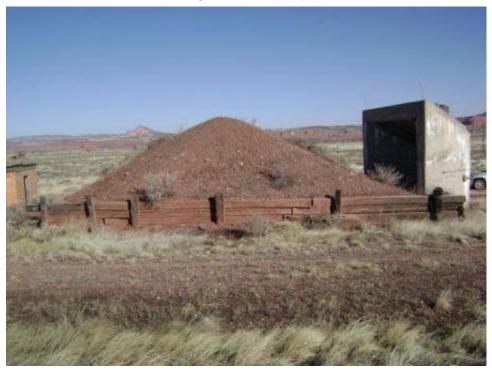
Earth Barricade East side looking west.

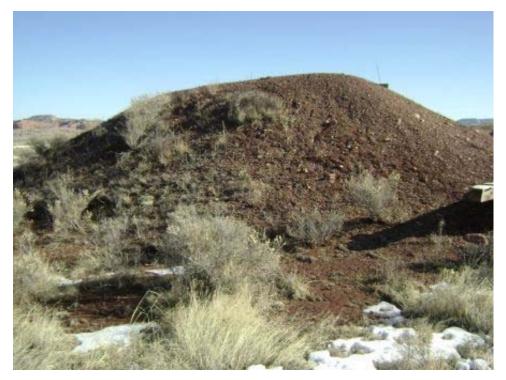
Earth Barricade South side looking north.

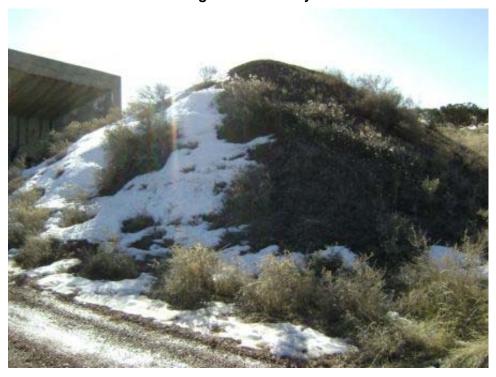
**EARTH BARRICADE**Earth Barricade West side looking east.

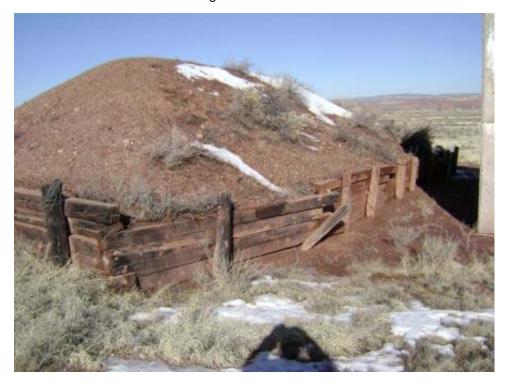
Earth Barricade North side looking west. Note condition of timbers.

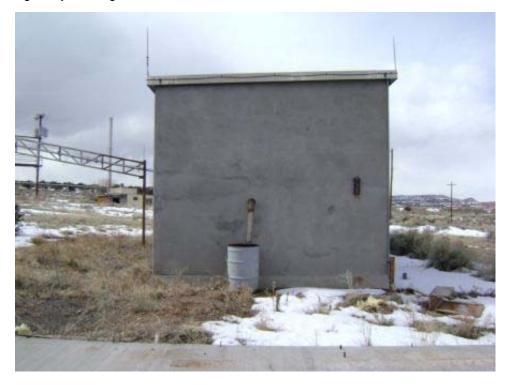
Building 550 East side looking west. Note vacuum line to Building 528.

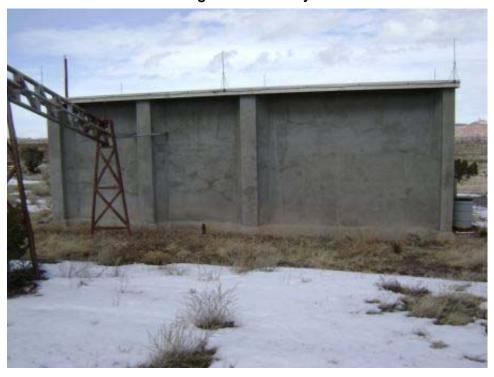
Building 550 South side looking north. Line runs to Building 528.

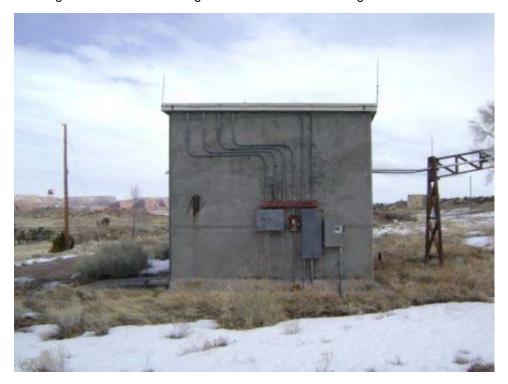
Building 550 West side looking east. Note electric service panels.

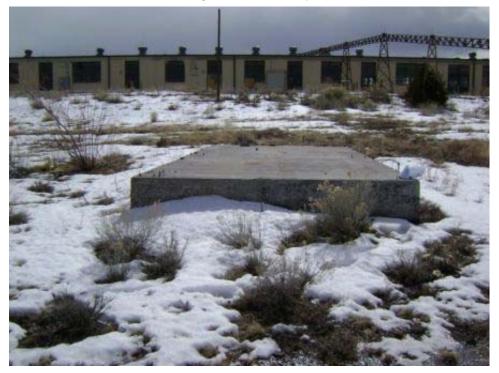
**B550B**Building 550B Structure removed leaving foundation. Building 528 in background.

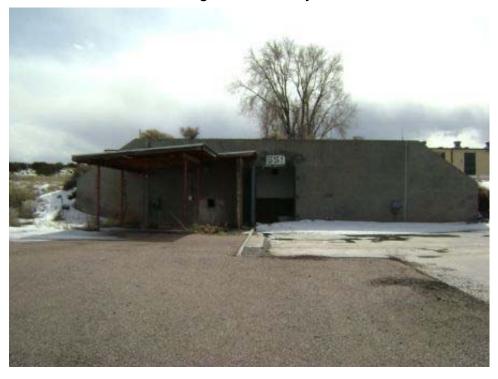
Building 551 North side looking south. Building 528 in background.

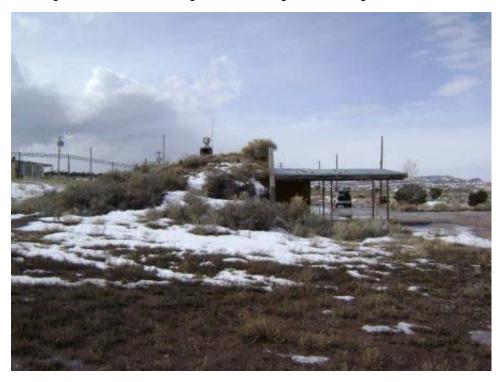
Building 551 East side looking west.

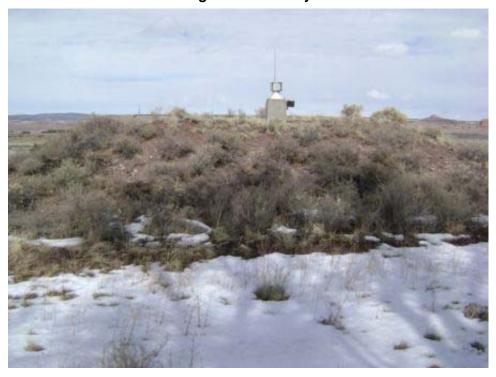
Building 551 South side looking north.

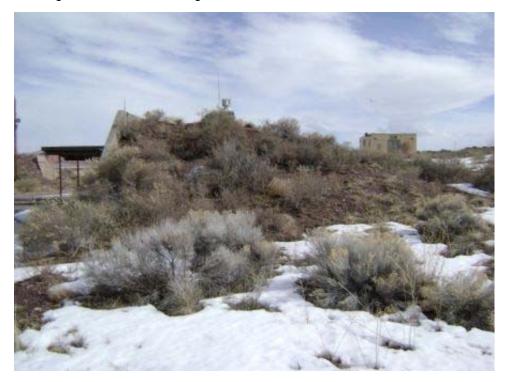
Building 551 West side looking east. Building 529 in background.

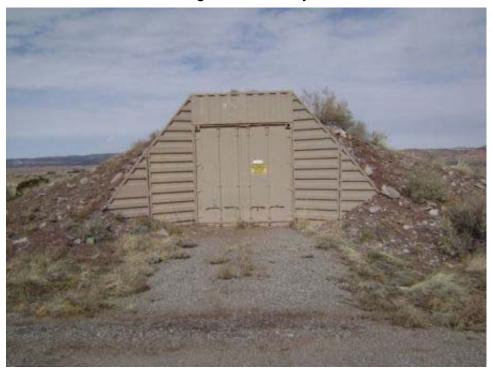
**B551B**Building 551B South side looking north.

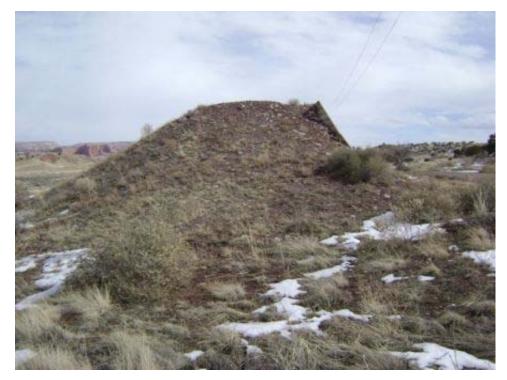
**B551B**Building 551B West side looking east.

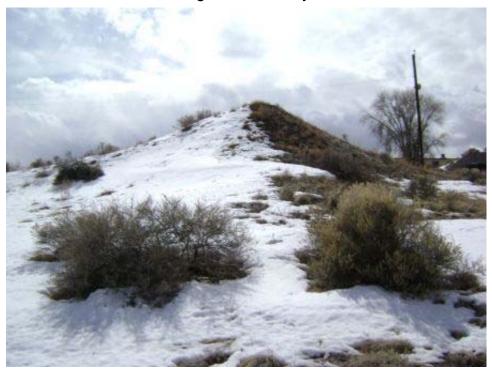
**B551B**Building 551B South side looking north.

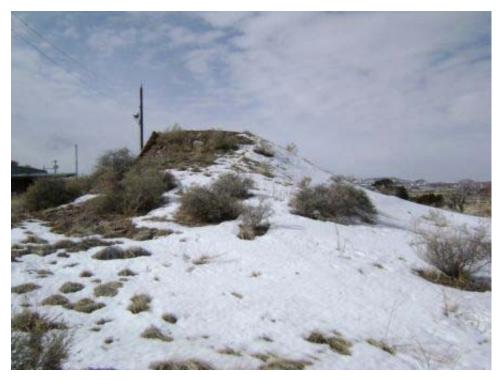
**B551B**Building 551B East side looking west.

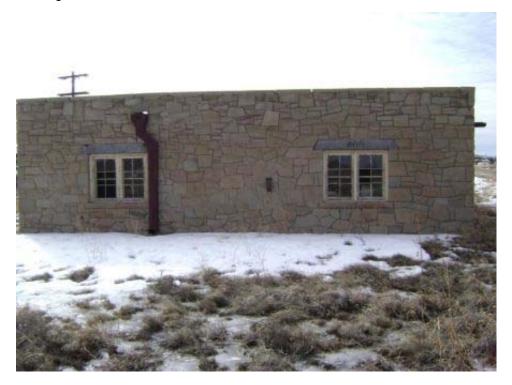
Building 600 North side looking south. Notice roof drain.

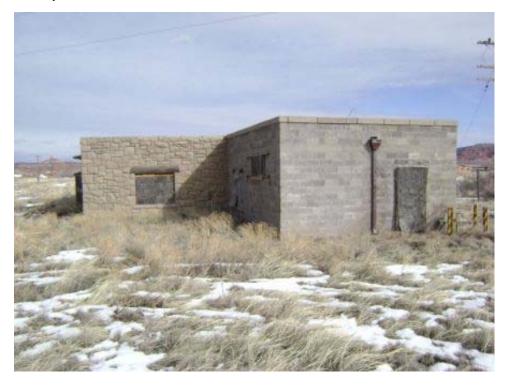
Building 600 South side looking north. CMU block addition contains boiler equipment.
